USOY NATURAL DAM: PROBLEM OF SECURITY (LAKE SAREZ, PAMIR MOUNTAINS, TADJIKISTAN)

A.R. ISCHUK

Institute of Earthquake Engineering and Seismology of the Academy of Sciences of the Republic of Tadjikistan

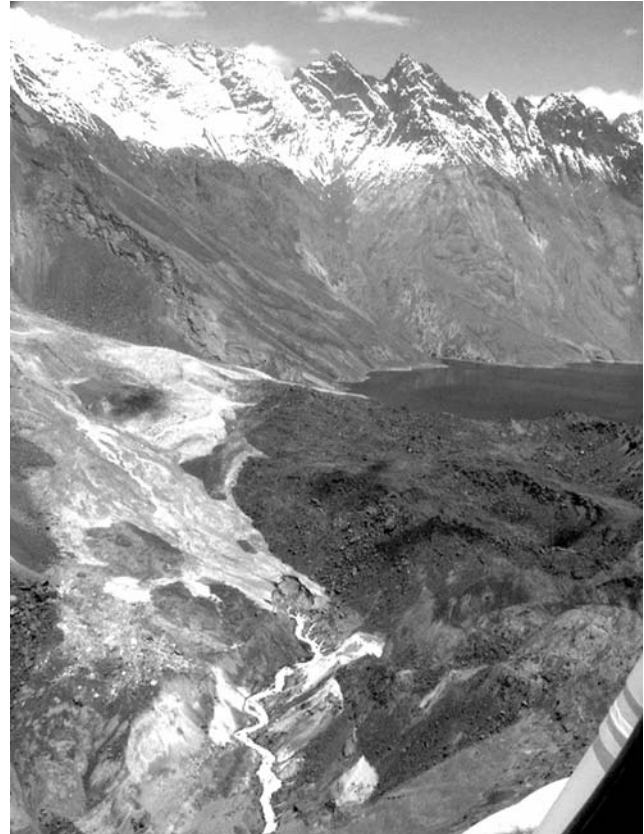
From north to south three steps are clearly visible in the central

Figure 2 - Helicopter view on the proximal (northern) part of the Usoy Dam

and southern parts of the dam. The first (upstream) step looks like the ridge with very steep (60-70°) slope. The crushed and broken surface of the next step is clearly visible from this ridge. Along the downstream face of the dam (close to the western scar’s wall) a large cone of fine debris flow material has been deposited since the dam formation. This debris flow deposit rests partly on the blocky dam material and this depositional mass is terminated by a local canyon on the downstream face of the dam, which has developed due to erosion caused by the seepage flow.

The canyon eroded by the filtrating water will progress in its actual direction, along the contact between the collapsed carboniferous material and the debris flow and mudflow sediments (see figure 2). In this case the head of the canyon would progressively approach the zone of the lowest part of the dam, but significantly slower than it would have been along a direction transverse to the dam body.

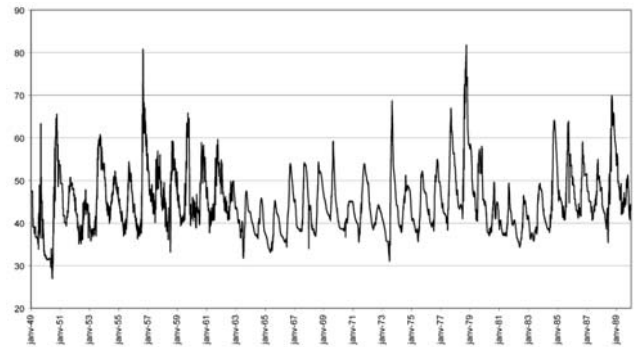
The lake level increased very rapidly during the 1911-1914 and when it reached the 3050 m, the filtration started in spring 1914 with about 2 m³/s discharge. In 1925 discharge reached 78 m³/s in summer, and was decreasing to 50 m³/s up to 1940. After that during long time the annual discharge was more stable, though varying from 32 m³/s (in winter) to 73 m³/s (in summer). The highest level of 3270 m was recorded in 1994 when maximum depth reached 520 m and the lowest part of the dam was only 38 m higher. The perennial observations indicate very slow increase of the seepage outflow (Figure 3) and attenuating growth of the average, maximal and minimal lake levels (Figure 4).

Figure 3 - Evolution of seepage outflow from 1949 to 1989 (m³/s) (after BIEDERMANN & ATTEWILL, 2002)

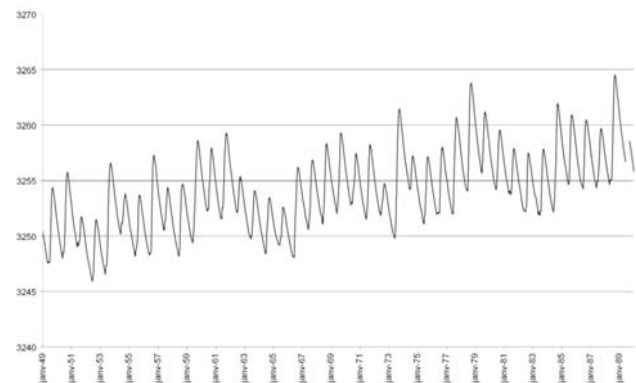
Figure 4 - Evolution of the Sarez Lake level from 1949 to 1989 (after BIEDERMANN & ATTEWILL, 2002)

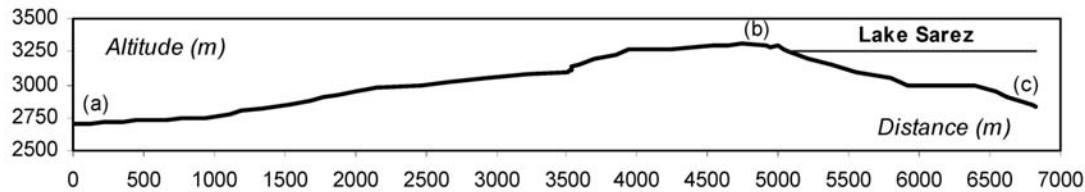
I hold the second opinion. The stability of the dam with regard to very compact structure and huge dimensions of the dam body (Figure 5) is admitted to be guaranteed with a high safety factor. The morphology of the dam surface however shows that some secondary movements have taken place. As a matter of fact a settlement of up to 75 m is mentioned in various reports. The origin of such deformations is not known, and can be due to compaction (earthquake induced or not). But the latest investigation showed that contemporary surface subsidence does not exceed 5-10 mm per year (VINNICHENKO, 2000; STUCKY, 2001).

Figure 5 - The Ussoy Dam cross-section (after BIEDERMANN & ATTEWILL, 2002)
