SINES BREAKWATER HARBOUR: THE OSOM+ MONITORING PROGRAM

This paper presents an application of the OSOM+ program to the study case: the west breakwater of the port of Sines

The (visual and drone) inspections campaigns of this breakwater were carried out on November 13th, 2018.

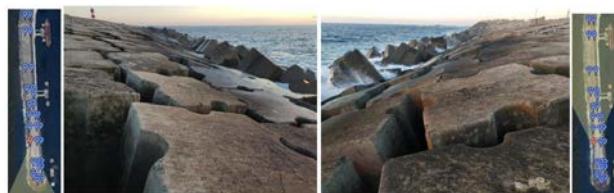
Figure 7 shows a photograph taken at a predefined point of Sines west breakwater (point 27, located in the seaward side of section G). Also Figure 8 shows one output of the visual observation in the Sines west breakwater (Point 30).

Fig. 7 - Systematic photos took during visual observation in the Sines west breakwater (Point 27).

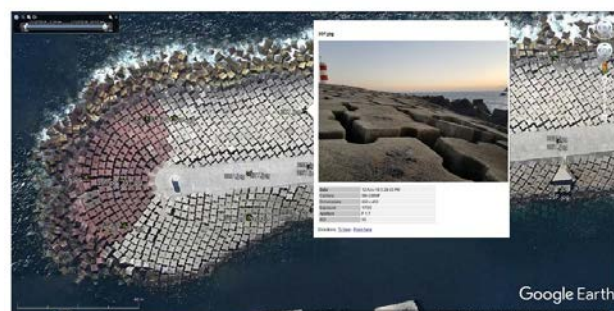
Fig. 8 - Output of the visual observation in the Sines west breakwater (Point 30).

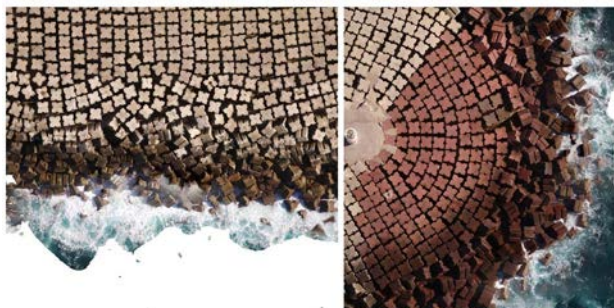
Fig. 11 - A detail (40%) of the orthomosaic of the section D and the head of the west breakwater.

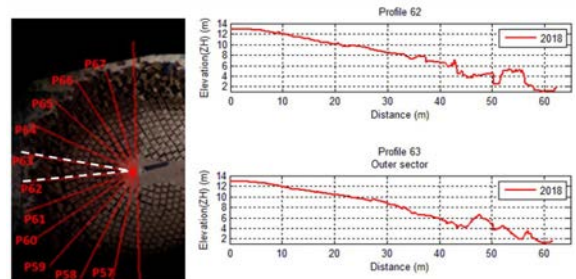
Also, profiles at more vulnerable points of the structure may be produced: Figure 13 shows profiles P62 and P63 of Sines west

Fig. 13 - Profiles (P62 and P63) of Sines west breakwater.

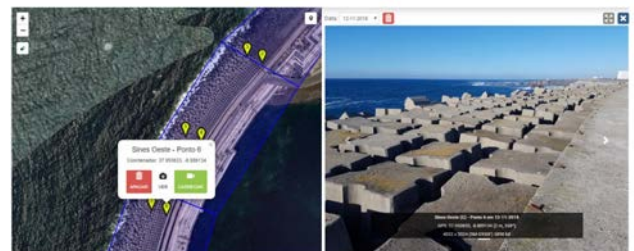
Fig. 14 - ANOSOM_WEB interface. Searching photos in real-time. Example of a photo from campaign of 12th November 2018, at Point 6 (Section C).
