## 13<sup>TH</sup> AUGUST 1935: A CATASTROPHIC DAM FAILURE IN THE ORBA VALLEY (PIEDMONT, ITALY)

VITTORIO BONARIA(\*) & GIOVANNI TOSATTI(\*\*)

### ABSTRACT

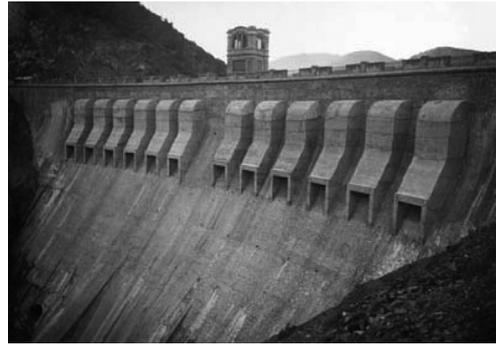
Fig. 2 - The Main Dam of Bric Zerbino showing the twelve dam siphons (O.E.G. photo, 1925)

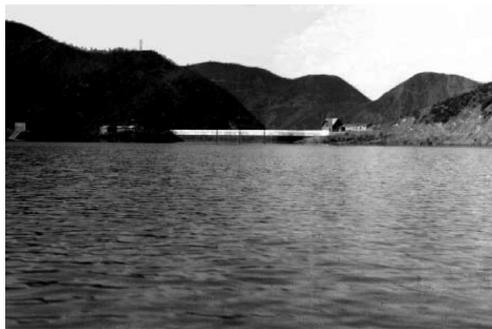
Fig. 3 - The reservoir and Secondary Dam of Sella Zerbino (photo from the mid-1920s)

Zerbino (Fig. 3), was a massive wall of Portland cement on top of which ran the road leading to the adjacent Main Dam.

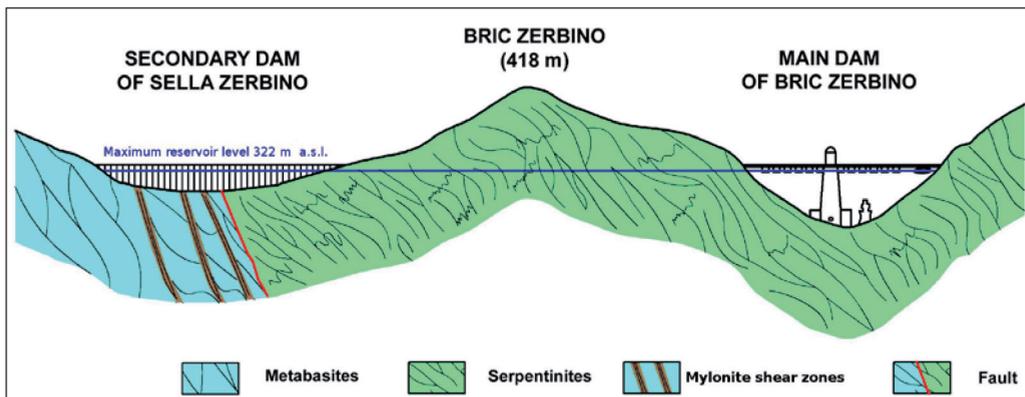
Zerbino, the tectonic boundary between the antigorite serpentinites, which make up the backbone of Bric Zerbino (right hydrographic side), and the metabasites cropping out on the opposite side of the valley is well exposed (CAPPONI *et alii*, 1988). Furthermore, the whole area is characterised by intense cataclasis due to the presence of numerous fault systems (VIGO, 1998) (Fig. 5).

Fig. 5 - Geological section across the Orba Valley reservoir showing the mylonite shear zones in correspondence with the Secondary Dam (modified after CAPPONI *et alii*, 1988)

Therefore, notwithstanding its modest size, it was the Secondary Dam which collapsed since it had been built on poorly compact and intensely jointed rocks, whereas the still standing Main Dam was founded on sounder serpentinites.

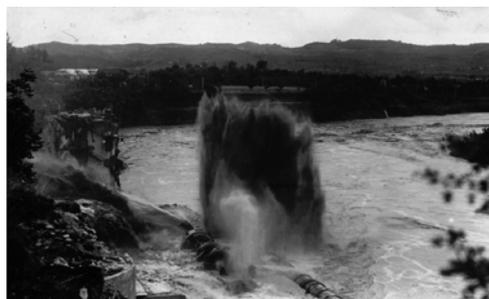
Fig. 6 - Destruction of the hydroelectric plant during the emptying of the penstock (August 1935)

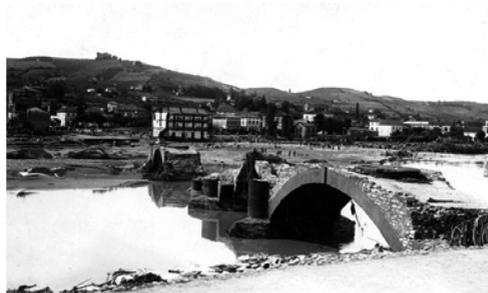
on the valley downstream, bringing death and destruction to the villages of Molare, Ovada and several other hamlets (Fig. 7). There were 111 ascertained victims, half of whom were from Ovada. 90 houses and 4 bridges were destroyed and the farming activities of the mid-lower Orba Valley severely compromised. The total damage caused by this disaster was estimated at over 45 million lire of the time.

Fig. 7 - Aftermath in the Orba Valley by the village of Ovada (August 1935)

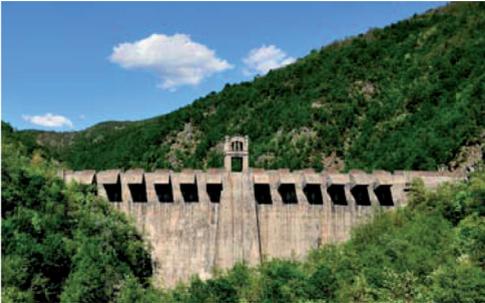
Since the collapse of the Secondary Dam, the Torrent Orba has found a new route across the rock sill of Sella Zerbino whereas the Main Dam is still standing. In what used to be the reservoir a vast wetland has developed with the presence of numerous vegetal and

Fig. 8 - The surviving Main Dam of Bric Zerbino as it appears today (June 2012)
