RESERVOIR BANK SLOPE IN LAXIWA HYDROPOWER STATION, CHINA

DEXUAN ZHANG^(*) & GONGHUI WANG^(**)

ABSTRACT

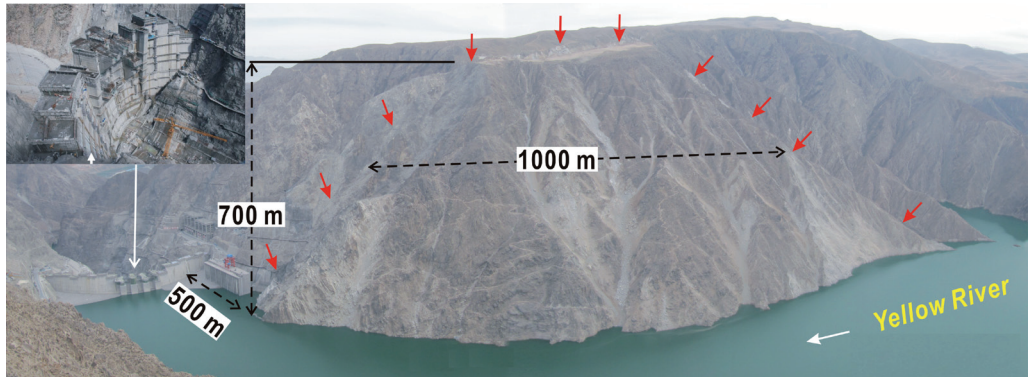
The landslide is located on the right bank upstream from the Laxiwa Hydropower station, 500-1700 m far from the dam (Fig. 2). The valley here is narrow and steep with the right slope's angle ranging from 38 to 46 degrees. The original water surface was 2,254 ~ 2,257

Fig. 2 - View of Guobu slope on the upper stream of Laxiwa dam after impoundment (Photo on 2010/1/14). Arrows show the boundary of the landslide

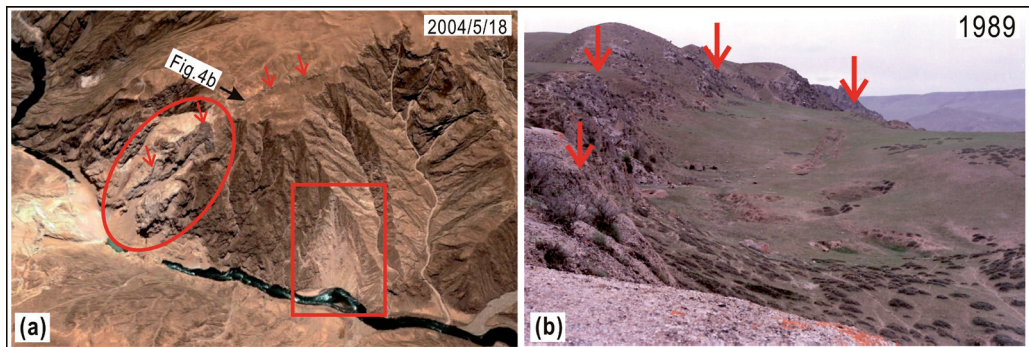
Fig. 3 - Oblique view of Guobu slope(a) from Google Earth, and the views of crest of Guobu slope at different time (b)

m a.s.l. Fig. 3a shows a view of the whole area from Google Earth that was based on the satellite images of May 18, 2004, while Fig. 3b shows the handmade photo of the crest that were taken in 1989. The crest of Guobu Slope is a triangular in plan view and relatively flat 'terrace', 750 m long and 50~290 m wide at 2930~2950 m a.s.l., ~700 m above the river bed. It is bounded by a distinct scarp, and talus can be seen in two areas outlined by the circle and the square in Fig. 3a.

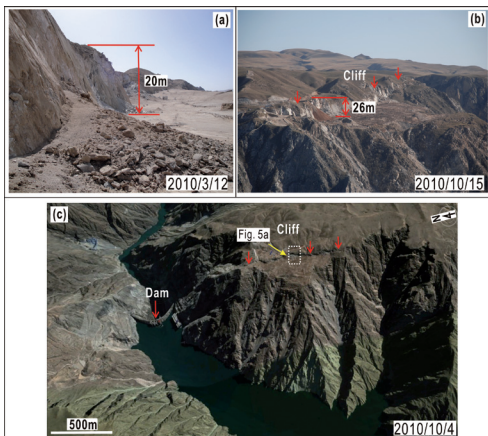
slope in May, 2009, about two months after the impoundment. These cracks extended along the direction of North-South with linear features, being parallel to the main cliff. The terrace showed a settlement of 1.0~1.5 m. Also, there were some small-scale rockfalls on different parts of the slope, with rocks dropping into the reservoir. Acknowledging the potential of catastrophic landsliding, urgent reconnaissance had been conducted to the slope, including the setup of slope deformation monitoring system, geophysical survey, drilling exploration, tunnel investigation at differing altitudes and site reconnaissance. The deformation monitoring system started to work in August 2009. The monitored data showed that the whole slope was deforming significantly and continuously with the increase of the reservoir water level. Some monitoring points indicated a daily displacement of several centimeters, and the total displacement in five months (from middle August 2009 to middle January 2010) reached several meters, and

Fig. 5 - Deformation on the crest of Guobu slope after the impoundment

the displacement rates showed good correlation with the variation of water level. It is noted that although a lot of monitoring data had been obtained, they are not available at present, and will be open only after counter-measures being performed. Here we present two photos (Fig. 5) from which the scale of the displacement can be briefly understood through the subsidence appearing on the crest of the slope. The crest had a settlement of about 20 m by 12 March 2010 (Fig. 5a). A further settlement of 6 m was identified seven months later (Fig. 5b).

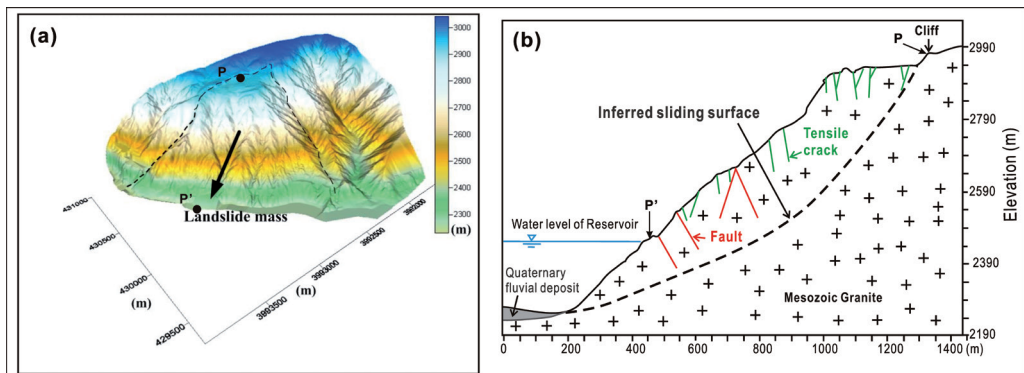
The topography map with a contour interval of 10 m was surveyed by airborne laser scanner after May 2009 (Fig. 6a). A longitudinal section along the line connecting point 'P1' and 'P2' in this figure is given in Fig. 6b, where the sliding surface is just an inferred one. As mentioned above, there is yet not clear evidence showing the location of sliding surface. If this sliding surface be correct, the total volume of the potentially unstable massif will be approximately 120-150 Mm³. This volume will be about one half of that of the Vajont landslide (MÜLLER, 1964; GENEVOIS & GHIROTTI, 2005).

Fig. 6 - (a) Topography of Guobu slope area (a), and (b) longitudinal section along line P-P' in Fig. 6a

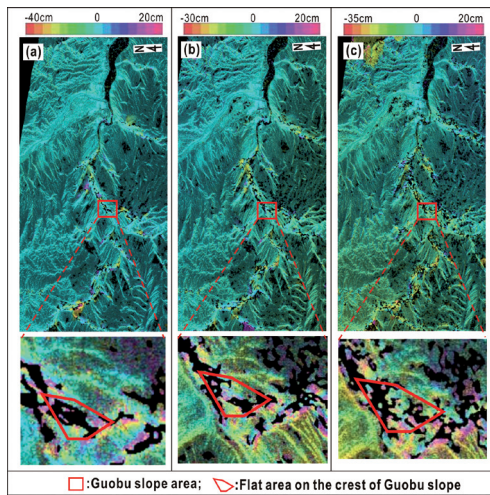
We processed three pairs of interference images taken from 2007 to 2008. The processing procedure involves mainly seven stages: image focusing, geometry calibration, generation of differential interferograms, phase unwrapping, atmospheric effect assessment and reduction, deformation map generation, and result geocoding from radar coordinates to Universal Traverse Mercator. The final results shown in Fig. 7 indicate that it is feasible to apply D-InSAR to monitor the deformation of Guobu slope, irrespective of the fact that the slope is steep. The selected four images have good coherence. As shown in Figs.7a and b, the pairs of 20071209-20080124 and 20080124-20080310 show a high coherence, while the coherence in the final pair of 20080310-20080610 (Fig. 7c) is relatively lower. The deformation value at the platform (within the polygon) corresponds to light green-light blue on the color bar. Therefore, we estimated that the deformation at the slope platform was quite small within the range of allowable error during the period from 10 March 2008 to June 10 2008. Namely, no obvious deformation occurred during this period before the impoundment. It is noted that we also tried

Fig. 7 - Interpreted deformation for different periods. (a) For the period of 2007/12/9 to 2008/1/24; (b) for the period of 2008/1/24 to 2008/3/10; (c) for the period of 2008/3/10 to 2008/6/10

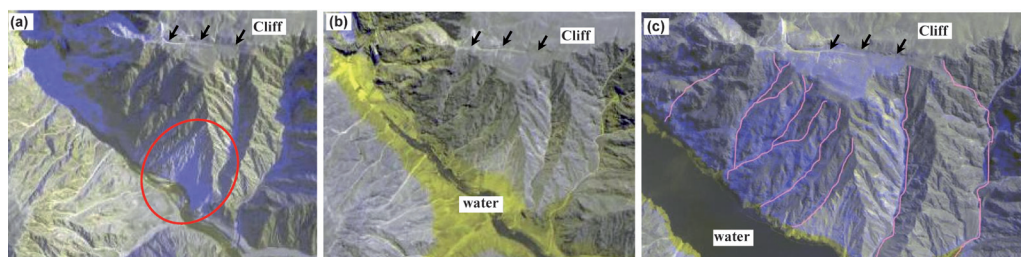
Using the ALOS PRISM images listed in Tab. 3, we obtained three interpreting results as shown in Fig. 8, where Fig. 8a presents the result for the period of 14 November 2007 ~1 July 2008, Fig. 8b for the period of 1 July 2008 to 3 April 2009, and Fig. 8c for the period of 3 April 2009 - 22 May 2010. From Fig. 8a, it can be noticed that on the crest part (the platform) of Guobu slope, the gray value after synthesis is close to that before the synthesis, indicating that no obvious deformation occurred on this part during this period. The blue area on the toe part of the slope (within the red cycle) may result from the local failure accompanying the river incision.

From Fig. 8b, it can be noticed that on the platform of Guobu slope, the gray value after synthesis is also close to the one before synthesis. This indicates that the slope deformation, if any, should be smaller than the value that could be detected by one pixel. Because the resolution of the images is 2.5 m, we conclude that the deformation was less than 2.5 m during the period before and soon after the impoundment. The topographic change indicated by the yellow color resulted from the water level change due to impoundment. However, from Fig. 8c it can be noticed that remarkable change occurred during the period from 3 April 2009 to 22 May 2010. Large blue areas appeared on the slope and platform (marked by yellow circle), indicating that the whole slope showed remarkable deformation. Comparing two images of different phases in the same window enabled us to capture a maximum deformation of about 3 pixels (about 7.5 m) on the leading edge of the platform, directing toward NW280°~300°. This result showed good consistency with the ground-based monitoring results.

Fig. 8 - ALOS-PRISM image interpreting results for the period of 2007/12/14 to 2008/7/1 (a), 32008/7/1 to 2009/4/3 (b), and 2009/4/3 to 2010/5/22 (c), respectively

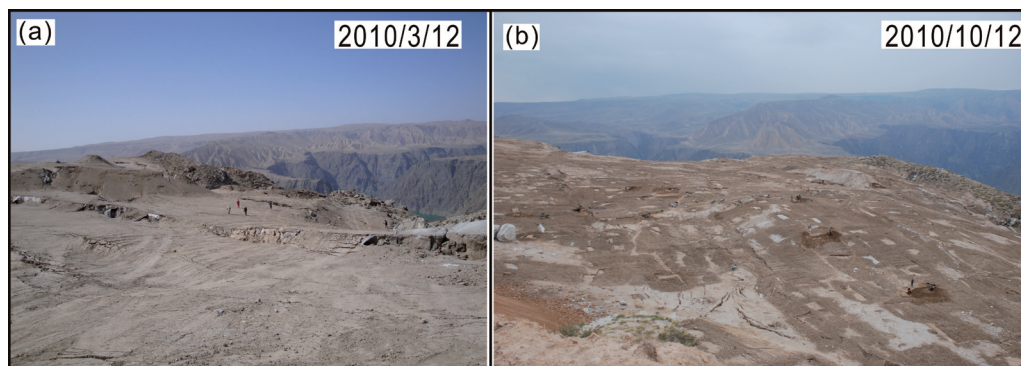
Fig. 9 - Deformed crest of the landslide at different dates
