THE CASE STUDY OF DEBRIS FLOW HAZARD CAUSED BY TYPHOON MORAKOT IN TAIWAN, 2009

MEEI-LING LIN^(*), KUO-LUNG WANG^(*), TIEN-CHIEN CHEN^(**) & SHEN-CHI LIN^(***)

^(*)Department of Civil Engineering, National Taiwan University, Taipei, Taiwan

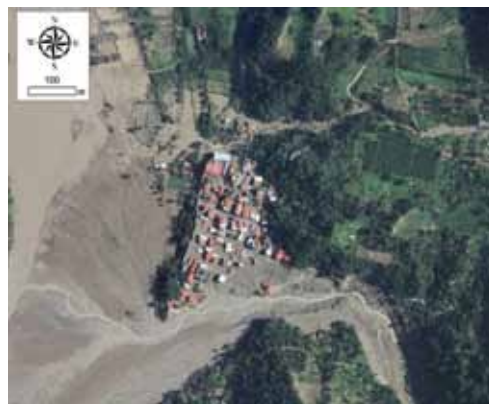
Fig. 5 - Aerial photo of Nanshalu village after typhoon Morakot (provided by National Science and Technology Center for Disaster Reduction, NCDR)

The aerial photo of the Nanshalu village after typhoon Morakot is as shown in Figure 5. Two debris flows hit the village. The buildings in the village were buried by debris and boulders as shown in Figure 6. The roads and riverbed are difficult to identify after being struck by debris flow especially for the debris

flow torrent to the south of the village as observed in Figure 5. The significant change in terrain was caused by the landslides upstream of the river forming a dammed-up lake, and with the bursting of the lake at 5pm of August 9, huge amount of debris was flushed out and carried by the debris flow.

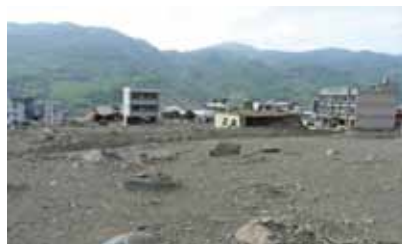
Fig. 6 - Debris covered entire Nanshalu village (photo: Meei-Ling Lin)

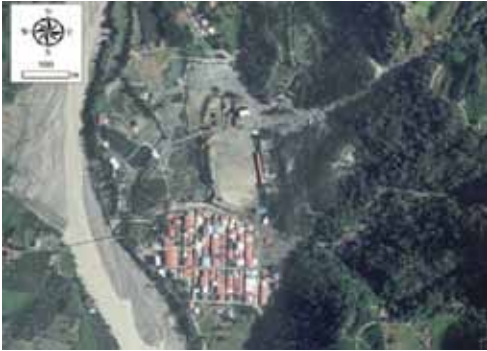
Fig. 7 - Aerial photo of Maya village after typhoon Morakot

The aerial photo of the Maya village after typhoon Morakot is as shown in Figure 7. Two debris flows attacked the village from the north and south, and debris deposited in the Sanming junior high school and main resident area of this village. The Mingquan elementary school was filled with debris as shown in Figure 8. Moreover, the highway No. 21 was covered with debris about 3 meters thick.

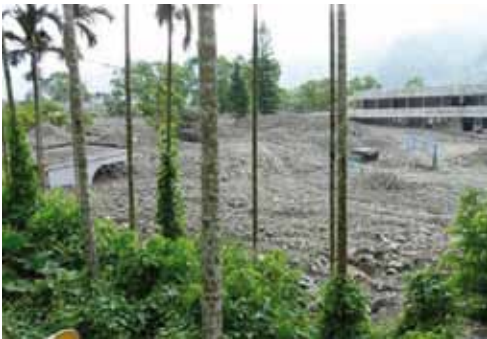
Fig. 8 - Debris flow occupied Minquan elementary school (photo: Meei-Ling Lin)

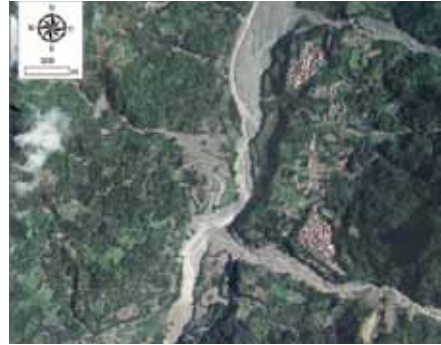
The aerial photo of Dakanuwa village is as shown in Figure 9. Debris flows occurred at the north and south part of this village. The Markalung area at the right hand side of the Nanjishian River opposing the Dakanuwa village was also struck by severe debris flow. The roads and bridges connecting the Markalung area and the Dakanuwa village were destroyed by the debris flow and flood of the Nanjishian River.

Fig. 9 - Aerial photo of Dakanuwa village after typhoon Morakot (provided by NCDR)

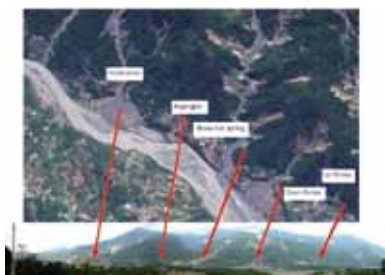
Slope-type debris flow occurred at Upper-Shinkai, Lower-Shinkai, and Meilunshan stream, while stream-type debris flow occurred at Bashilan river and Bulau river during typhoon Morakot. Distribution of the debris flows and landslides of this area is as shown in Figure 13. The Shinfa community was struck by debris flow at 8:30 pm, August 8, and the Tsaihun temple was struck by debris flow at 8:50pm at the same date. The outlet of valley, deposition fan and buildings nearby river bank were damaged by debris flow. Four people were dead and 24 people were missing at Lower-Sinkai debris flow site. More than 10 buildings were buried by debris. Bridges connecting the areas including Sinbao bridge and Sinkai bridge were destroyed by debris flow. Moreover, Shinfa bridge was damaged by debris flowing from Bashilan river to Launon river. Shinfa village was separated into several smaller isolated areas and lost connections to these areas.

Fig. 13 - Landslide and debris flow conditions of Sinkai area (photo: Tien-Chien Chen)

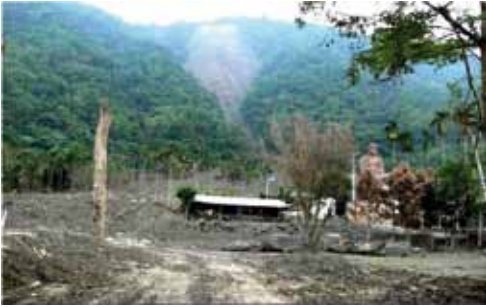
The Tsaihun Temple in the Upper-Sinkai was struck by debris at about 8:50 pm, August 8. The in-situ debris flow condition is as shown in Figure 14. The height of landslide is about 250m and travelling distance is about 350 m. The debris flow was blocked by a big Buddha statue and then redirected into the local community. The length of debris deposition is about 150m covering an area of about 0.5 hectare. Local residents were evacuated before debris flow occurred.

Fig. 14 - Debris behind Tsaihun temple (photo: Tien-Chien Chen)

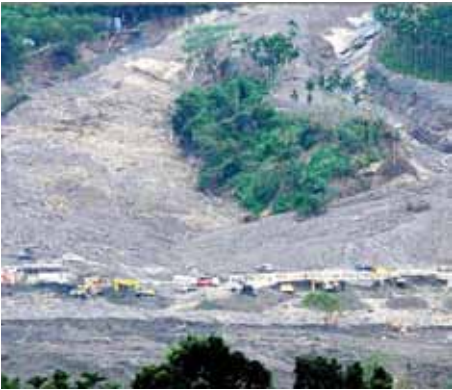
Lower-Sinkai was struck by debris flow at about 8:30pm, August 8. Four people were killed and 24 people were missing during this event. The travelling velocity of debris flow in this event is too fast to react. The resident area of Lower-Sinkai is an old deposition fan and the elevation is 20 m lower than Upper-Sinkai. The height and width of landslide are 450m and 1200m, respectively. The length of debris deposition is about 300 m and covering an area of about 20 hectares. The width of the stream increased to 200 m and the width of deposition fan is about 600 m. More than 10 buildings were buried by the debris deposition as shown in Figure 15. The deposited material flowed into Launon river and pushed the river channel, which resulted in erosion of embankment across the river.

Fig 15 - Deposition condition of lower Sinkai debris flow (photo: Tien-Chien Chen)

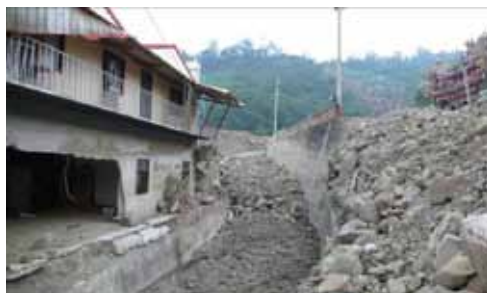
Figure 19 illustrate the overflow position of debris flow and the buildings destroyed. The original stream channel of the debris flow path is as shown in Figure 18. However, after the channel was filled with debris, the debris overflowed in the trajectory direction and flowed downward in a straight-line direction toward the lower elevation area as illustrated in Figure 19.

Fig. 18 - Building was damaged by debris flow (photo: Meei-Ling Lin)

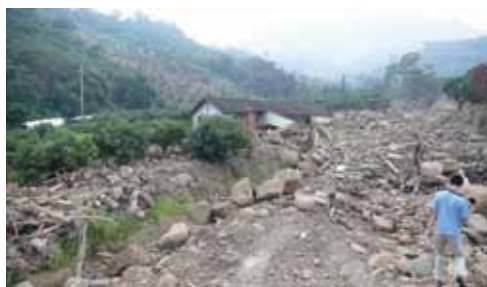
Fig. 19 - Downstream of overflow position (photo: Meei-Ling Lin)
