BIOCLASTESYS INDUCED FRACTURES AND ROCKFALL ON THE EAST FLANK OF THE RAVINE OF MATERA: PRELIMINARY INVESTIGATIONS

ANNALISA ALBANO(*), VINCENZO SIMEONE(*), GIOVANNA D'AMBROSIO(*) & ANGELO DOGLIONI(*)

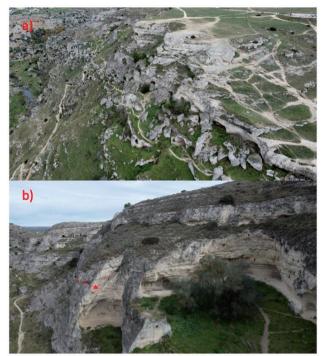
The site of the fractured was surveyed, using a UAV, in order to have aerial views of those details which were not visible from the ground. The aerial view of the east flank of the ravine of Matera, in front of the urban area, shows a number of collapsed calcarenitic blocks (Fig. 3a).

These collapses are not documented, thus their occurrences is unknown. However, looking at the alteration of the detached blocks, it is reasonable to assume that they moved during the last 30-50 years. It is noteworthy that rupestrian settlements of ravine suffered during all their history of precarious stability conditions. Their fragility was due to the irregular distribution of voids and solids of calcarenite related to quarrying activity. Calcarenites are characterized by severe differences due to variation of the deposition environment, with sudden variations in facies, porosity and diagenesis degree (Doglioni & Simeone, 2020; Festa *et alii*, 2018). The calcarenitic rocks are characterized by a severe system of fractures, mainly parallel to the flank of the ravine, induced by the opening of the ravine for the tectonic uplift and the induced stress relief. Artificial hollows made it prone to collapse phenomena due to the excavation or to overload. The collapses of

Fig. 3 - a) View of the calcarenitic front where collapses and fracturing occurred. b) Investigated recently opened fracture

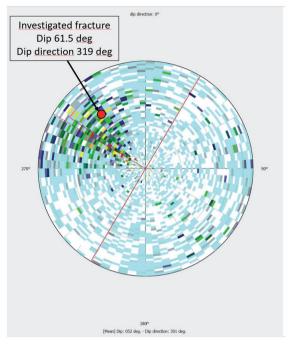
5 cm width, with a maximum aperture of 8 cm. It is 17.5 m long and it has a dip angle of 61.5 degrees. Fig. 4 shows detailed cross section in the order from south and north, corresponding to the main vertical fracture. Fig. 4 clearly shows the presence of two small trees coming out from the fracture. Looking at fig. 4 it is evident the role of the roots of the small tree, which penetrating through the fracture stresses the front of the flank. The flank where the fracture is located shows other discontinuities, which share similar orientations, as shown by the stereogram of the facets in Fig. 5. The average dip of the discontinuities is 81 degrees, while the average dip direction is 88 degrees.

Fig. 5 - Stereogram of the facets reconstructed on the point cloud of front and position of the surface of the main fracture
