THE IMPACT OF VERY SLOW MOVING GRAVITATIVE SLOPE DEFORMATIONS ON INFRASTRUCTURES: THE CASE STUDY OF THE BRIDGE OF GINOSA

GIOVANNA D'AMBROSIO^(*), ANGELO DOGLIONI^(*) & DAVIDE OSCAR NITTI^(**)

EXTENDED ABSTRACT

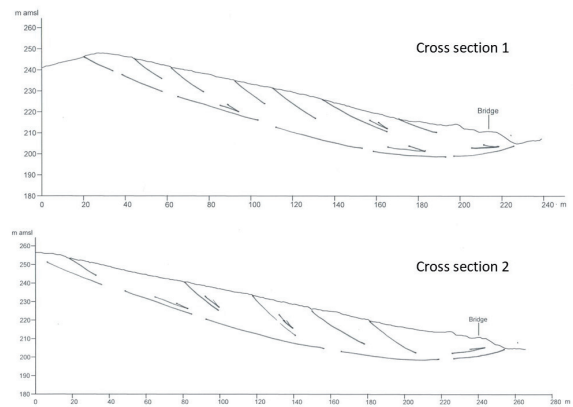
Fig. 2 - Cross sections of the slow-moving instability phenomena based on 1m-resolution LiDAR of the area around the bridge

From a morphological point of view, the bridge crosses a small and quite deep valley, oriented along NW to SE direction. The landscape around the site is made by smooth clayey hills alternated to small valleys, with really small alluvial deposits. Elevations decrease going from E to W, towards the valley of river Bradano. The stream network is ephemeral, draining only the runoff generated by severe rainfall events. The slope of the bottom of the valley is about 10%, the slope of the right flank of the valley has a slope of about 12° (20%) (fig. 2). It is evident the deformation of the ground profile at the base slope upward the bridge abutment, like if the slope is involved in a sort of confined landslide, even if, fig. 2 shows a sort of infinite slope landslide.

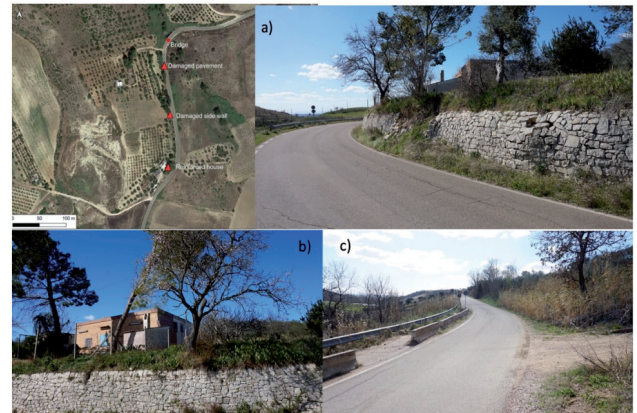
The area around the bridge, even if is not characterized by the presence of evident landslides, shows several evidence of land instabilities: the side walls are visibly deformed, a small house, close to the road, is severely damaged, and the pavement of the road is diffusely fissured, see fig. 3. These could be considered as signs of shallow deformation phenomena that cannot be separately considered from each other. Indeed, they are consequences of a general extended instability affecting all the slope, moving towards the bottom of the valley in SE direction.

Fig. 3 - Images of the damages evidencing the displacement of the landslide: a) damages of the side wall; b) reinforcement of the house; c) damages on the road pavement

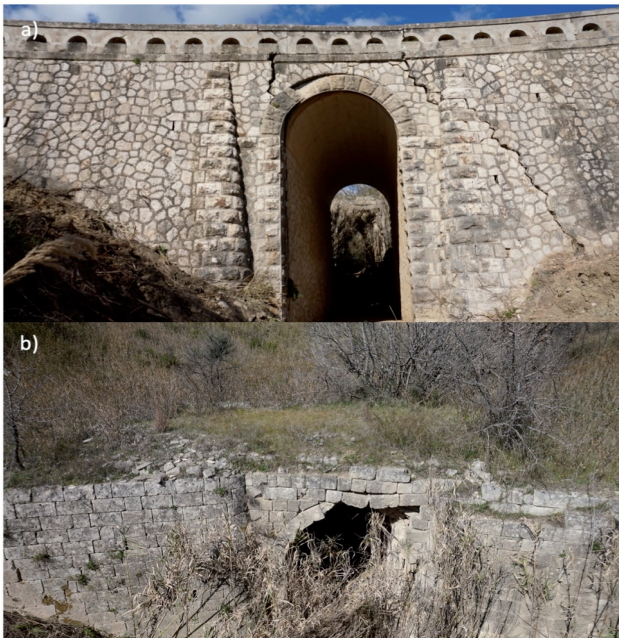
The damaged bridge is a single arch masonry structure, 50 m long and 8 m large. The arch is 4.8 m tall from the ground above the keystone, the springer line is at 3.8 m from the ground, the span of the arch is about 2.4 m large. Most of the structure is made by its abutments. Fig. 4a shows the SE side of the bridge. The bridge was presumably built between 1940 and 1947, replacing an older bridge, seriously damaged by the movements of the slope and still visible on the NW side of the bridge see fig. 4b. The bridge was recently closed to vehicular traffic for safety reason.

As showed by fig. 4a, the right abutment was displaced toward the bottom of the valley and slightly uplifted, thus causing the first fissure above the arch. The central section slipped down, causing the deformations, and fissuring on the barriers. The movement of the central part of the bridge caused the failure on the left abutment of the bridge.

The damage of the new bridge seems to be the same of the older, see fig. 4b, which was damaged by compression caused by the deformation induced by the right-side slope, this is consistent with the slow movement of the slope and the damages on both the bridges.

Fig. 4 - a) View of the SE side of the damaged bridge. b) Old, damaged bridge

The bridge seems to be compressed from W-NW by the slow displacements of the flank. This is consistent with the cracks of the bridge, as well as with the damages observed on the old, abandoned bridge (Fig. 4b). Fig. 2 shows cross sections with the reconstructed slow moving landslide phenomena affecting the right side of the bridge. Finally, it is noteworthy that the masonry abutment adsorbs part of deformation, instead the concrete vault of the arch shows major failures, repaired after the fissuring.

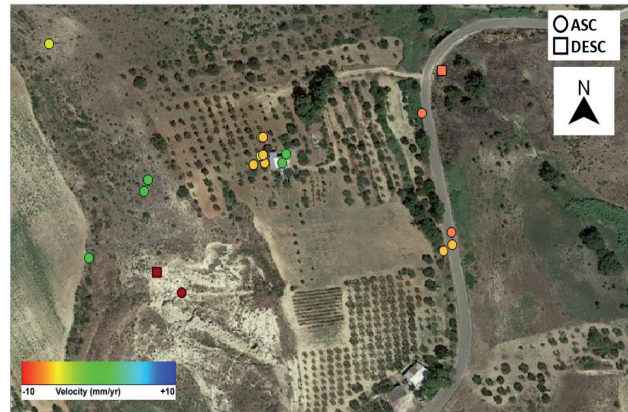
Fig. 5 - Positions of the MPs identified close to the bridge and upstream on the slope, along ascending (circles) and descending (squares) passes

Two MPs have been identified in proximity of the bridge (one for each satellite pass direction); their average velocities of displacement are $-6.6 \pm 0.2\sigma$ mm/year and $-7.4 \pm 0.2\sigma$ mm/year, measured along the satellite Line-Of-Sights (LOS) with a quite low temporal coherence (0.52 and 0.49, respectively), thus showing a relatively poor stability of the backscattering properties of these targets.

Another cluster of MPs is located along the road, close to the position of the damaged side wall reported in fig. 3. They are all detected along ascending passes and are moving away from the satellite, with LOS velocities ranging from $-5.7 \pm 0.2\sigma$ mm/year and $-6.2 \pm 0.2\sigma$ mm/year. All these movements are consistent with the slow movements of the slope described in the previous section.
