## THE SAN LEO CLIFF IN THE NORTHERN APENNINES, ITALY: SLOPE INSTABILITY AND RISK MITIGATION MEASURES AFTER THE 2014 LANDSLIDE

## ABSTRACT

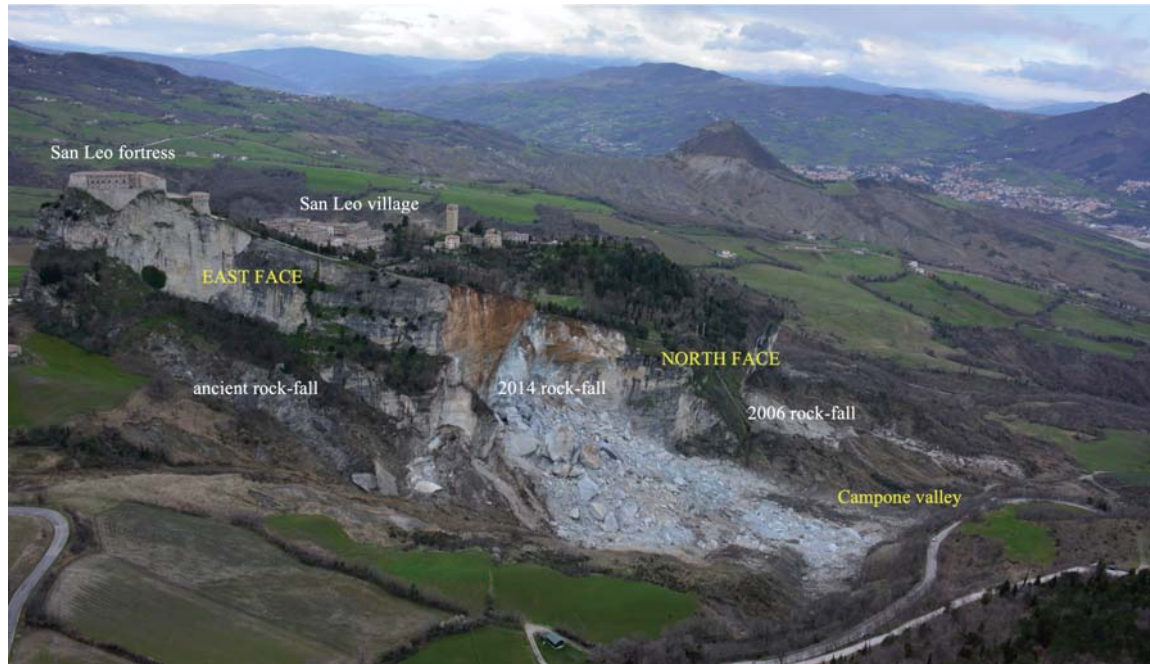
Even more impressive was the 2014 event which affected a large portion of the rock mass equal to a volume of 330,000 m<sup>3</sup>, along a front approximately 160 m wide and approximately 100 m high (Fig. 4). The scarp showed a retrogression of about 30 m. Following the failure of the rock mass, the debris propagated (block and debris avalanche) violently along the Campone valley for 400 metres, raising a gigantic cloud of dust and projecting blocks of rock for hundreds of metres. The landslide debris covered an area of 60,000 m<sup>2</sup> with huge boulders up to 10,000 m<sup>3</sup> (LUCENTE, 2014; BORGATTI *et alii*, 2015). In the days following the event, the largest amount of debris near the wall

Fig. 4 - Panoramic photo from helicopter after the 2014 event at the north-east edge of the cliff. The landslide generated an extensive and thick rock avalanche deposit invading the Campone valley. On the right, along the north side of the cliff, we can appreciate the 2006 rock-fall deposit at the foot of the wall. Finally, an ancient huge landslide rests at the foot of the east face

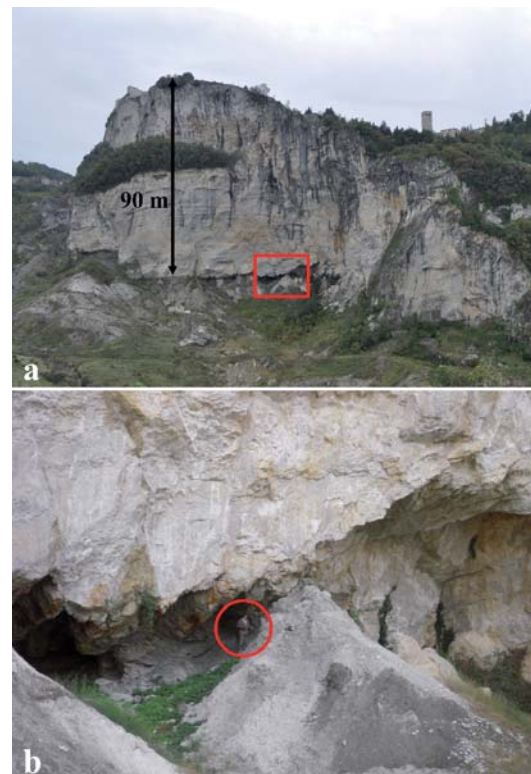
The reduction of the geotechnical parameters of the clays under the cliff and the removal of portions of clayey substrate at the edges are widely observed phenomena and probably act concomitantly. With the removal of the uppermost layer of the clays, even the innermost and deeper materials can undergo weathering phenomena, and this leads to the progressive widening of the cavities under the cliff. It should be noted that before the February 2014 collapse, cavities up to 20 meters deep were verified (Fig. 5).

Fig. 5 - a) The undermined north face of the San Leo cliff before the 2014 landslide; b) the detail shows the size of undermining (man as a scale, red circle)

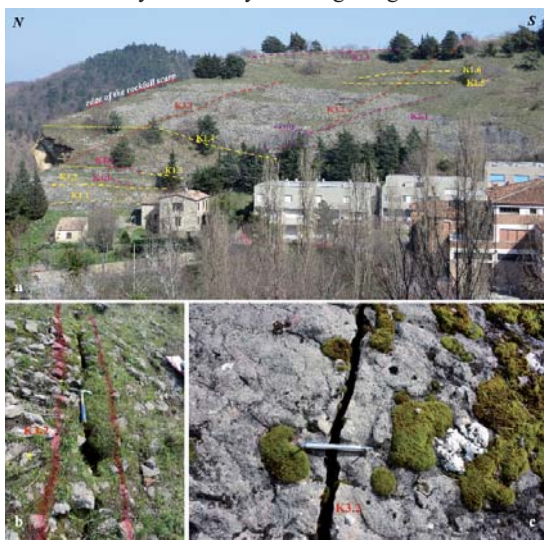
The geo-mechanical survey at the summit revealed the existence of four main sets of fractures known as K1, K2, K3, and K4, along with another set of discontinuities corresponding to the stratigraphic (bedding) surfaces, called Ks. Two other smaller fracture sets, K0 and K5, were also identified (Fig. 6).

Fig. 6 - a) Trace of the main fractures on the top of the cliff (families K1, K2, K3 and K4); b) and c) details of the K3.2 fracture which belongs to the same family as the fracture of the 2014 landslide

This family comprises two very distinct individual fractures, called K3.1 and K3.2, open several centimetres and probably quite persistent, similarly to the fracture that generated the scarp of the event of February 2014. The K4 family is approximately parallel in strike to the K1 family but shows a variable inclination between 30 and 60 degrees.

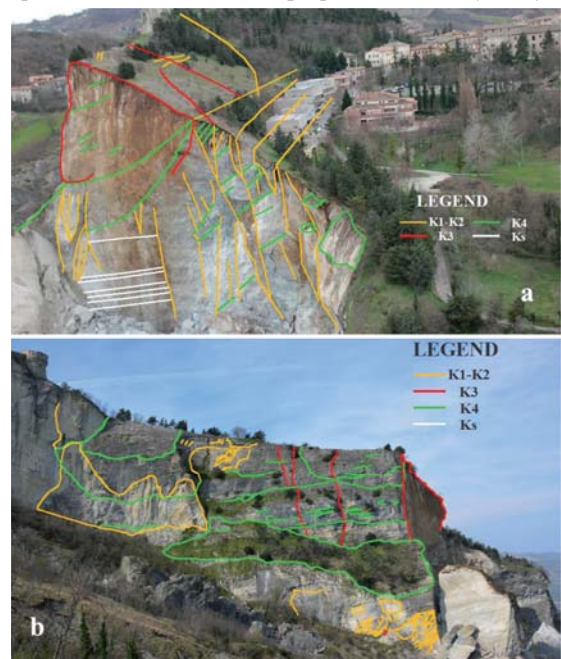
Fig. 7 - a) Main fractures detected along the scarp (north wall); b) main fractures detected along the east wall

rocky slab could disrupt road traffic and jeopardize the safety of vehicles and people passing through. It should be noted that the investigations reasonably allow us to believe that the collapse which occurred on 27 February 2014 did not produce significant and visible damage in this area. The stability of the slab is therefore not substantially modified following the recent events. The most likely failure mechanism involves planar sliding along the discontinuities of the K4 family, dipping towards the outside of the rocky wall (see Fig. 7).

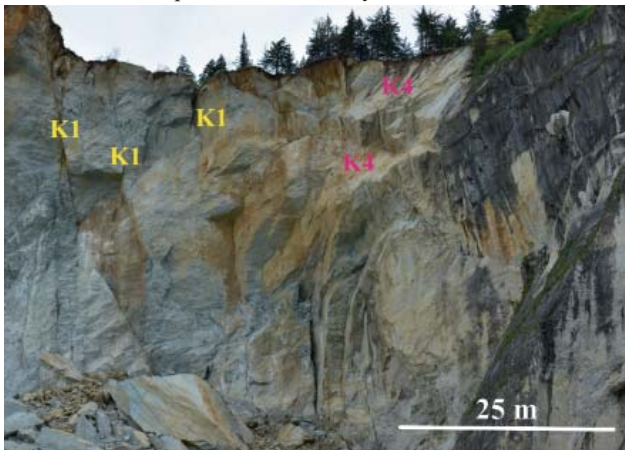
The local stability analyses of the north face were conducted using the limit equilibrium method (BOLDINI & TOMMASI, 2014a; DOGLIONI *et alii*, 2014a). The analysis focused on the central portion of the collapse, a highly fractured area by joints K1 and K4 (Fig. 9). The stability analyses of the rock wedges meet the static requirements, but there are still uncertainty factors that make the edge unsafe. Regarding the stability of the area, it seems to be in a precarious state because of the potential sliding of rock blocks along the discontinuities of the K4 family.

The stability analyses conducted led to the conclusion that the stability criteria are met only when assuming a certain percentage of rock bridges along the fractures of the K4 family. Unfortunately, determining the percentage of rock bridges on site with reliable precision is unlikely.

Fig. 9 - The highly fractured detachment scar in the north face, characterised mainly by K1 and K4 discontinuities

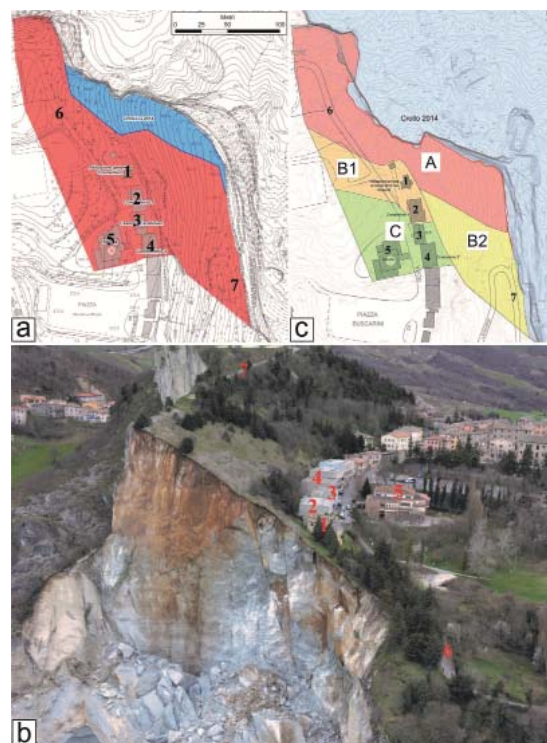
The first surveys conducted, along with the use of interferometric radar (ground-based SAR) and the initiation of instrumental monitoring (to control surface fractures), allowed for an update of the initial risk assessment. With the new scenario, known as “risk scenario 2”, the area around the collapse was divided into 4 zones: zone A, B1, B2 and C (Fig. 10c).

Zone A. The ring road was considered no longer safe due to a section of about 100 meters being close to the edge of the rock face and affected by significant fractures and discontinuity planes in the rock lying dip slope. It was therefore proposed to create an alternative route away from the edge and the potentially unstable area.

Zone C. The police station, condominium 2, and the school seemed to be in a lower-risk area, away from the areas that might be affected by a further landslide. It was therefore considered possible to remove the restrictions under the following conditions: activation of phase 1 monitoring and definition of the related Civil Protection Emergency Plan.

Zone B2. The studies conducted have highlighted that the hairpin turn area of the access road to the fortress is not among the areas affected by the failure of February 2014, nor are there any visible or tangible damages attributable to the failure. However, the initial surveys of the wall revealed a risky situation due to

Fig. 10 - a) The first risk scenario defined immediately after the 2014 landslide; b) the photograph shows the elements at risk falling into the red area. Legend: 1 – private cottage; 2 – residential condominium n.1; 3 – police station “Carabinieri”; 4 – residential condominium n.2; 5 – nursery and primary school; 6 – ring road; 7 – access road to the fortress; c) the last updated risk scenario – meaning of the four zones A, B1, B2, and C is explained in the text

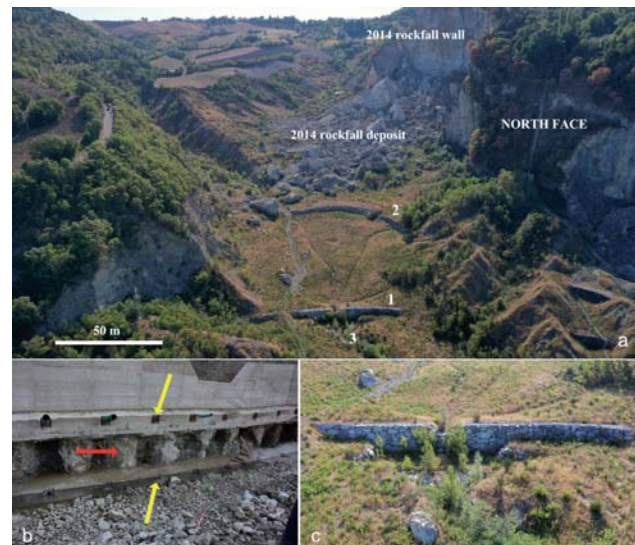
Fig. 11 - a) Aerial photo of the two first works carried out for the stabilization of the 2014 rockfall deposit along the Campone valley. Legend: 1 - the downstream structural work; 2 - the upstream structural work; 3 - the Campone stream. b) the downstream structural work was founded on large diameter piles (1) and strengthened by a double line of active nails (2 and 3); c) boulders were used to reduce the environmental impact of both structural works

This movement, if left uncontrolled, could have destabilized the main body of the debris. The containment was achieved by building an arch-shaped bulkhead, founded in the stable substrate using 20 meters long, large diameter piles (diameter = 100 cm). The bulkhead was reinforced with a double row of 25 meters long tie rods, inclined at 20° (Fig. 11b). Two drainage branches were realised upstream of the containment work, collecting the water into the Campone stream. The concrete wall of the bulkhead was masked with boulders to mitigate its visual impact (Fig. 11c).

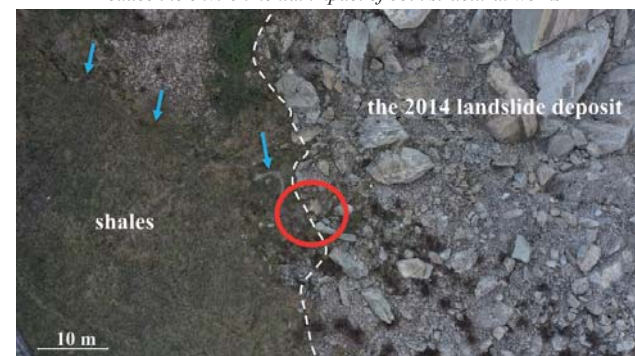
Fig. 12 - The Campone stream (sky blue arrows) buried by the 2014 landslide deposit. The dotted white line is the boundary between shales and landslide deposit

The failure of 2014 completely buried the Campone gully, leading to an underground water flow at the contact between the debris and the basal clays (Fig. 12).

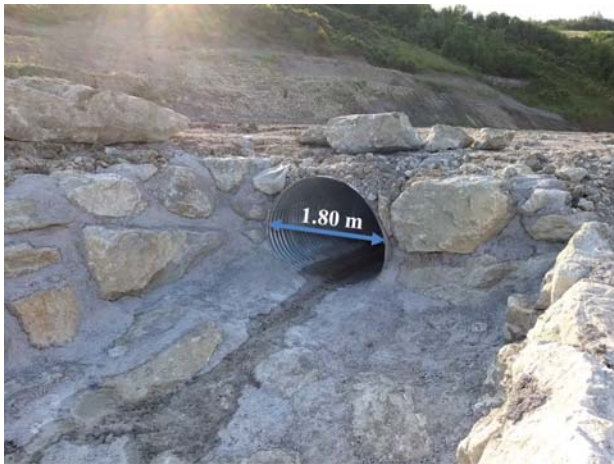
Fig. 13 - The steel pipeline for bypassing the 2014 landslide deposit

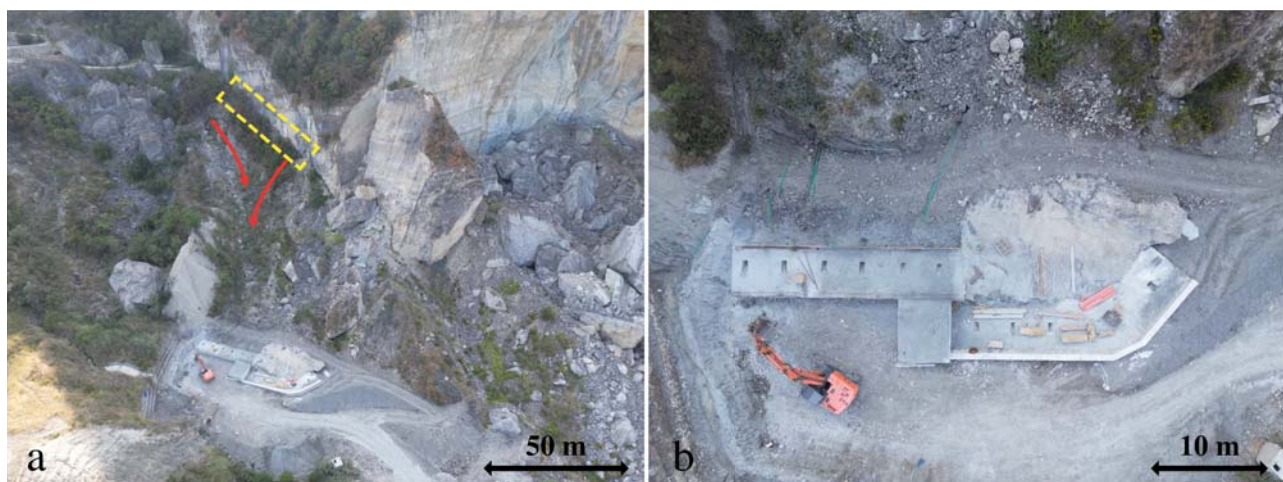
Fig. 14 - a) The structural work to contrast the movement of large earthflows (red arrows) causing undermining of the east face (yellow rectangle); b) the irregular shape of the retaining work to incorporate a large boulder

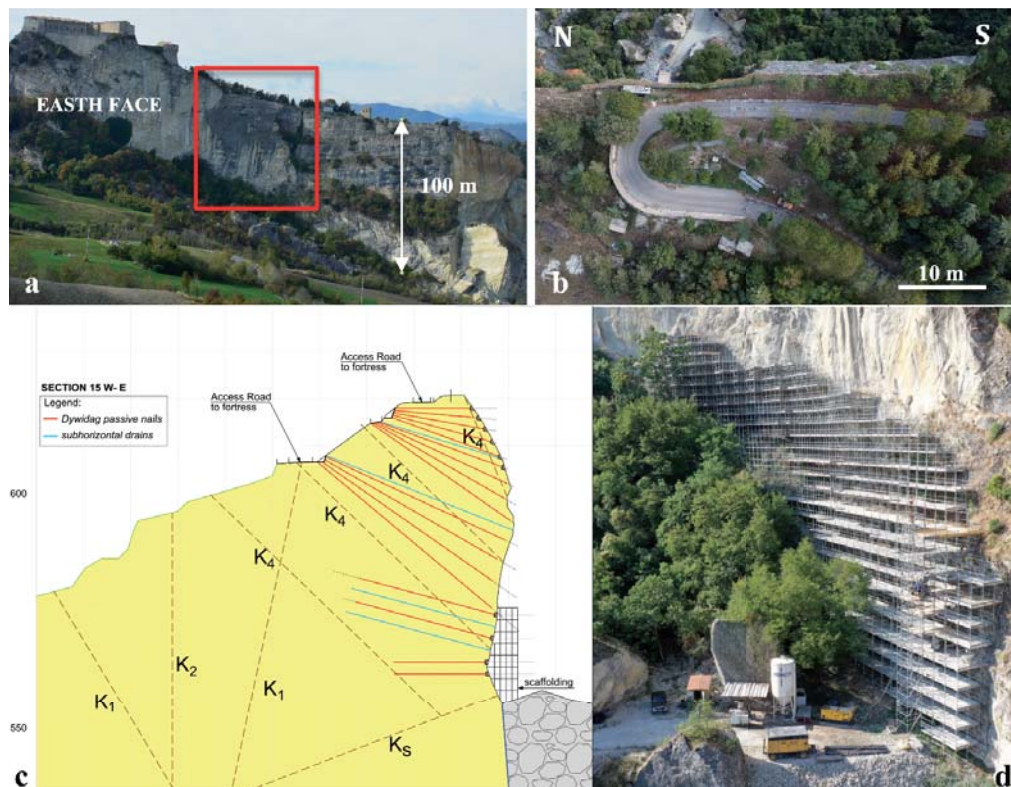
The rope abseils survey revealed the presence of a large rock block parallel to the road. This block is separated at the rear by a major vertical crack belonging to the K1 system and at the base by extensive fractures belonging to the K4 family (see Fig. 7b). The most likely instability scenario involves plane sliding of a large block on a K4 base joint dipping outwards the cliff and the tensile opening of a nearly vertical fracture, running roughly parallel to the cliff face, belonging to the K1-K2 joint family. The potentially unstable rock portions could be laterally delimited by nearly vertical joints, with a wide opening angle in relation to the cliff face (60-70°), part of the K3 joint family.

Fig. 15 - a) The portion of the east face that has been consolidated. b) bird's-eye view of the intervention area. c) the design intervention scheme with a first group of nails made at the top of the cliff (perforation towards the outside of the rock mass), and a second group made at the base (perforation towards the inside of the rock mass). Red line=Dywidag passive nails; blue line=sub horizontal drains; K4 and K1=fractures; Ks bedding. d) the scaffolding for installing the passive bars at the base of the face (east face of the cliff)

The sizing of the consolidation intervention (density of bars required and their best arrangement) was established through a series of limit equilibrium analyses (LEMBO-FAZIO, 2017), which led to defining the intervention scheme represented in an example section of the wall (Fig. 15c). Without delving into the specifics of the stability analysis, which are beyond the scope of this article, the results indicate that the chosen reinforcement scheme is effective. It notably enhances the stability of the east wall along the access road to the fortress.

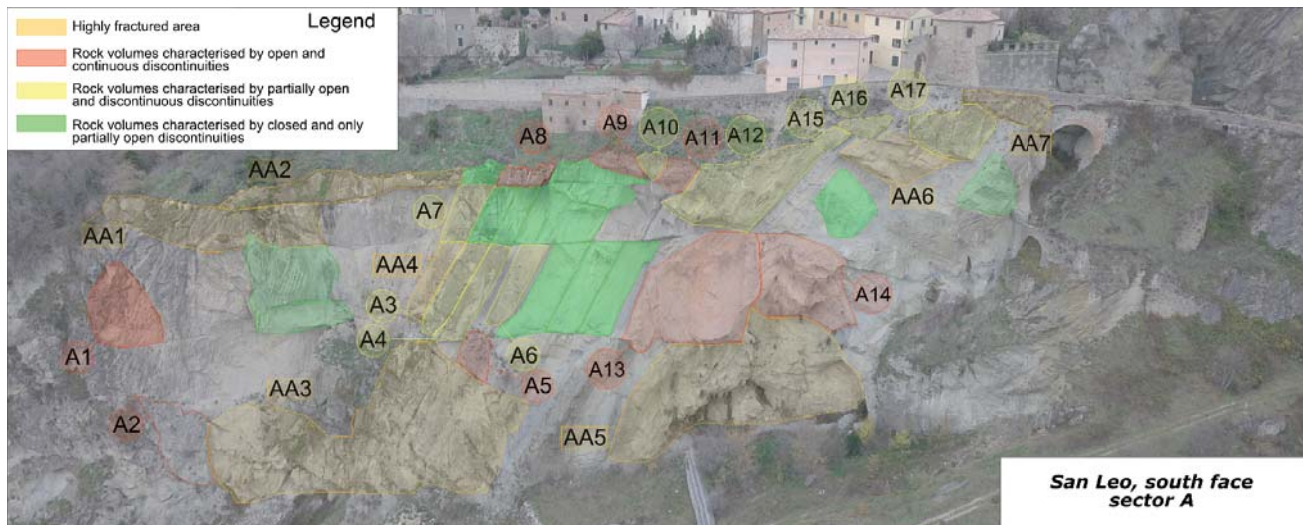
Fig. 17 - Representation of the unstable rock volumes in the sector A - blocks and/or rock portions with three different degrees of danger were identified: P1=high to very high danger; P2=medium danger; P3=low danger

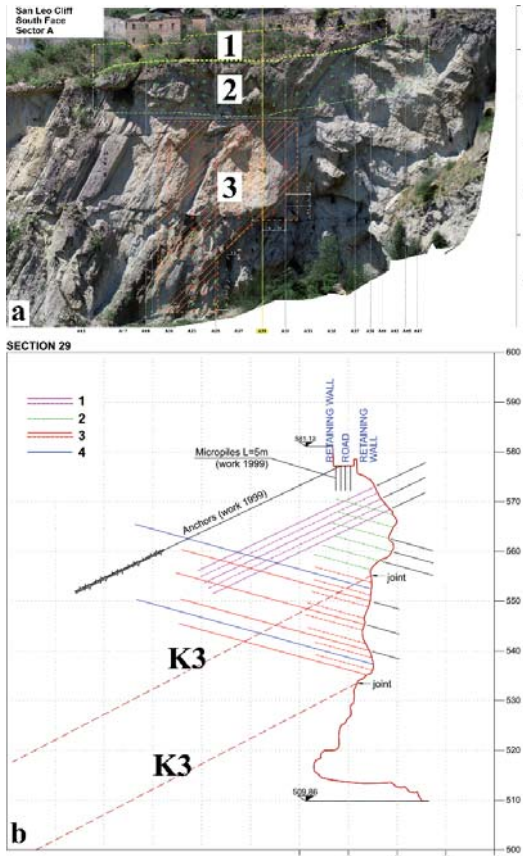
Fig. 18 - a) Design scheme (prospect) of the consolidation intervention of the sector A, along the south face of San Leo cliff. From top to bottom, the intervention area was divided into three bands. Legend: 1 – the upper band; 2 – the middle band; 3 – the lower band; b) Design scheme of the consolidation intervention of the sector A, in section. In the uppermost portion of the face, the bars are 40 m long and inclined downwards by 25° (violet traces); in the middle portion the bars are 12 m long and inclined upwards by 15° (green traces); finally, in the lowermost portion the bars are 12 and 40 m long and inclined upwards by 15° (red traces). Note the marked overhang of the face

three areas (Fig. 18a in prospect, Fig. 18b, in section). At the summit strip (intervention 1), 40 m deep bars, with a diameter of  $\varnothing$  32 mm, inclined  $25^\circ$  downwards and with a mesh pattern with a pitch of 2.5 m, were laid in a clear overhang. In the intermediate band (intervention 2), the plan included using 12-meter-deep bars, with a diameter of 26.5 mm, inclined  $15^\circ$  upwards, and arranged in a mesh pattern with a pitch of 2.5 meters. To carry out interventions 1 and 2, a drilling slide lowered along the wall was used (Fig. 19).

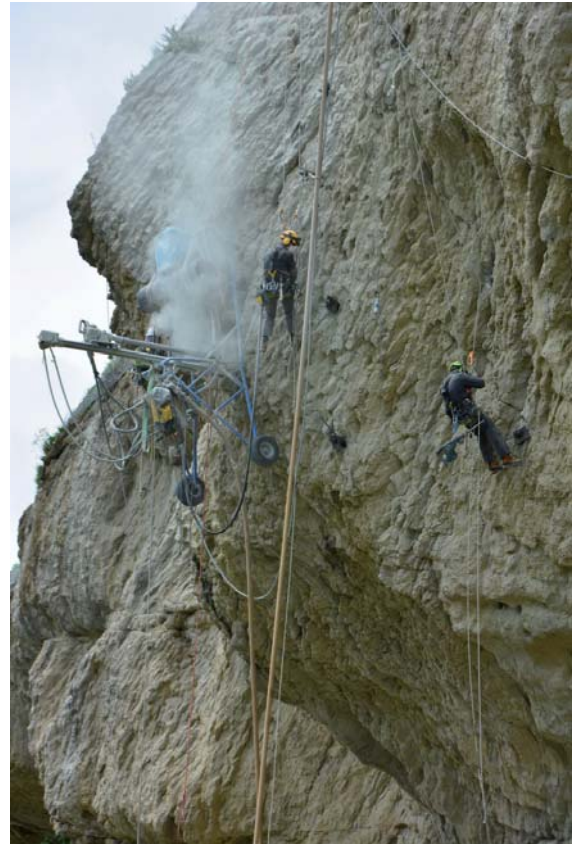
Fig. 19 - Rock drilling operations with mountaineering technique before the subsequent installation of the bars

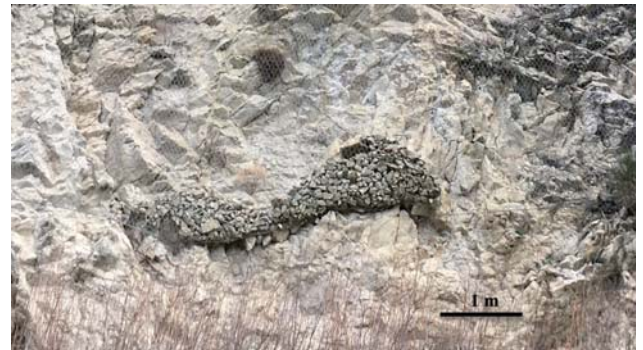
different areas (Fig. 20), it is not enough to ensure safe conditions. In addition, it should be noted that the net is damaged in several places and occasionally small blocks of rock fall to the ground. As a result, it is specifically intended to strengthen the wall by utilizing double-twisted wire mesh (8×10 mm hexagonal mesh) and rectangular steel wire mesh panels (6×3 m, 300×300 rhomboidal or square mesh, frame  $\varnothing = 8$  mm), which will be fixed to the wall and connected to the mass using Gewi bars ( $\varnothing = 25$  mm, L = 6 m).

Fig. 20 - Small-block debris retained by the hexagonal metal mesh net

The panels are equipped with perimeter steel ropes  $\varnothing = 14$  with fixing to the top and foot of the rock face using steel ropes  $\varnothing = 16$ . The connection between adjacent network panels and the connection between the network and the anchors are created by steel cables with a metal core with a diameter of  $\varnothing = 10$ . The intervention aims to stabilize only what is defined as ‘cortical
