SENIGALLIA HISTORIC TOWN WALLS: MATERIALS AND STABILITY ANALYSES

PAOLO BUSDRAGHI, FRANCESCO VENERI & VALENTINA IAMPIERI

EXTENDED ABSTRACT

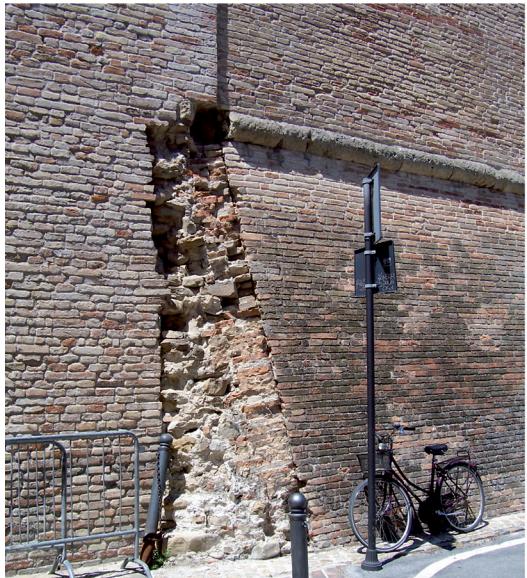
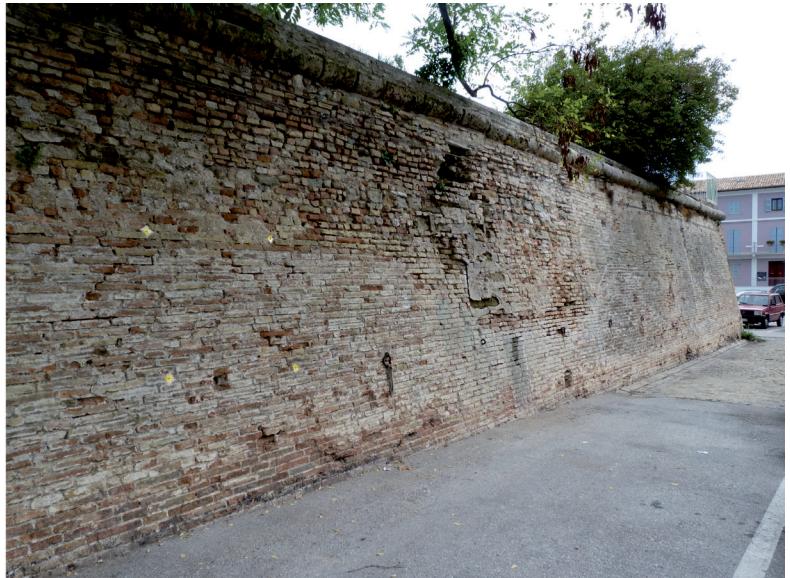
Fig. 3 - Left: section of the sixteenth century scarped walls near Porta Lambertina; it is possible to make out the characteristic 'rubble stone fill' structure, characterized by an orderly outer brick wall face with sporadic stonework elements, and an internal portion of filler (the internal façade is not visible here), chaotic, in which recycled materials of various nature may coexist, like whole or fragmented bricks and rocks; these are all immersed in mortar. Right: eighteenth century heavily eroded outer brick wall, Gothic brick wall pattern

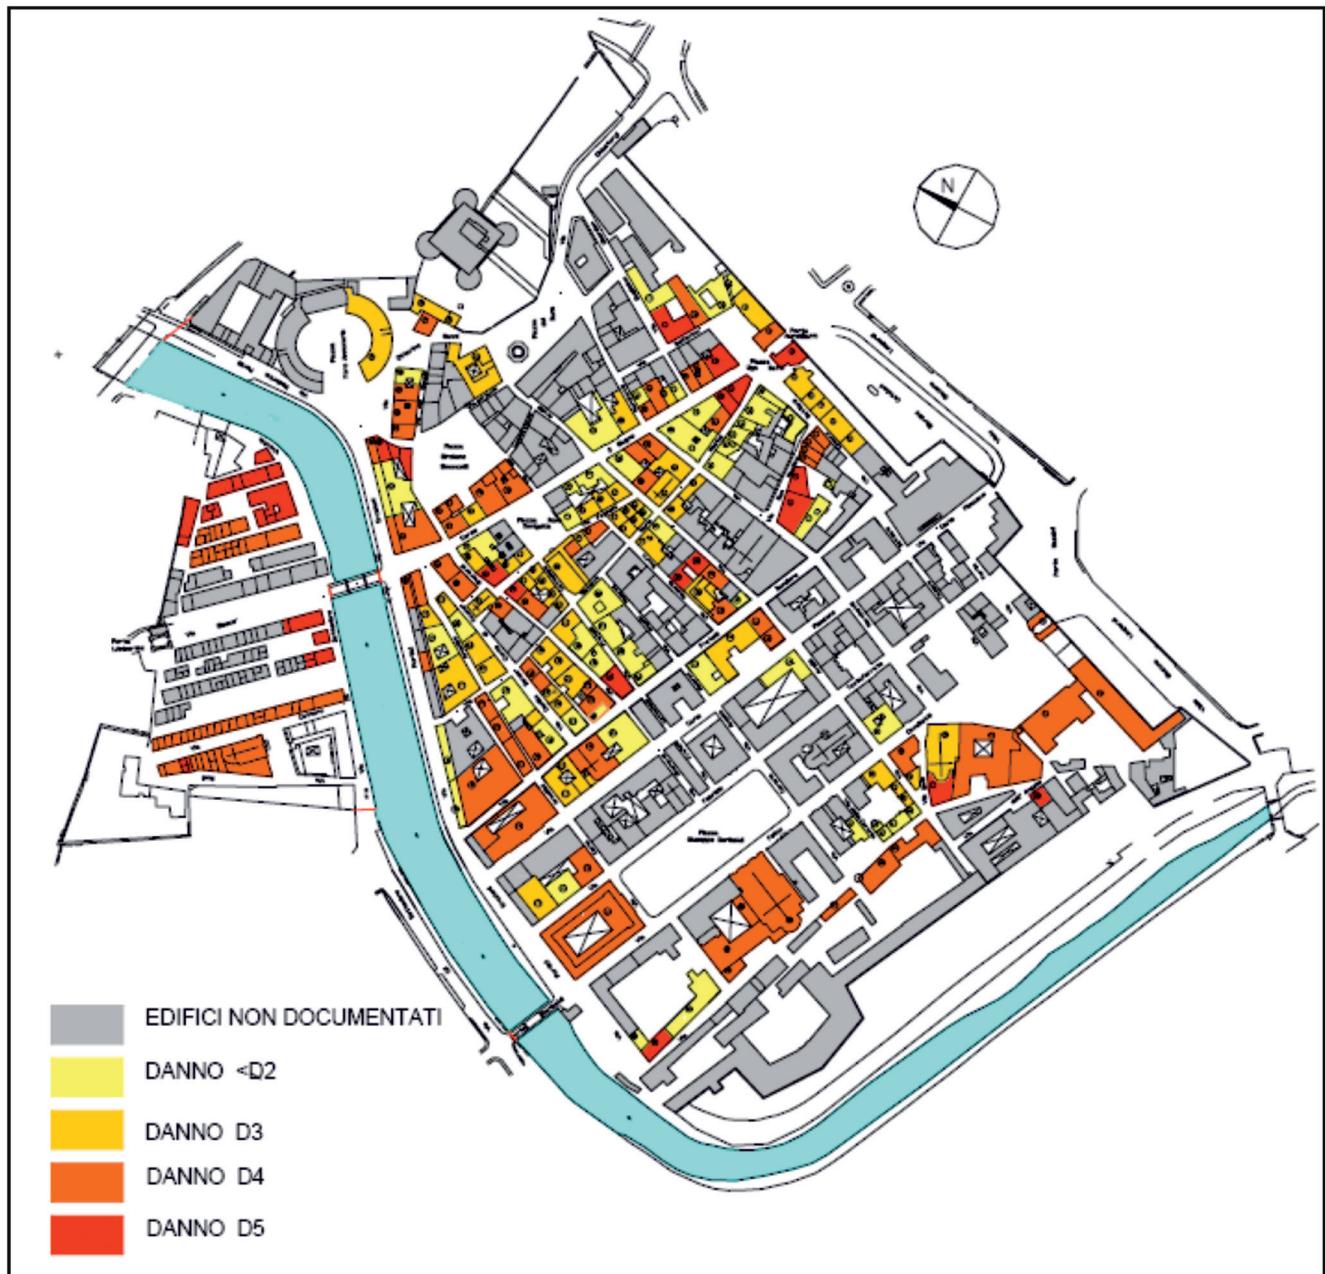
Fig. 7 - 1930 earthquake damage assessment map of the Senigallia Historical Centre (DOLCE & SPERANZA, 2007)

mutation in the urban and structural planning. Thanks to a series of photos, DOLCE & SPERANZA (2007) were able to create the map of the Senigallia Historical Centre Damages (Fig. 7) which involved numerous portions of the wall adjacent to the urban buildings. Their direct involvement had produced hefty damage, both for the eighteenth century and sixteenth century walls, as well as the Foro Annonario-Rocca Roveresca.

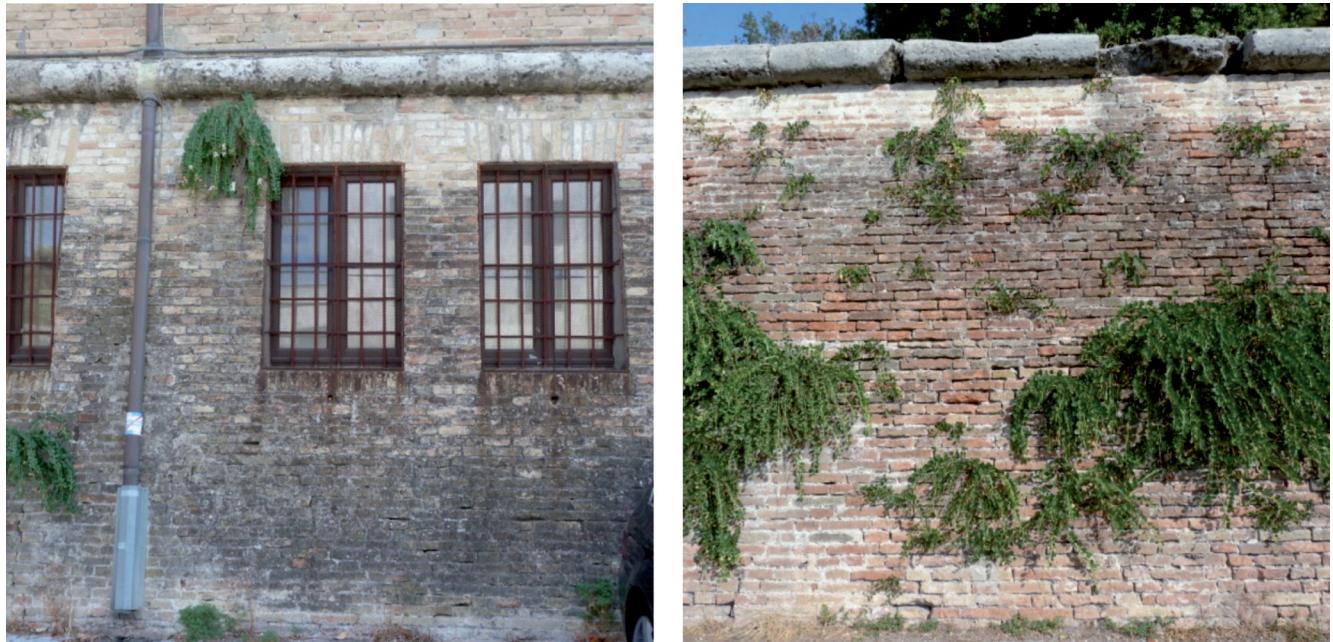
Fig. 10 - Left: detail of some windows built in the lower wall beside the Penna bastion during construction of the upper building. The wall section is susceptible to degradation phenomena (a light grey 'patina' formation most likely tied to exhaust gas emissions from vehicles in the adjacent parking lot) Right: sixteenth century walls contiguous to the Penna bastion. The chemical degradation is coupled by a physical-mechanical action exerted by weeds (wild capers) along the mortar joints

As far as the aggression of biological agents is concerned, a biological patina has formed: a clearly organic surface film, soft and homogeneous, adhering to the surface, of variable colour, mostly green, made up mainly of micro-organisms, such as lichens, to which dust and soil can adhere. The biological degradation is also connected to the top infesting vegetation and other organisms, such as musk and mushrooms. Furthermore, poor management of the structure from an urban planning perspective must not be overlooked: buildings too close to the walls, instances of neglect or poor maintenance (Fig. 10).

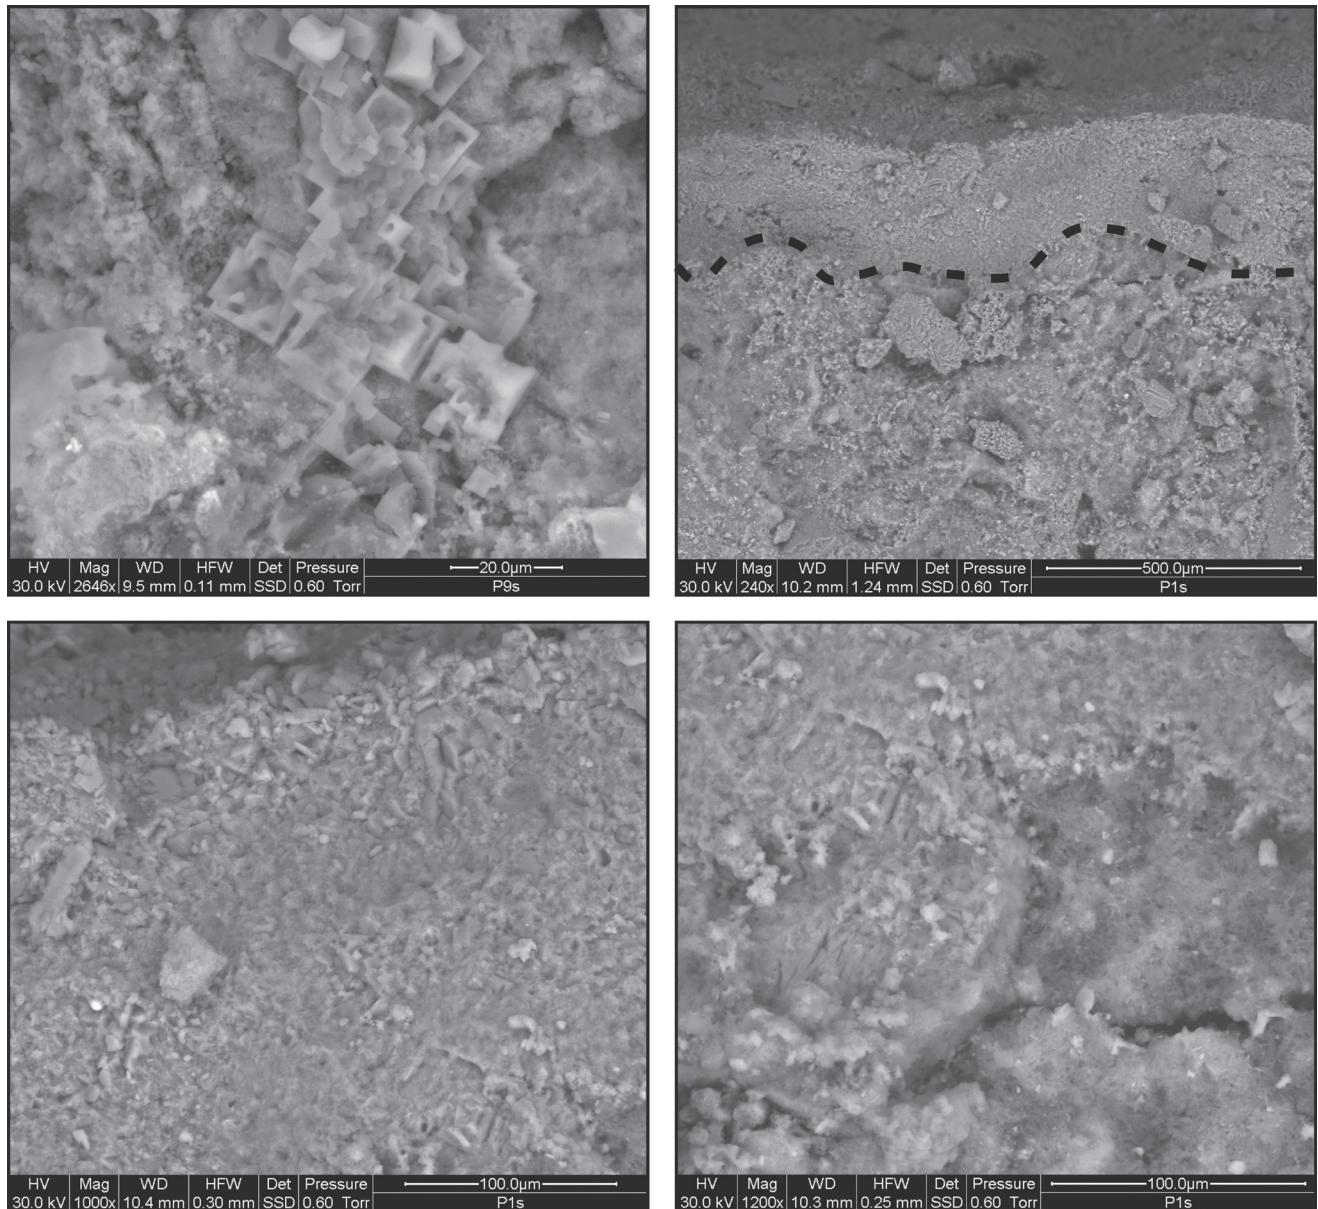
Then, only the binder fraction, mechanically split from aggregates under a direct light microscope, have been analysed. The ESEM analyses (Fig. 11) have helped to identify halite, chalk and barium minerals, albeit in small quantities in comparison of what one would expect and, above all, delimited to the most superficial portion. The X-ray diffractometer analysis (Tab 2) of highlights a high contents of calcite, an abundant amount of quartz and a minor quantity (a few percentage points) of other silicates, such as plagioclase and other feldspars. The calcimetry tests (Fig. 12) have confirmed the XRD analysis results, displaying a high content of CaCO_3 in all samples, to values ranging between a minimum of 46.91% for the crusts, up to a maximum peak of 67.22% for sample P10 of the Eighteenth century.

Fig. 11 - ESEM images: 1 - sample P9, where NaCl crystals with their characteristic cubic crystalline shape are highlighted; 2 - a top to bottom pass from crust to unaltered portion in sample P1 (numerous quartz crystals can be observed); 3 - magnification of the crust of sample P1; 4 - the unaltered portion of sample P1

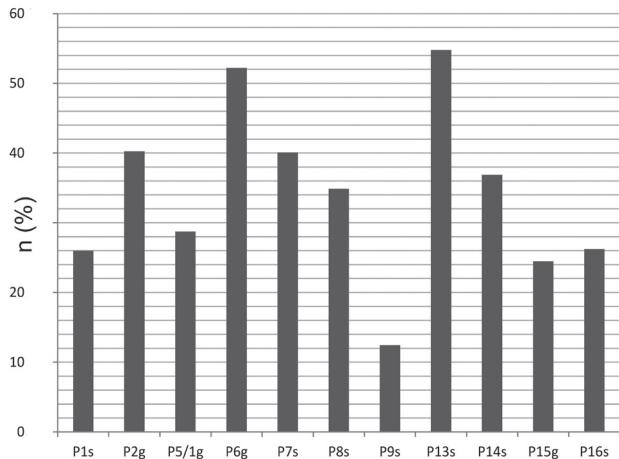
23.0 and 25.6 kN/m^3 and, consequently, also very high values of porosity for the sixteenth century masonry, above 50% in some cases (Fig. 14).

Fig. 14 - Porosity (n) expressed as a percentage, s = structural mortar; g = mortar joints, lat = brick sample

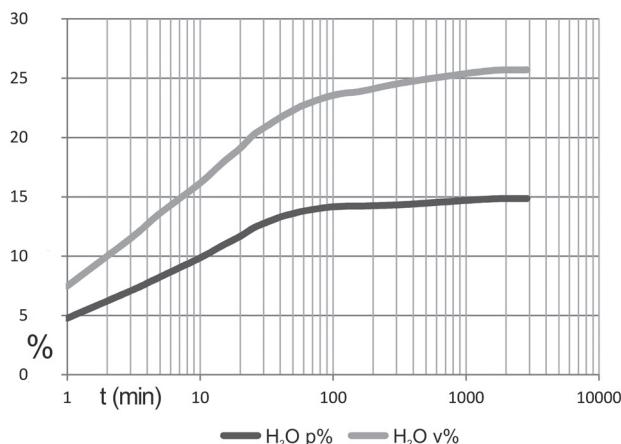
Fig. 15 - Average values from the capillary absorption test results on 12 samples. It should be noted how an increment in water weight and volume occurs in less than two hours

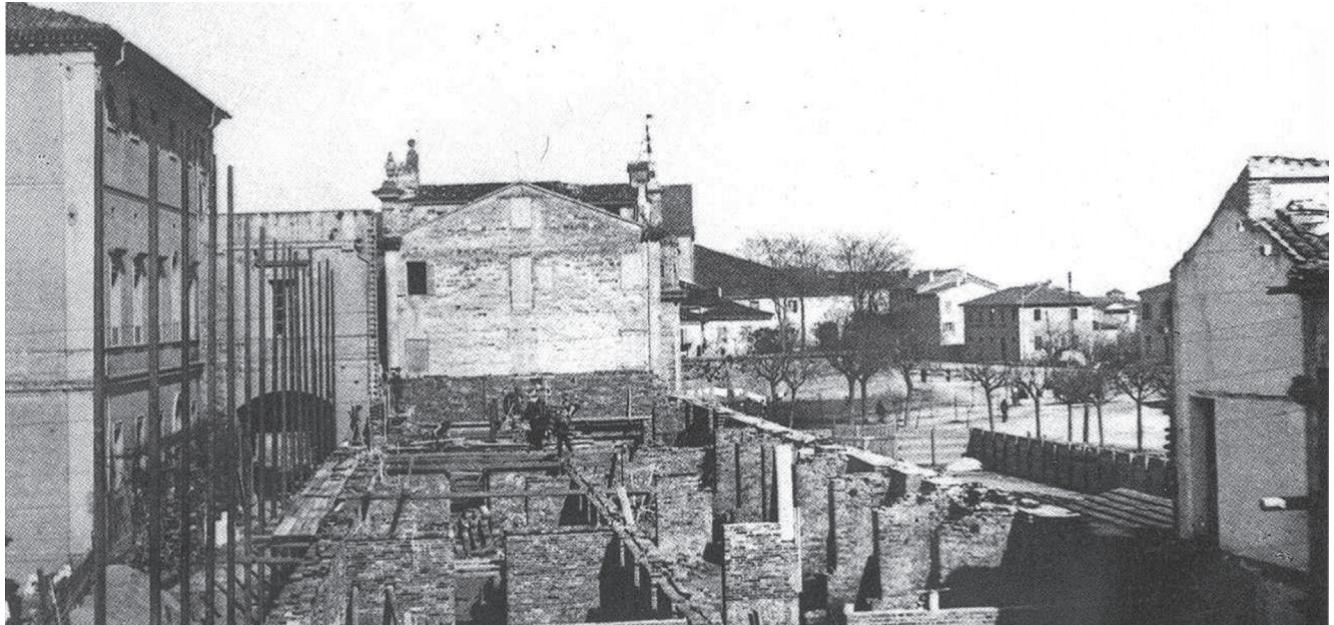
Fig. 16 - *Opera Pia Service Wing construction supported by the eighteenth century walls. The spine walls act as dividing element to the ground floor premises (1926 project, built in 1929)*
