TECHNICAL AND HUMAN ASPECTS OF HISTORIC ROCKSLIDE DAMMED LAKES AND LANDSLIDE DAM BREACHES

CH. BONNARD

Soil Mechanics Laboratory, Swiss Federal Institute of Technology, Lausanne, Switzerland EPFL-ENAC-ICARE-LMS, Station 18, CH-1015 Lausanne

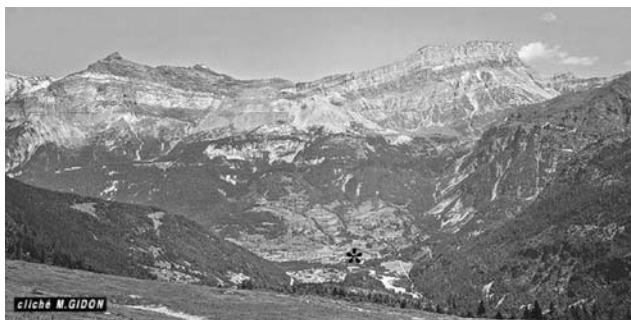
Figure 2 - Perspective view on the slides affecting the slopes of the Massif of Platé. The village of Servoz is shown by a star

One of the most ancient reported cases originates below the limestone Massif of Platé, near the Mont-Blanc, some 1500 m above the Arve river (Figure 2). During the early Christian era a large slide mass blocked the gorge of the Arve, an affluent of the Rhone river, impounding a lake which overflowed, not into the original gorge, but into a parallel gorge of Le Châtelard, some 500 m to the south. The lake seems to have persisted until the XIII century, that is more or less 1000 years, which can be justified by the fact that the initial overflow did not occur on the slide mass itself. The failure of the landslide dam finally reestablished the old course of the river.

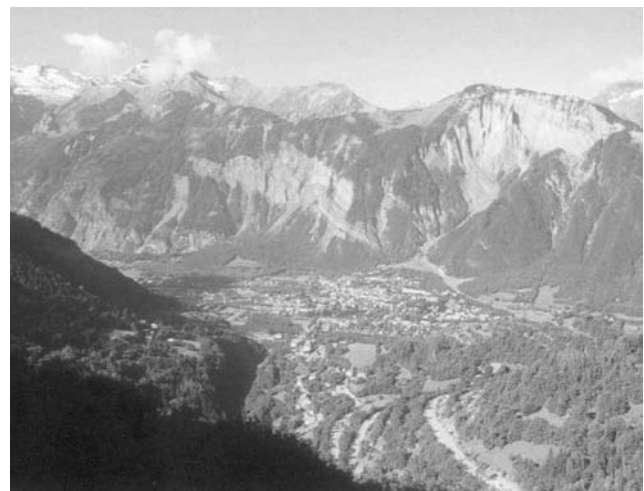
Figure 3 - View of Bourg d'Oisans in Romanche valley

turies, the lake bed was progressively filled with sediments and became a swampy area along a channelized river course. In the XIX century drainage ditches allowed the plain to become a fertile agricultural land and later the town to extend (Figure 3).

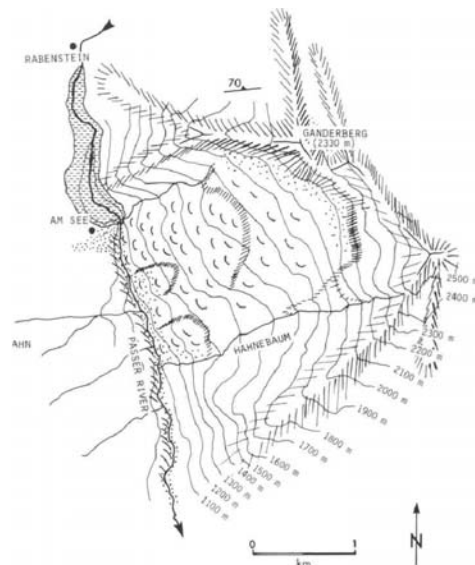
Figure 5 - Sketch of Ganderberg rockslide (CAVALLIN & MARTINIS, 1974)

Finally, some 250 km to the west of Dobratsch massif, in the Passer narrow valley upstream of the town of Merano, the large Ganderberg rockslide blocked the valley in 1404 and created a lake 50 m deep and 1 km long, called Wildsee (or Wild lake) (Figure 5). This lake lasted for almost 400 years, despite of several serious overflow episodes: in September 1419 a section of the debris dam failed and the consecutive flood killed 400 people, down to the town of Merano, 25 km south of the lake; in September 1503, the walls of the town of Merano were completely demolished; in September 1512, the city tower of Merano collapsed and in May 1572, the reconstructed walls were breached again. This series of events is probably due to the constant sagging movement affecting the Ganderberg slope. After a quiet period of nearly 150 years, a section of the dam failed again in June 1721 and a flood dashed downstream; at that time plans were prepared to design a protection structure, but the works were not carried out.

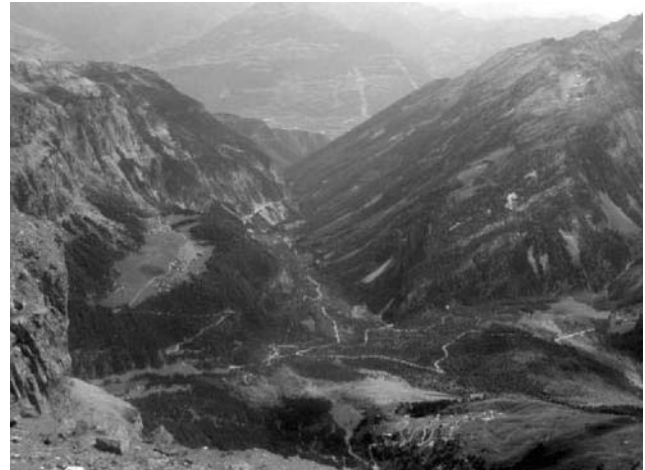
Figure 7 - Lower part of Derborence rockslide as seen for Les Diablerets mountain. The major lake is visible on the right side of the photo

and moved over a total distance of 5 km, creating the lake of Derborence at the outlet of a nearby creek called the Derbonne, the lake of Godey in another creek, which has been raised by a dam built just on the side of the landslide mass, as well as three small lakes just on the side of the landslide mass itself which still exist (GABUS, 1990). The total landslide mass has been assessed by HEIM (1932) at 50x10⁶ m³. Smaller rockfall events still occurred later but without major impact. The main natural lake, still existing today, is now nearly filled with sediments and its depth does not exceed 3 m so that it does not represent a threat anymore (Figure 7).

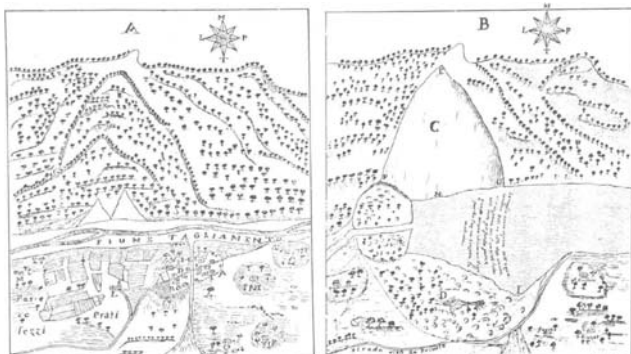
Figure 9 - Sketch of Tagliamento valley rockslide produced by Pascolo Pascoli one month after the event, i.e. in 1692 (EISBACHER & CLAGUE, 1984)

in August 1692, is represented on one of the most ancient sketches of landslide disasters, produced by Pascolo Pascoli one month after the event (HEIM, 1932), quoting (CAVALLIN & MARTINIS, 1974) (Figure 9). It created a lake almost 7 km long which reached a maximum depth of 80 m in two months; then it experienced two overflows on 4 and 20 October 1692 which lowered the lake level. The lake persisted for some times then filled with sediments over a depth of 30 m which were eroded to form a deep channel across the river deposits and rockslide mass. Other events affected the Tagliamento valley in the last two centuries, mainly due to seismic activity, but they did not modify the stability conditions of the slope that had destroyed the village of Borta.
