ROCKSLIDE AND ROCK-AVALANCHE DAMS IN THE SOUTHERN ALPS, NEW ZEALAND

O. KORUP

WSL Swiss Federal Institute for Snow and Avalanche Research SLF Fluelastr. 11, CH-7260 Davos, Switzerland

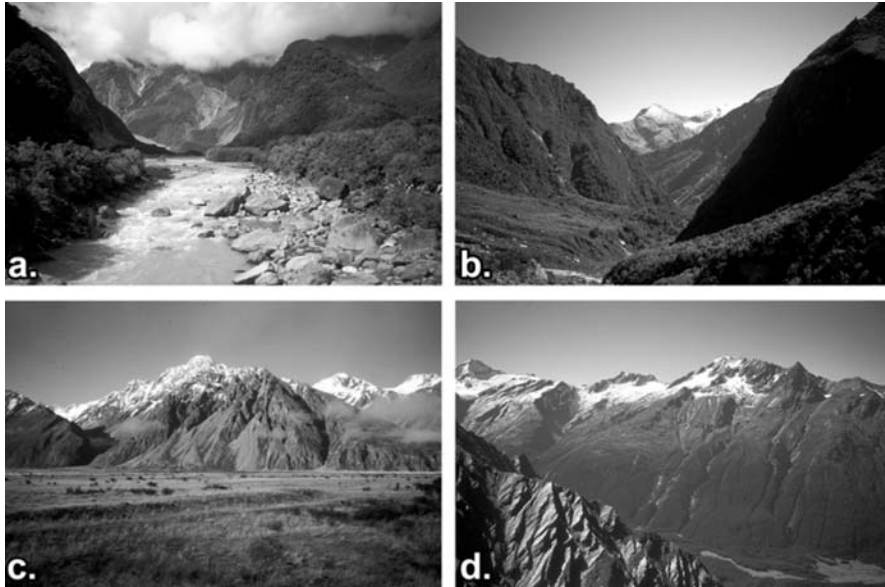
Figure 1 - Typical valley geometries of the Southern Alps, New Zealand. (a) Glacial trough valley, lower Fox River, WSA; (b) Fluvially-incised V-shaped valley near the main divide, upper Copland River, WSA; (c) Extensive valley train fringed by debris-mantled slopes, Tasman River, Mt Cook, ASA; (d) Alpine valley walls developed in Otago Schist, West Matukituki River, ESA

The mountain belt acts as a barrier to moisture-bearing winds from the Tasman Sea, causing orographically-enhanced precipitation of up to 14 m/yr west of the main divide (HENDERSON & THOMPSON, 1999). During the Quaternary, the Southern Alps were subject to numerous glaciations, and the terminal moraines of valley glaciers on the fringe of the WSA were drowned by postglacial sea-level rise. Based on physiographic characteristics, the Southern Alps can be divided into a Western (WSA), Axial (ASA), and Eastern (ESA) part (WHITEHOUSE, 1988). Valleys in the WSA are generally steep, V-shaped, closely spaced, and rejuvenated by coseismic base-level changes along the Alpine Fault. The axial Alps have the highest elevations and are dominated by glacial landforms. East of the divide, basin areas are generally larger, and tributaries feed into broad moraine-fringed valley trains, which retain extensive amounts of glacial deposits and large ice-scoured intramontane lake basins (Figure 1).

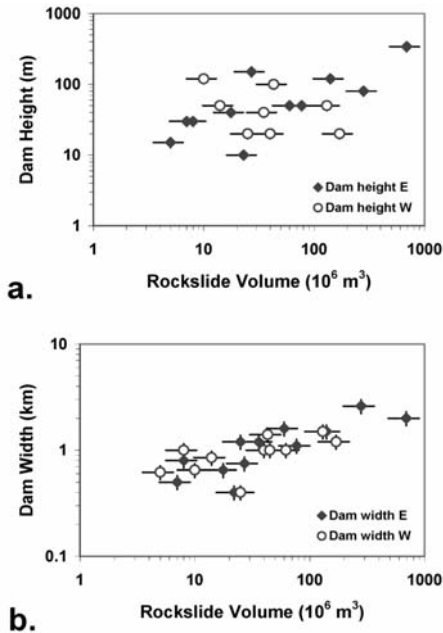
Figure 3 - Rockslide- (and rock-avalanche) dam height H_D , and width W_D , as a function of rockslide volume V_L , for selected cases in the eastern (black dots) and western (white dots) Southern Alps. Bars allow for errors of $\pm 30\%$ and $\pm 15\%$ on x- and y-axes, respectively

Rockslide and rock-avalanche dams occur on both sides of the main divide in similar numbers (Figure 2). Although rock avalanches appear to be less present in the WSA (WHITEHOUSE, 1983), rivers there are blocked by large complex rockslides. Scatter plots show no significant differences in the relationships between deposit volume and dam dimensions on either side of the divide. Rockslide or rock-avalanche volume V_L explains almost 60% of the (low) variance in dam width W_D . Dam height and length, H_D and L_D , respectively, may vary by over one order of magnitude for a given V_L (Figure 3).

Assuming comparable numbers of occurrence on both sides of the divide, the geometry of rockslide and rock-avalanche dams may be expected to reflect one or combined differences in external controls such as lithology, climate, valley geometry, or erosion rates. For instance, the runout of large rockslides and rock avalanches may be assumed to be less constrained by valley geometry in the trunk valleys east of the divide. The notion, that a given deposit volume, V_L , would thus produce a lower dam height, H_D , on average in the ESA, is not confirmed by the data (Figure 3a).

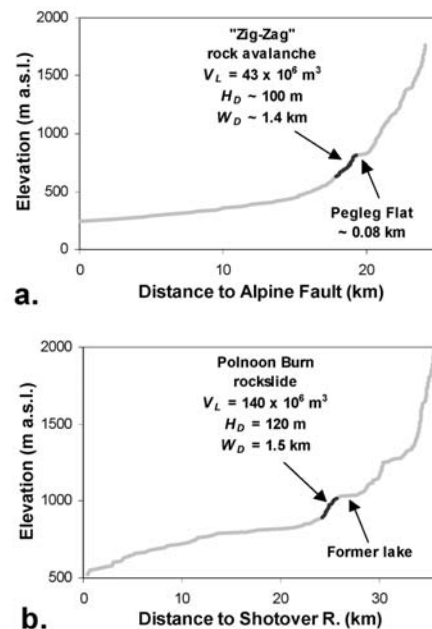
Figure 5 - Longitudinal profiles of (a) Otira River (WSA), and (b) Polnoon Burn (ESA). The ~ 2000 -yr old "Zig-Zag" rock-avalanche dam (WHITEHOUSE, 1983) continues to form a prominent step, with Pegleg Flat marking the extent of aggradation behind the dam. A similar step is evident in the upper Polnoon Burn

The dam impounds Pegleg Flat, forming a distinctive horizontal step ca. 0.8 km long and extending over 0.07 km^2 . The river has cut a headward-eroding and 50 to 60 m deep gorge with an average gradient $S = 0.19$ through the debris (Figure 5a). Geotechnical drilling conducted during the construction for a state highway viaduct through the rock-avalanche deposition zone revealed that the bridge pylons required grounding in rock-avalanche debris > 30 m thick (RAMSAY, 2000). The Otira River thus has not adjusted to its former gradient since blockage occurred. Net fluvial downcutting along Pegleg Flat was as high as 0.1 m/yr historically (KORUP, 2004b), and may be related to headward erosion at the dam crest.

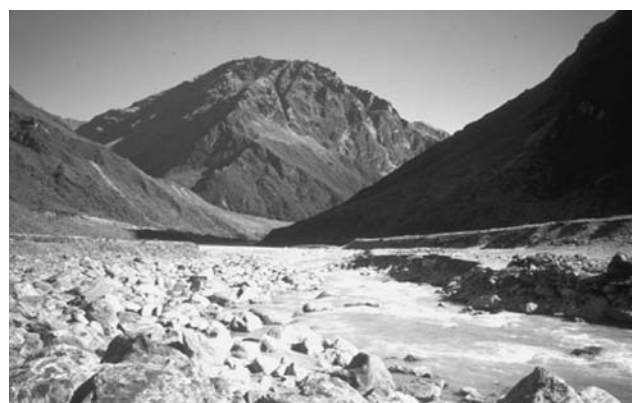
Figure 8- Downstream view of remnant of deep-seated rockslide ($V_L \sim 22 \times 10^6 \text{ m}^3$) on Dart River near Dart Hut (#78, Figure 2), ESA (February 2001). Repeated rock-slope failure at this site may have caused short-lived river blockage several times

Similar geomorphic impacts on river channels are common in the WSA, where large deep-seated rockslides have diverted river channels around their toes without creating persistent or well-defined blockage. At several such occlusion sites, fluvial trimming has oversteepened landslide toes, and triggered nested secondary rotational failures. Blockage of rivers by these secondary failures is interpreted to be mainly ephemeral and in close feedback with fluvial erosion, where no major obstructing deposits remain (Figure 8).

The geomorphic impact of rockslides and rock avalanches on alpine rivers is characterised by two distinctive types: (a) Rock-slope failures that produced clearly (and often catastrophically) detached deposits, which formed type II and III dams (COSTA & SCHUSTER, 1988); and (b) Deep-seated, low-displacement, suspended or chronic, often sackung-type failures causing river diversion and occlusion around their toe zones. This type of landslide-induced river occlusion not always forms cross-valley barriers, though may involve ephemeral blockage through nested secondary rockslides or large surficial debris flows (Figure 8).

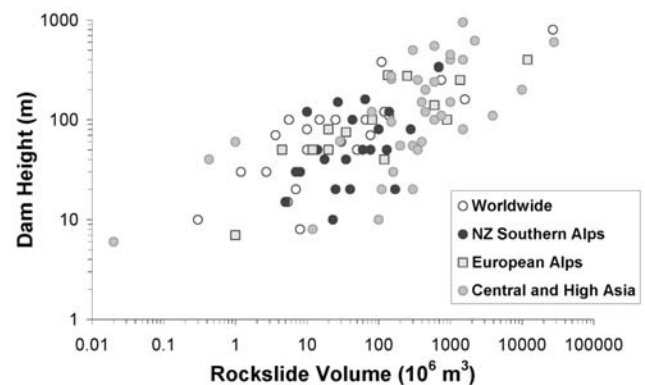
Figure 9 - Comparison of relationship between dam height, H_D , and deposit volume, V_L , for selected data from the New Zealand Southern Alps, the European Alps, Central and High Asia, and others. Data from the New Zealand Southern Alps take a “mid-field” position within the general scatter

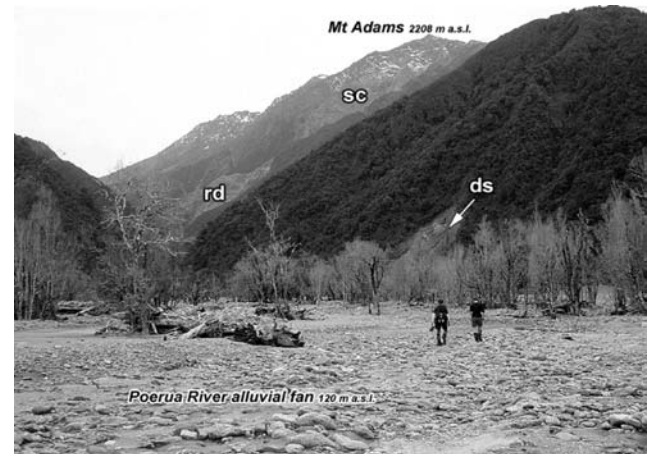
Figure 10 - Catastrophic aggradation is one long-term and long-range effect following the failure of rock-avalanche dams, e.g. the >100-m high blockage (rd) below Mt Adams, Poerua River, WSA, in 1999 (HANCOX *et alii*, 1999). Sc = Scarp area; ds = secondary debris slide, induced by aggradation. Coarse sedimentation on Poerua River alluvial fan has buried pristine floodplain forests up to six metres, with numerous dead trees remaining in growth position (photo taken by J. Thomson in March 2004, i.e. four-and-a-half years after dam failure)

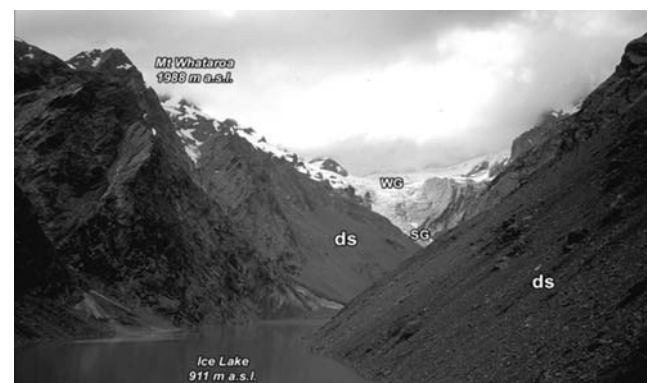
Figure 11 - Ice Lake on upper Butler/Whataroa River, near the main divide, WSA (March 2003). WG = Whataroa Glacier; SG = Shackleton Glacier. Instability on steep rock- and debris slopes (ds) may trigger landslide-induced displacement waves in this proglacial lake, potentially causing downstream flooding
