## LANDSLIDE DAMS IN THE HIGH MOUNTAINS OF INDIA, NEPAL AND CHINA - STABILITY AND LIFE SPAN OF THEIR DAMMED LAKES

J.T. WEIDINGER

### ABSTRACT

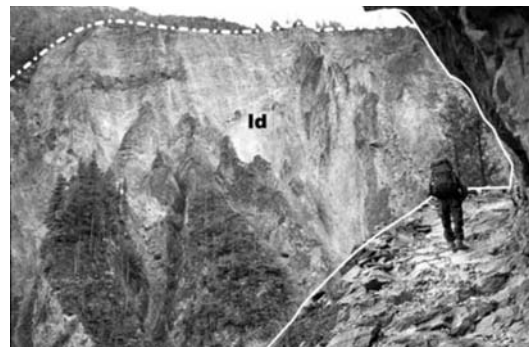
Figure 7 - SE-NW view towards Dukur Pokhari rockslide (ld, dashed-dotted line); position: 1.5 km west of Bhratang, alt. 2900 m; photograph: J. T. Weidinger 1993

this rockslide shows a much higher disintegration (Figure 7), indicating high and destructive mechanical energy during the event. Thus the mechanism of sliding of this composite rockslide occurred in a translational manner at the bottom and in the form of rolling on the top. Despite the formation of a spillway at the distal part of the masses at the border to the hard rock, the dam kept stable. Due to sufficient availability of glacio-fluvial sediments, the basin behind was silted and filled up within a short period.

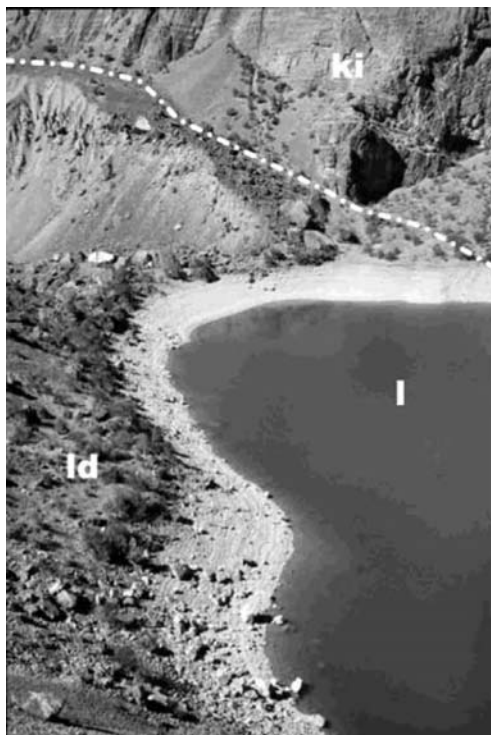
Figures 9 -View of Tso Tok Phu rock avalanche;ld = landslide deposit (dashed-dotted line), l = Tso Tok Phu Lake, ki = Kioto Limestones; photograph: G. Fuchs 1985

The blocky materials of the Kioto Limestone (Figure 9), which primarily composed the deposit of the Tso Tok Phu rock avalanche, obtained its stabilizing input from fine sediments of the seeping waters. Due to dry weather conditions, low rate of sedimentation into the reservoir, and low rates of erosion, the lake still exists.

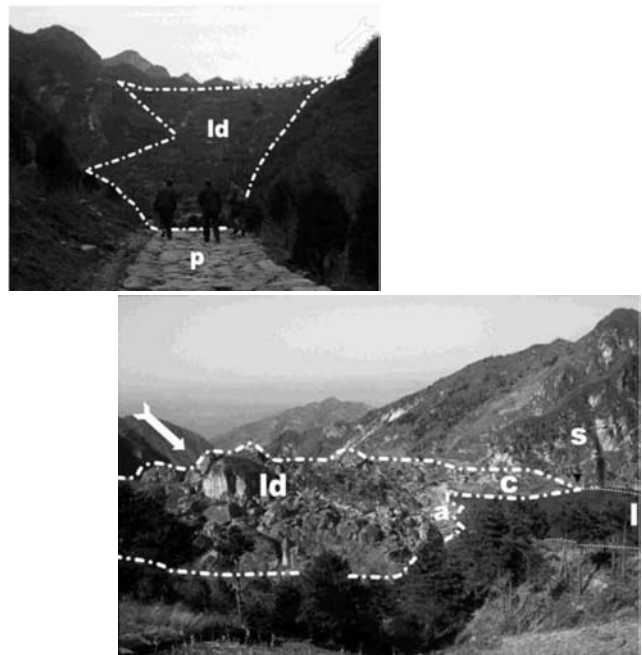
Figure 13 - Left side: view from the pathway (p) towards SSE, to the barrier of Cui Hua rock avalanche (ld, dotted-dashed line); arrow = direction of movement. Right side: The village of Chui Tsho Tshe (c) on top of Cui Hua rock avalanche (ld, dotted-dashed line); s = spillway of the dammed Tianchi Lake (l, dashed line) regulated for agriculture; s = artificial sealing of the lake

northern shore of Tianchi Lake has been sealed by the locals with artificial cementation, preventing the water from seeping through the material of the rock avalanche. Due to this stabilizing input, the natural dammed waters of Tianchi Lake are kept at a higher level, thus functioning as a water reservoir. And with an isometric shape of the deposit and a volume of more than 100 times that of the dammed waters behind it, the barrier of the Cui Hua rock avalanche must be safe from a breaching of the dam.

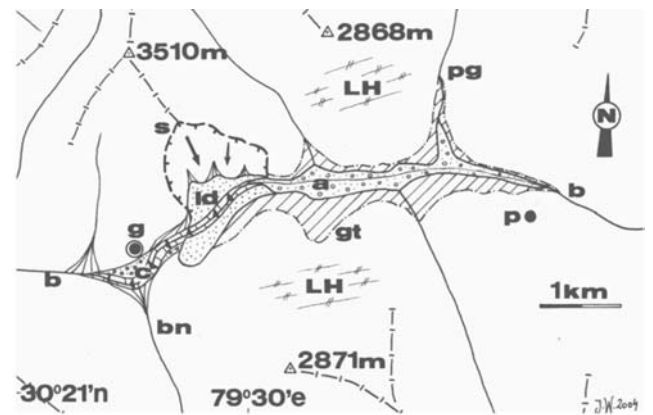
Figure 14 - Geologic sketch-map of Gohna Tal landslide; LH = Lesser Himalayas, s = scarp (2900 m), arrows = direction of movement, ld = landslide deposit, gt (dotted-dashed line) = max. extension of the lake, a = last extension and alluvial fillings of the lake, c = terraced outbreak channel along the Birahi Ganga River (b), g = Gohna village (1600 m), p = Pagna village, pg = Pul Gadera River, pn = Begar Nala River.

Much more spectacular was the catastrophic outbreak of the lake Gohna Tal, which devastated the valley of Alakananda River over a long distance downwards, when the dam failed on the August 26 1894, most probably because of overtopping. Subsequent catastrophic outbreaks of the lake are documented by at least four river terraces of different ages within the eroded flanks of the landslide deposits and downstream in the valley, which were created during and after flood events (Figure 16). Further on, local eye witnesses observed that the water level of Gohna Tal was lowered to a depth of 120 m.

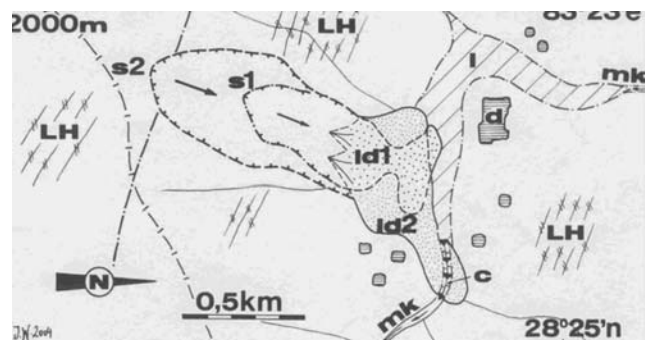
Figure 15 - Geologic sketch map of Dharbang landslide; LH = Lesser Himalayas, s1/2, ld1/2 = scarp and landslide deposit from 1923 (1400 m) respectively from 1988 (1750 m), arrows = direction(s) of movement, l = temporary dammed lake 1988, c = outbreak channel along the Myagdi Khola River (mk), d = Dharbang village, houses (1150 m)

Because of the rapid breaching of a natural rock blockage, the Dharbang landslide of 1988 maintains an extraordinary position among all those investigated in the Himalayas so far. The source of the landslide material must have been soaked with precipitation waters during the monsoon season before the event. Heavy rain-falls during late September caused the rock failure and the rapid damming of a lake. Morphology and internal structure of the remaining deposition area after the lake's outbreak (Figure 18) show that the movement of the slide was an in-situ collapse due to increasing pore water pressure and weight.

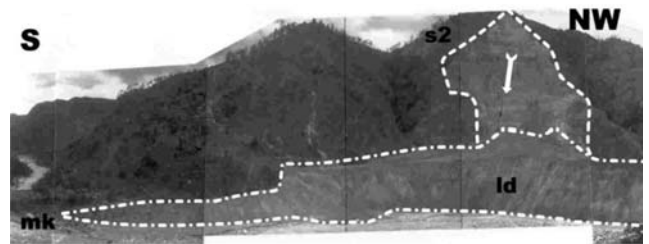
Figure 18 - Panoramic view over the remnants of Dharbang landslide area (ld, dotted-dashed line); note the morphology of the cone of landslide debris; s2(dashed line) = scarp (1988), arrow = direction of movement, mk = Myagdi Khola River; photo: J. T. Weidinger 1994

While sliding, crashed rocks and mineral particles together with water formed a suspension with no inner rupture under rheologic conditions. Instead of becoming compacted, the bulk of the landslide mass became more and more saturated with water. That is why the dam failed by overtopping and material was washed away rather than breaching during the lake's outbreak flood.
