3D SURVEY MODELLING FOR DAMAGE ASSESSMENT IN RUBBLE-MOUND BREAKWATERS UNDER OBLIQUE WAVE INCIDENCE

EXTENDED ABSTRACT

ABSTRACT

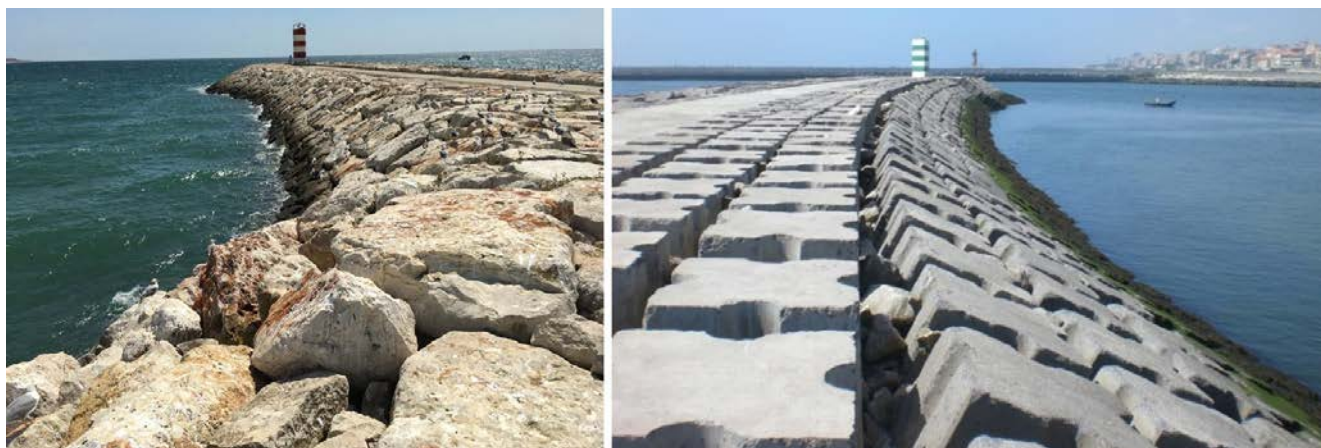
Fig. 1 - Typical rubble-mound breakwaters with armour layers composed of: Left: rock units; Right: artificial units.

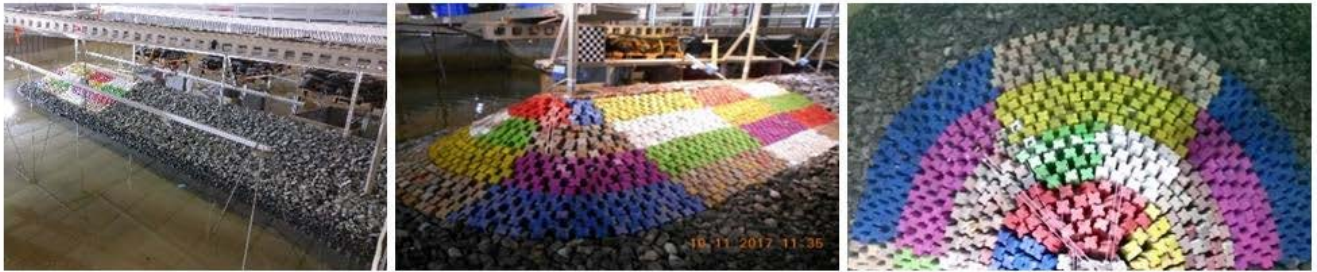
Fig. 2 - Different views of the physical scale model.

A stretch of a rubble-mound breakwater (head and part of the adjoining trunk, with a slope of 1(V) : 2(H) was built in the wave-current basin of the LUH to assess, under extreme wave conditions (wave steepness $s = 0.055$) with different incident wave angles (from 40° to 90°), the structure behaviour in what concerns wave run-up, wave overtopping and damage progression of the armour layer. The armour layer consisted on Antifer cubes of 0.350 kg with a nominal diameter (D_n) of 0.051 m and of rock units of 0.315 kg with a nominal diameter of 0.03 m. The trunk of the breakwater was 7.5 m long and the head had the same cross-section as the exposed part of the breakwater. The model was 9.0 m long, 0.82 m high and 3.0 m wide. Figure 2 shows the physical scale model ready to be operated.

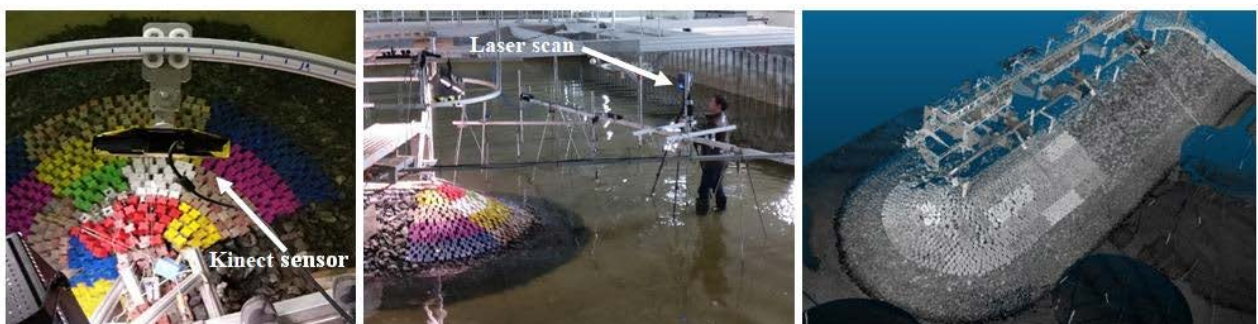
Fig. 3 - Left: Rail to support the Kinect© motion sensor; Center: Laser scanning; Right: Laser scan survey.

The second technique is a laser scan survey (Faro Focus 3D) of the armour layer envelope, which established the reference for the measurements made with the Kinect© sensor. Figure 3 illustrates the equipment used to evaluate armour layer damage.

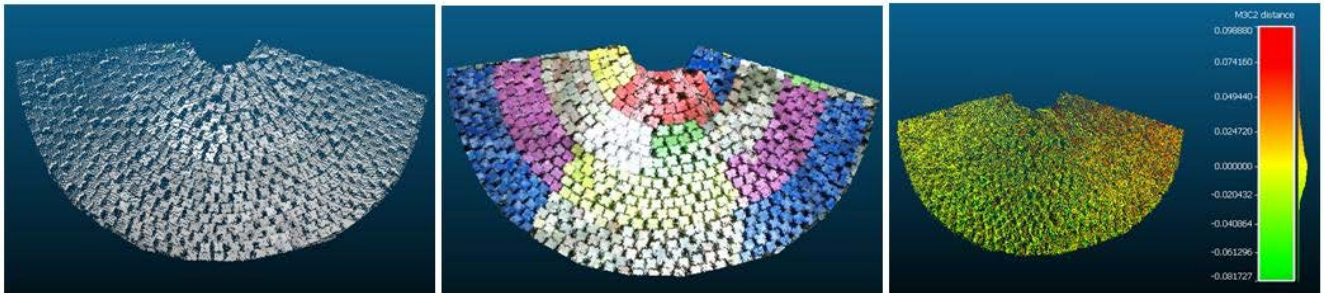
Fig. 6 - Survey before test T17. Left: Laser scan survey; Center: Kinect® sensor survey; Right: Map of distances between both surveys.

As said in section 2.2, a laser scan survey (Faro Focus 3D) of the armour layer envelope established the reference for the measurements carried out with the Kinect© sensor. In order to compare the differences between both survey methodologies, a comparison was carried out between laser scan and Kinect© sensor surveys obtained without water before test T17 (Figure 6).

The average distance between both clouds of points was 0.008 m. The maximum distance was 0.081 m, corresponding to some anomalies occurred, for both methodologies, due to the placement of a run-up gauge along the armour layer slope.

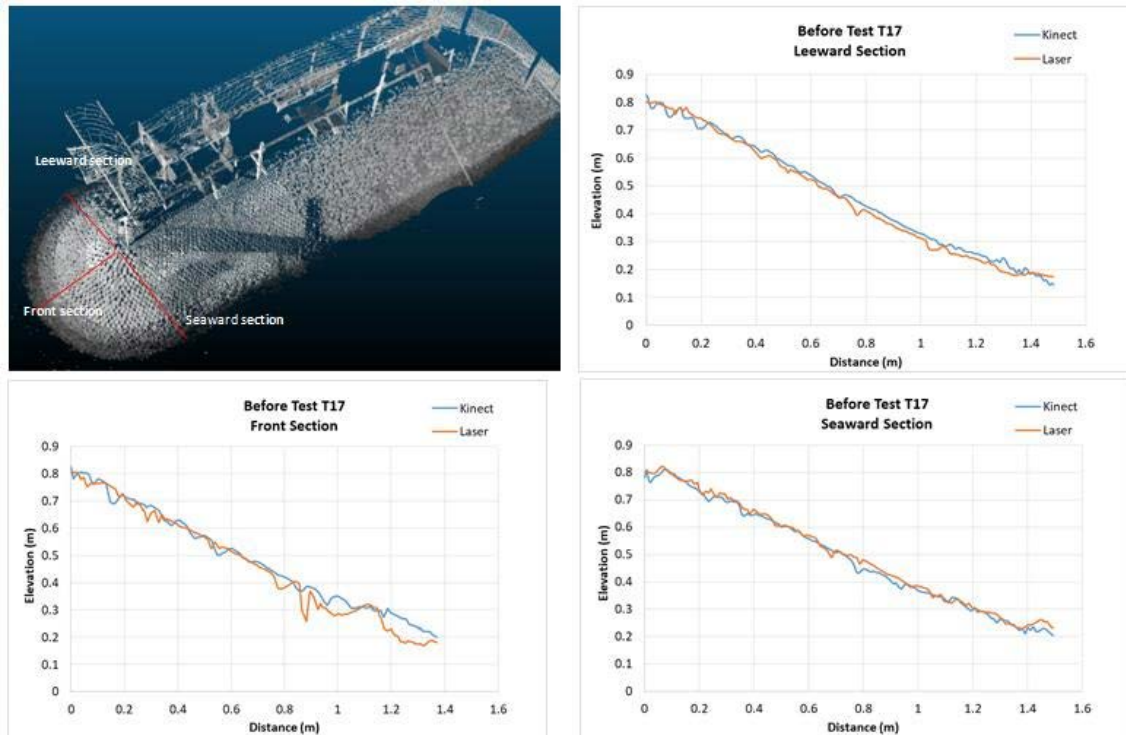
Fig. 7 - Roundhead scanned with a laser scan before test T17 and profiles extracted for the leeward, front and seaward sections.

Profiles extracted for the leeward, front and seaward sections

showed that both methodologies revealed a good agreement in the leeward and the seaward sections. The average error was of 0.015 m and the maximum error was of 0.053 m. On the other hand, the profile corresponding to the front section confirmed the interference of the run-up gauge in the armour layer surveys (Figure 7). In this last case, the average error was 0.028 m and the maximum error was 0.13 m.

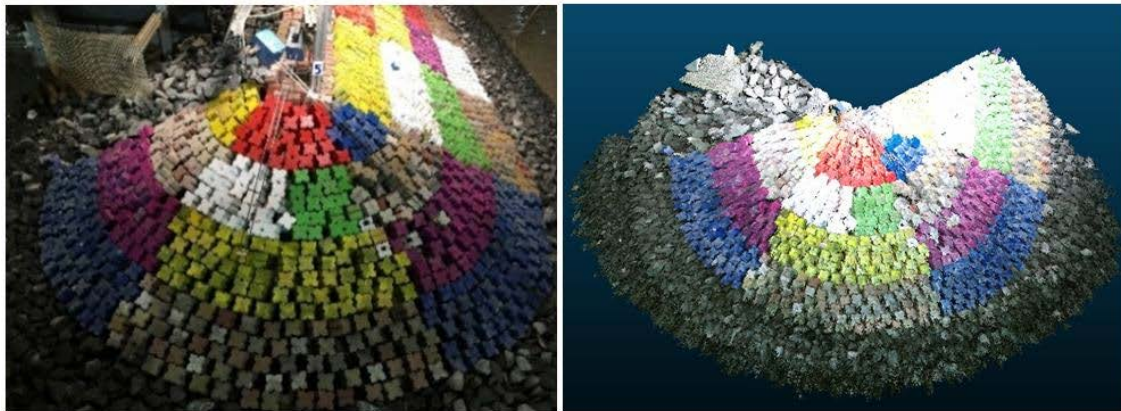
Fig. 9 - Left: Model after test T16; Right: Roundhead scanned with Kinect© after test T16.

Regarding test series T13-T16, the most affected parts of the roundhead were the central and outer sectors, where an important number of movements were detected, without armour unit extraction (Figure 9). Figure 10 illustrates the depth changes map, caused by movements of the armour layer units during the test series.

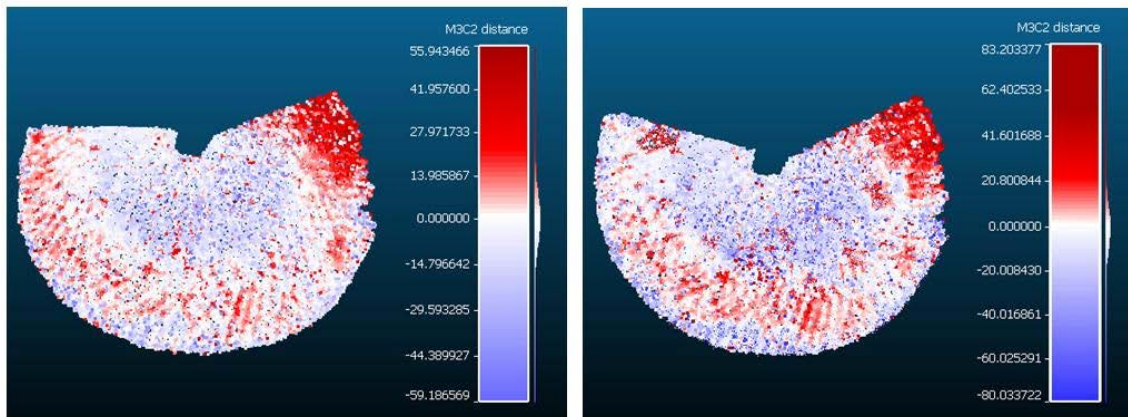
Fig. 12 - Tests T17-T20. Armour layer eroded depth, in mm (Red - erosion; Blue - deposition). Left: After test T17; Right: After test T20.

During test series T17-T20, an important number of movements were also detected, as well as a small number of armour units removed from the inner section of the roundhead. Figure 11 illustrates an overview of the model at the end of test T20, as well as the scan of the model at the end of the test series. Figure 12 shows the depth maps at the end of tests T13 and T20.

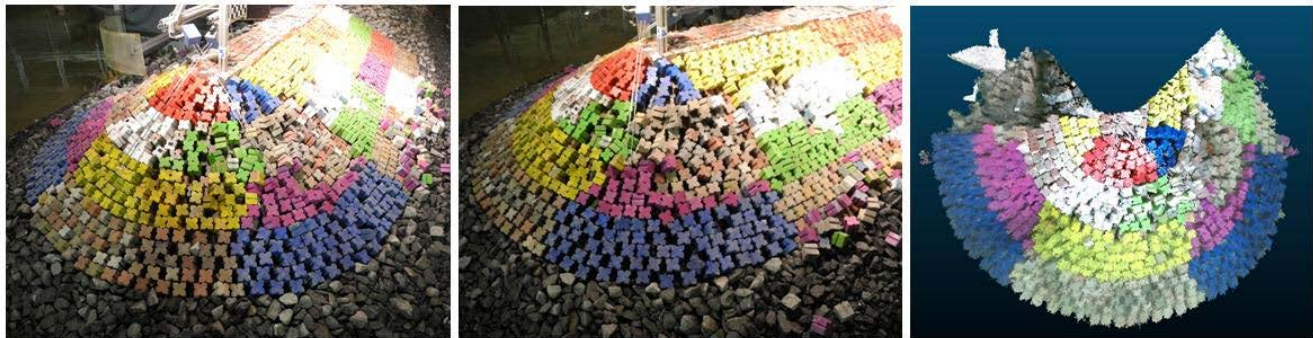
Fig. 14 - Left and center: Model after test T25; Right: Roundhead scanned with Kinect© after test T25.

Test series T21-T25 and T35-T39 presented more severe damage levels than the other series. At the end of series T21-T25, an important eroded volume was observed, mainly at the center and outer sectors of the roundhead, around the still water level, exposing the inner layer of Antifer cubes (Figure 14). The global

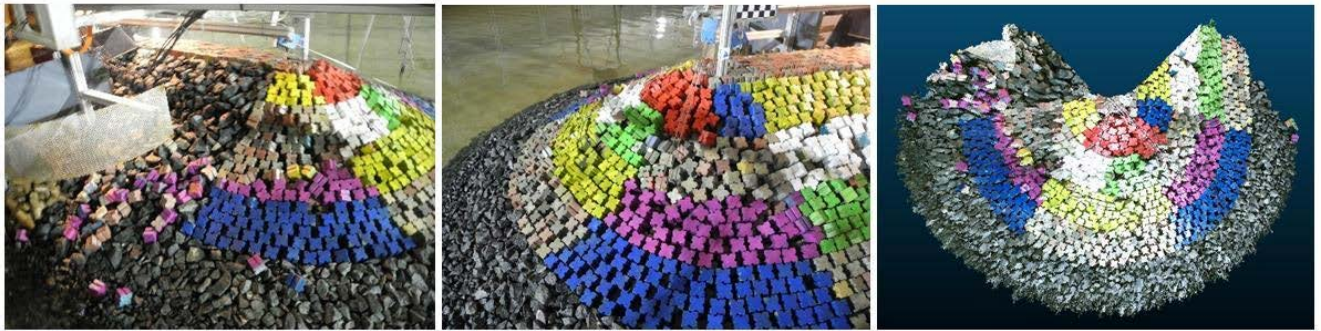
Fig. 16 - Left and center: Model after test T39. Right: Roundhead scanned with Kinect© after test T39.

Surveys during test series T35-T39 also revealed important damage at the leeward section of the roundhead, around the still water level, with exposure of the Antifer cubes of the inner layer. The armour layer of the outer sector of the roundhead presented several movements and rearrangements of the Antifer cubes (Figure 16). These tests, conducted with the same wave conditions ($d = 0.60$ m and $\beta = 40^\circ$) as tests T13-T16, but with a directional

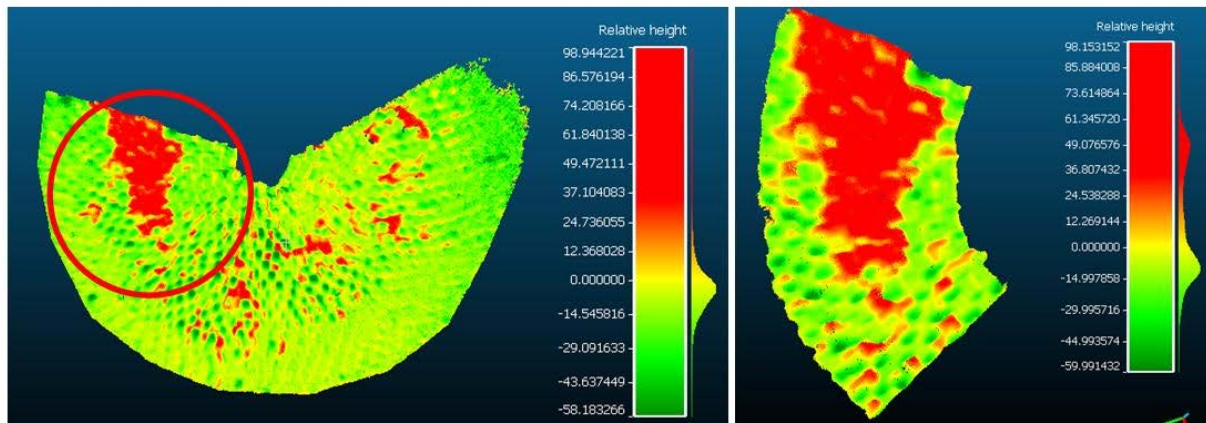
Fig. 17 - Tests T35-T39. Armour layer eroded depth (in mm) (Red - erosion; Green - deposition). Left: Global estimate; Right: Local estimate.

spreading of 50° (for short-crested wave reproduction), presented a higher localized damage (Figure 17).
