PRELIMINARY ANALYSIS OF THE NOVEMBER 10, 2014 RAINSTORM AND RELATED LANDSLIDES IN THE LOWER LAVAGNA VALLEY (EASTERN LIGURIA)

ANDREA CEVASCO^(*), GIACOMO PEPE^(*),
GIACOMO D'AMATO AVANZI^(**) & ROBERTO GIANNECCHINI^(**)

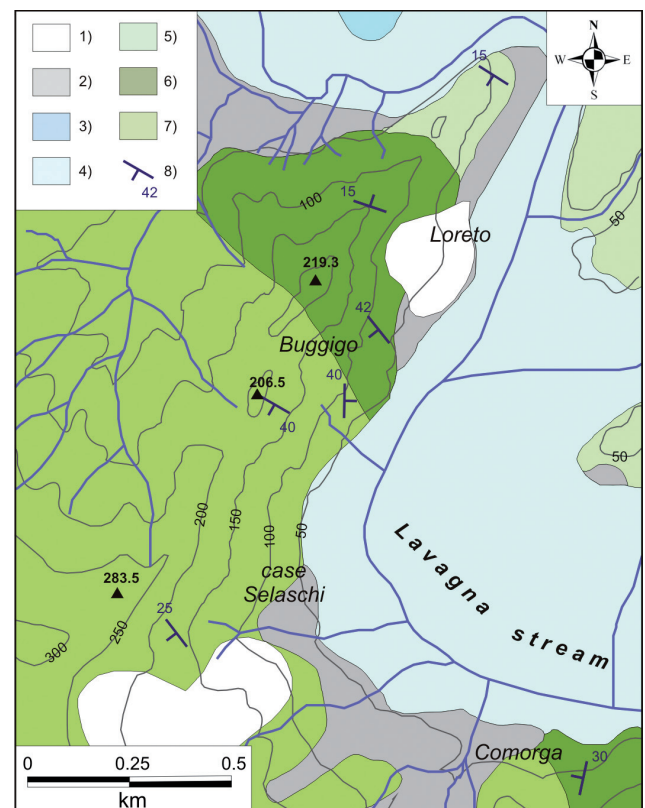
From a geological point of view, the bedrock is represented by formations belonging to the Gottero Unit (Internal Ligurid Units of the Northern Apennines). From SW to NE they outcrop in the following order (Fig. 2; ABBATE *et alii*, 2011): Palombini Clays, Manganiferous Shales and M. Verzi Slates. The Palombini Clays (Berriasian-Santonian p.p.) are formed of grey claystones and silstones with dark grey limestone interbedding; the Manganiferous Shales (upper Santonian-lower Campanian) are constituted by arenaceous-pelitic turbidites with exclusively siliciclastic composition whereas the M. Verzi Slates (Campanian) are represented by arenaceous-pelitic-turbidites interbedded by siliciclastic and marly-limestone levels (ELTER *et alii*, 2005). Such formations are tightly folded with axes NW-SE striking and show a dominant bedding attitude oriented south-westwards.

Fig. 2 - Geologic map of the study area (after ABBATE *et alii*, 2011, re-drawn and modified.). LEGEND: 1) landslide deposit; 2) slope deposit; 3) terraced alluvial deposit; 4) alluvial deposit; 5) M. Verzi Slate; Manganiferous Shales; 6) Palombini Clays; 7) bedding attitude

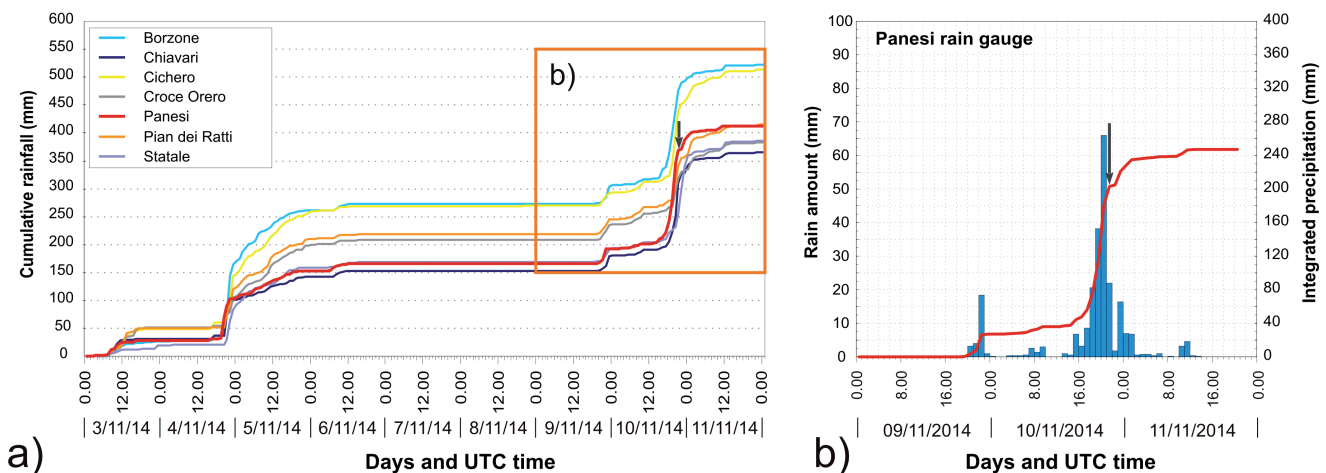
at Panesi, which is located about 2 km east from the study area. The 1h maximum intensity reached 66 mm between 20.00 and 21.00 UTC (Fig. 3b). The same raingauge recorded 147 mm/4h from 18.00 to 22.00 UTC. As an example of the very low lag time characterizing most of the Liguria basins, the hydrometric level of the Lavagna Torrent at Carasco raised 5.5 m in only three hours (from 19.00 to 22.00 UTC).

Fig. 3 - a) cumulative rainfall recorded by different raingauges located in the Lavagna, Sturla and Graveglia valleys from November 3, 2014 to November 11, 2014 (data from REGIONE LIGURIA-ARPAL 2014); b) hyetograms (blue bars) and cumulative rainfall (red line) of November 9-11, 2014 recorded at the Panesi raingauge (after CEVASCO *et alii*, 2015b, modified). The dark green arrows reported in a) and b) mark landslides a and a1 occurrence

However, it is interesting to point out that during the week before the event significant rainfall occurred. In fact, between November 3 and 6, 2014, cumulated rainfalls reaching 273 mm at Borzone, 153 mm at Chiavari, 269 mm at Cichero and 166 mm at Panesi raingauges were recorded (Fig. 3b; Tab. 1). Therefore, in the period between November 3 and 11, 2014 the cumulated rainfall exceeded 500 mm at Borzone and Cichero raingauges and 400 mm at Panesi raingauge.

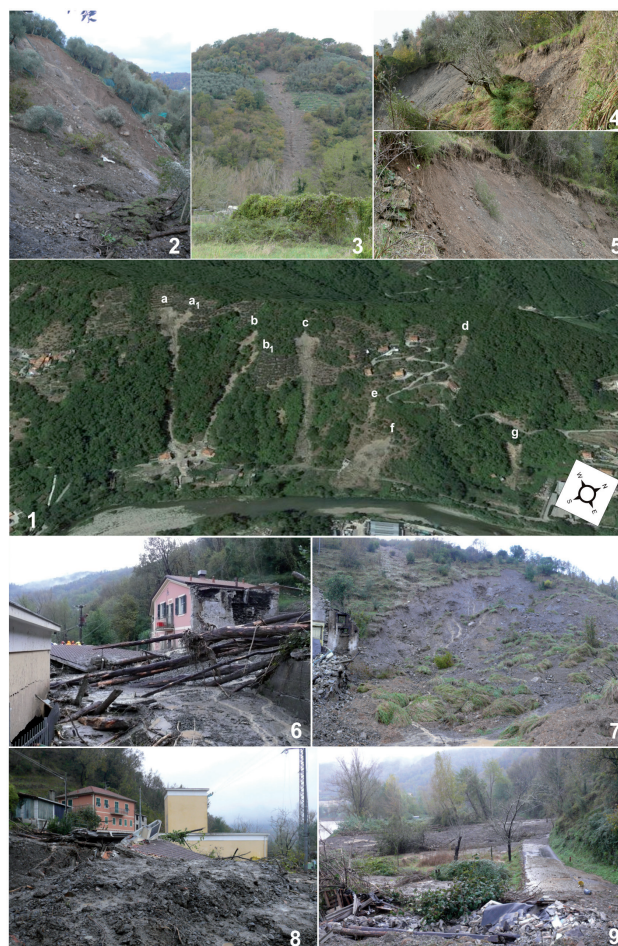
In the evening of November 10, 2014 eight shallow landslides (Fig. 4) occurred on an area of just 160.000 m² (0.16 km²). According to the landslides classifications proposed by CRUDEN & VARNES (1996) and HUNGR *et alii* (2014), such landslides can be classified as debris slides, debris flows and debris avalanches. Shallow landslides affected terraced slopes which were characterized by different state of conservation. Abandoned terraced areas (partially invaded by mixed woods) were mainly affected by landslide activity, even though large portions of well maintained and cultivated terraces with olive grove were also scoured and damaged. However, solely one of the considered landslides affected a sparsely vegetated area. Landslide activity involved man reworked debris covers (from 0.5 m to about 3-4 m thick) and portions of the weathered and fractured bedrock. In all cases, landslide deposits reached the

toe of the slope, involving one road and some sparse houses. In the south-western sector, one of such houses was destroyed by a debris flow (Fig. 4), causing two casualties, whereas a nearby service station for water supply was impacted and damaged by debris deposits, leading to a long time interruption of water distribution. Damage also affected other two houses located in the central and the north-eastern sector of the slope, respectively. The first one was impacted and partially destroyed; the second one was only damaged by landslide deposits. Long tracts of the road running parallel to the Lavagna stream at the slope's toe were buried by landslides debris, producing interruption which currently continues. As a consequence of the severe damage, all the people living on slope settlements were evacuated.

Fig. 4 - Views of the shallow landslides triggered on November 10, 2014 in the study area and related damage. 1) aerial image (from Google Earth); letters indicate the landslides; 2) detail of the source area of a large shallow landslide that gave rise to a debris flow (landslides a, a1); 3) landslide c; 4) detail of the scar of the landslide c; 5): detail of the scar of the landslide d; 6) and 8) view of the toe of the slope, where a debris flow (landslides a and a1) destroyed one building, causing two casualties; 7) landslide f; 9) damage to roads and private properties by landslide activity

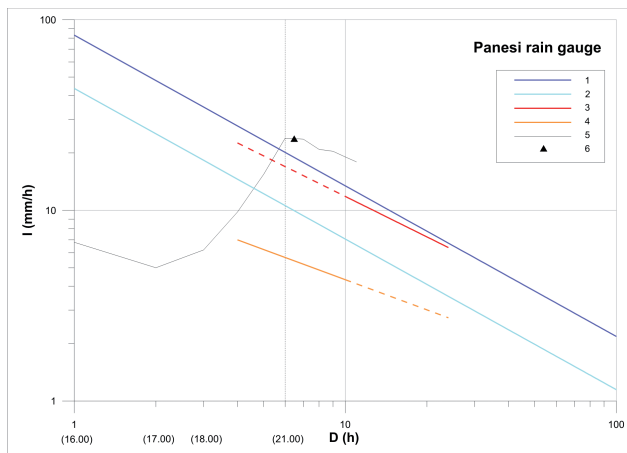
exceeded the worldwide (CAINE, 1980), national (BRUNETTI *et alii*, 2010) and local rainfall intensity-duration thresholds (CEVASCO *et alii*, 2008, 2010; GIANNACCHINI *et alii*, 2015) for shallow landslides activation (Fig. 6). As regards the time of landslides triggering, information coming from local people and newspapers revealed that the most destructive phenomenon was triggered on November 10, 2014 between 21.00 and 22.00 (UTC), which means just before the maximum 1h intensity peak recorded at the Panesi rain gauge.

Fig. 6 - Rainfall I-D thresholds established locally for triggering shallow landslides. The UTC time is shown, in brackets, on horizontal axis. LEGEND: 1) Eastern Ligurian Riviera (upper) (GIANNACCCHINI et alii, 2015); 2) Eastern Ligurian Riviera (lower) (GIANNACCCHINI et alii, 2015); 3) Bisagno valley, Genoa (upper) (CEVASCO et alii 2008; 2010); 4) Bisagno valley, Genoa (lower) (CEVASCO et alii 2008; 2010) 5) November 10, 2014 rain path at Panesi raingauge; 6) landslides a and a1 occurrence

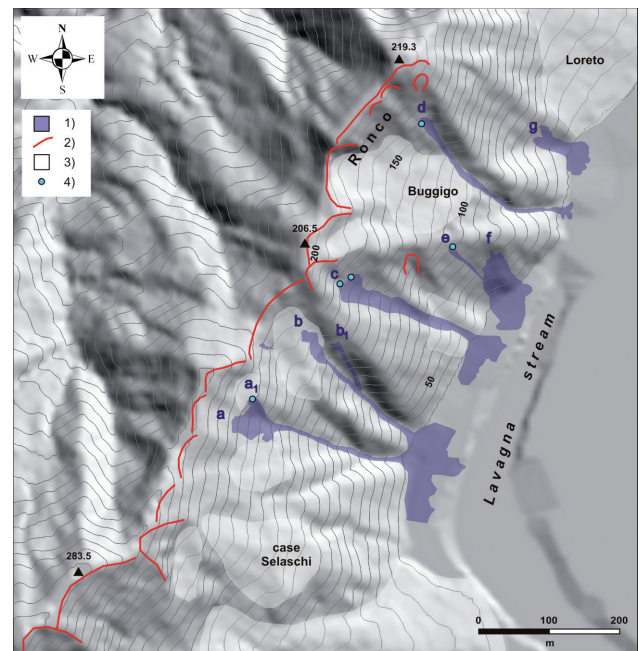
The morphological features of the landslides are shown in Fig. 7. The scars of the four main landslides that evolved into flows (a, b, c, d in Fig. 7) are located at similar height, ranging between 160 m and 185 m a.s.l. On the contrary, three shallow landslides (e, f, g in Fig. 7) initiated and affected the middle-lower slope, with scars reaching altitudes ranging between 60 and 100 m a.s.l. On-site observations showed that most of the landslides (a, b, c, d, g) initiated in hollows or in concave slopes; in all cases the landslide material reached the toe of the slope by means of a movement which can be classified from rapid to very rapid (Fig. 7).

Fig. 7 - Map of shallow landslides occurred on November 10, 2014 in the Leivi slope and morphological features of ancient landslides. LEGEND: 1) shallow landslides occurred on November 10, 2014 in the Leivi slope; 2), 3) scars and deposits of ancient landslides detected by the analysis of topographic maps and aerial photographs; 4) location of sampling points

The topographic maps analysis has allowed to recognize several morphological features, such as landslide crowns and deposits, testifying ancient landslides occurrence on the Leivi slope. Information on recent slope dynamics came from the local inhabitants and from the analysis of different time series of aerial photographs (referred to years 1974, 1982, 1990). On the contrary, no information on landslides was available from the IFFI (Inventario dei Fenomeni Franosi in Italia) landslides inventory. As shown in Fig. 7, the results of these investigations revealed an active slope dynamics also in recent periods. In particular, several landslide crowns affect the top of the slope above 200 m a.s.l. whereas landslide deposits have been mainly detected in the middle-upper slope, between 100 m a.s.l. and 200 m a.s.l. In addition, a shallow landslide, quite similar to those which evolved into flows on November 10, 2014, affected the north-eastern sector of the slope before 1974. This landslide, whose crown was located slightly higher than that of landslide d, was still visible on aerial photographs of 1982, but was completely hidden by vegetation in 1990. From oral sources collected on sites, it seems that a cowshed located at the toe of the slope, exactly where one house has been destroyed on November 10, 2014, was already damaged in the 1920's. This fact highlights another important issue, already pointed out by GIANNACCHINI & D'AMATO AVANZI (2012) namely the need of mapping and carrying out a proper database of landslide events rapidly. In fact, occurrences as the November 2014 event usually produce superficial effects (shallow landslides, debris flows, floods, etc.), which are typically obliterated in a few years without any significant morphological traces. The areas involved in shallow landslides are usually re-carpeted by vegetation, while the hydraulic structure of rivers and torrents is rapidly restored, especially in urban areas.

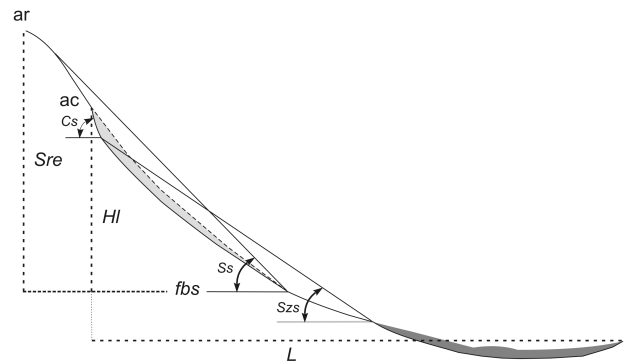
proposed by DI CRESCENZO & SANTO (2005) was applied (Fig. 8). The main morphometric parameters obtained for the four main landslides that evolved into flows (a, b, c and d) are showed in Tab. 2. They included slope angle of the crown (Cs) and of the sliding zone (Szs), crown altitude (ac), areal extent of the landslide source areas and sliding zone (Ass), areal extent of landslide deposits (Ad), length of the landslide (L), height of the landslide crown zone (HI), slope steepness (Ss) and slope relief energy (Sre). According to DI CRESCENZO & SANTO (2005), the slope relief energy was calculated as the difference in height between the divide of the landslide slope (ar) and the first break of slope at the foot of the slope (fbs).

The length of landslides a, b, c, d ranges between 258 m (landslide c) and 342 m (landslide a) while the extent of source areas and sliding zones varies between about 1,800 m² (landslide b) and 4,000 m² (landslide c). The length of landslides occurred in the middle lower slope (e, f, g) is lower than the previous ones and ranging between 88 m (landslide g) and 120 m (landslide f), as well as the extent of landslide source areas and sliding zones (Ass), which ranges between 360 m² (landslide e) and 1800 m² (landslide f). In the cases of landslides a, b, c and d, the slope steepness ranges between 32° (landslide d) and 39° (landslide b) while the crown steepness varies between 30° (landslide b) and 39° (landslide d). Values of sliding zone steepness are slightly lower than the previous ones, ranging between 26° (landslide d) and 33° (landslides a and c). As for the relief energy of slopes (Sre), the landslides a, b, c and d occurred on slopes between 114 m (landslide d) and 180 m (landslide a) in height. There is a small difference between the total extent of landslide source areas and

Fig. 8 - Morphometric parameters considered for the main earth-debris avalanches/earth-debris flows (after DI CRESCENZO & SANTO, 2005, modified). LEGEND: ar) altitude of the ridge (a.s.l.); ac) altitude of the landslide crown (a.s.l.); fbs) altitude of the first break of slope at the foot of the slope (a.s.l.); Sre) slope relief energy; HI) height of the landslide crown zone; L) length of the landslide; Ss) slope steepness; Cs) crown steepness; Szs) sliding zone steepness; Ass) extent of the landslide source area; Ad) extent of the landslide deposit

sliding zones (Ass) and the total extent of landslide deposits (Ad), estimated as 14,773 m² and 14,944 m² respectively. The total area affected by landslides (source areas, sliding zones and deposits) was assessed as about 29,717 m².

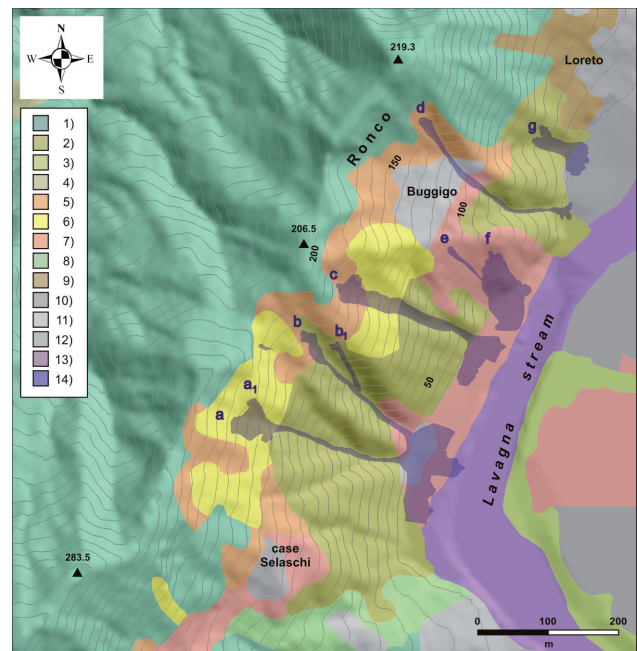
As stated previously, in the source areas the land use setting prevalently consists of terracing characterized by different state of maintenance. Where terracing has been abandoned since short and long time, scrubs and woods had grown, respectively. As can be seen in Fig. 9, most of the shallow landslide source areas affected abandoned terracing (landslides b, b1, c, d, e, f, g), which currently appear occupied by vegetation cover of different age. In particular, the source areas of landslides b, c and d were triggered on short time abandoned olive groves, where a sparse vegetation has grown. On the contrary, the source areas of landslides b1 and g were triggered on long time abandoned olive groves, where a mixed wood had grown. The source areas of landslides e and f affected very scarcely vegetated areas. Lastly, well maintained terraces with olive grove cultivations were involved by landslides source areas belonging to landslides a and a1 (Fig. 9).

Fig. 9 - Map of shallow landslides that occurred on November 10, 2014 in the Leivi slope and land use. LEGEND: 1) chestnut; 2) mixed wood; 3) wood of hygrophilous species; 4) area with shrub vegetation in evolution; 5) abandoned olive grove 6) olive grove; 7) complex cropping system; 8) grassland; 9) vineyard and olive grove; 10) industrial areas; 11) sparse residential fabric; 12) dense residential fabric; 13) riverbeds with scarce vegetation; 14) November 10, 2014 shallow landslides

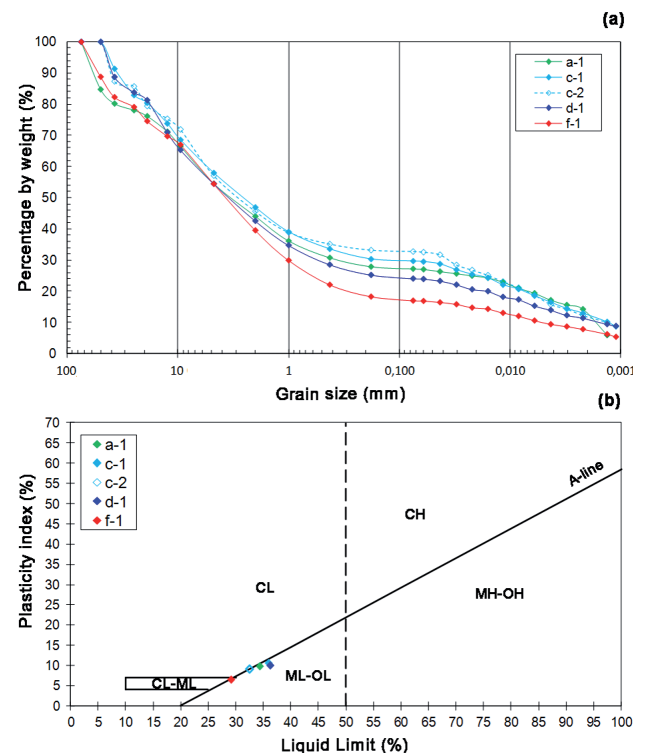
in different landslide source areas. Laboratory tests allowed both the soil classification and the determination of the physical properties (Fig. 10). According to the U.S.C.S. soil classification system, the soils can be classified as silty sands with gravel (SM). The results of the grain size analysis showed that the slope materials are somewhat homogeneous (Tab. 3). All the soils are very poorly sorted, with coefficient of uniformity (CU) values

greater than 100. Gravel content often reaches 45%, while sand fractions are 30% on average. The fines contents are usually less than 30%, and the clay contents rarely exceed 12%. The gravel fraction consists of angular and platy pebbles with a strong fissility. Liquid limits were not very high, ranging between 29.1% and 36.2% (Tab. 4). The Plasticity Index (PI) values, ranging between 8.3% and 10.7%, show a low plasticity of the soils. Lastly, the specific gravity of the soil particles ranges from 2.5 to 2.7 g/cm³.

Fig. 10 - Grain size distribution (a) and Casagrande Plasticity Chart (b) of the soil samples collected at different landslide source areas
