DEBRIS FLOWS IN VAL PARMA AND VAL BAGANZA (NORTHERN APENNINES) DURING THE 13 OCTOBER 2014 ALLUVIAL EVENT IN PARMA PROVINCE (ITALY)

KEYWORDS: debris flows, rainstorm October 2014, Val Parma, Val Baganza, Northern Apennines

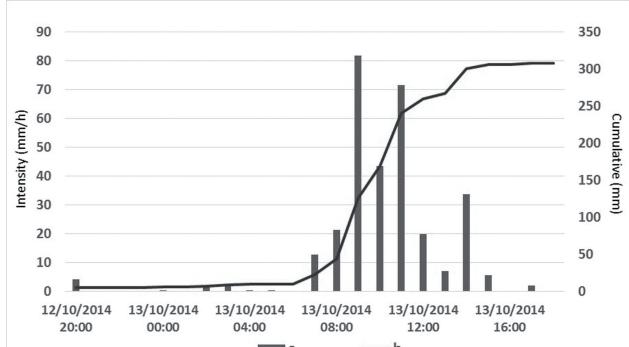
Fig. 1 - Rainfall data recorded by ARPA meteorological station of Marra (PR) between 12 and 13 October - time plot of the event. LEGEND: a) hourly rainfall intensity (mm/h); b) cumulative rainfall (mm)

network. The rain gauge of Marra (Parma province) is the closest to the slopes affected by debris flows (approximately 5 km away). The Marra record between 12th and 13th October 2014 indicates a rainfall of 308.6 mm in 24 hours (Fig. 1). Rainfall intensity peaked between 7.00 and 15.00 of 13th October 2014. In particular, around 9.00 o'clock, the intensity was of 81.8 mm/h, while around 10.00 o'clock it was 43.4 mm/h. The peak intensity at 15 minutes was 31.2 mm. These values are similar to those obtained from other ARPA meteorological stations located near Marra (Tab. 1). If compared to the debris-flow triggering thresholds presented in scientific literature (CAINE, 1980; CANCELLI & NOVA, 1985; CERIANI *et alii*, 1994; GUZZETTI *et alii*, 2008), the values are above almost any of the threshold values proposed (Fig. 2a). The intensity-duration plot shows that peaks of such an intensity can be associated to return periods exceeding 100 years (Fig. 2b).

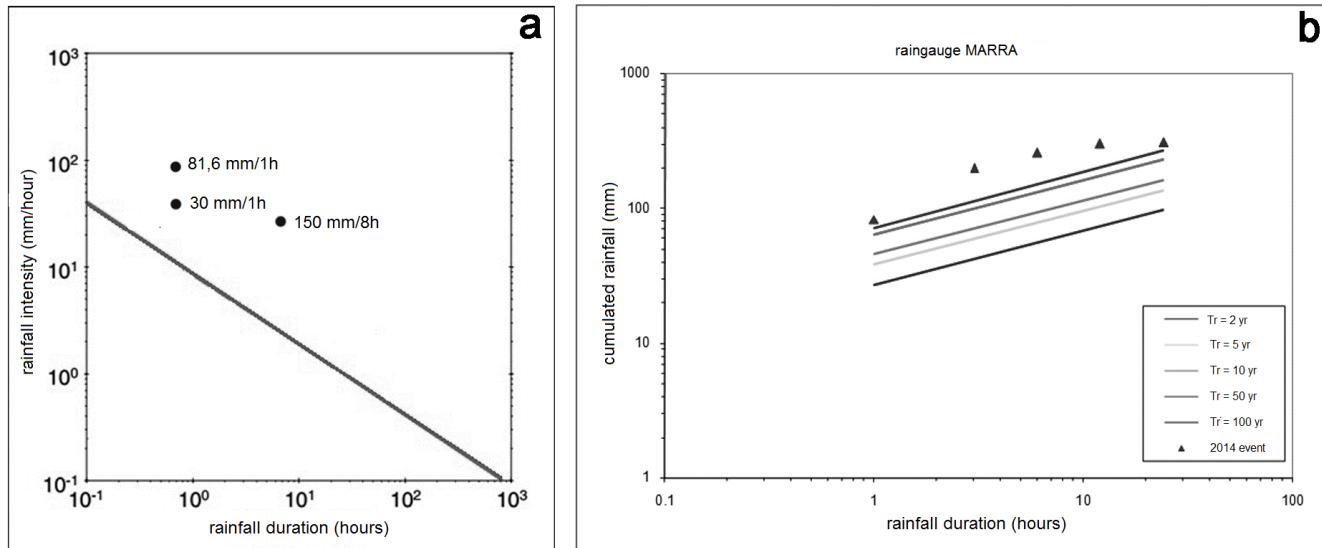
Fig. 2 - a) The event in Val Parma compared to rainfall thresholds triggering debris-flow collected by GUZZETTI *et alii* (2007); b) Intensity – duration plot for the event of 13th October 2014 compared to return period lines

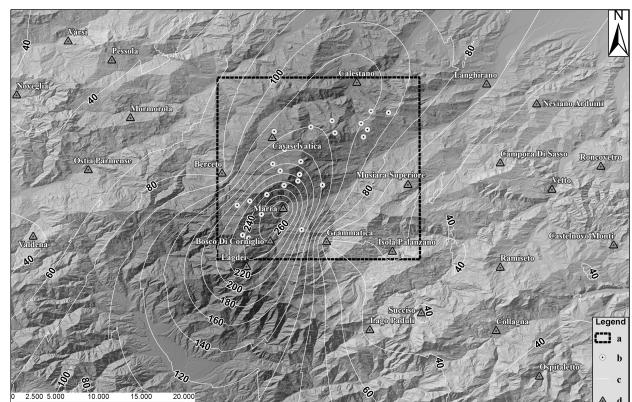
Fig. 3 - Cumulative rainfall map obtained by interpolation of rainfall data recorded in 24 hours. The triggering zones are located in the areas where the isohyets produced shows higher values of cumulative rainfall. LEGEND: a) area affected by debris flow; b) debris flow triggering zones; c) cumulative rainfall isohyets (24h); d) Arpa meteorological station

Cumulative rainfall maps have been derived by the kriging method (LASLETT, 1994) adopting the parameters in Tab. 2. Such approach is generally used in literature to interpolate extreme rainfall data (ATTORRE *et alii*, 2007 and FIORENZO *et alii*, 2008). The 24 hours cumulative rainfall map shows that about 50% of debris flows have occurred in areas where rainfall exceeded values between 200 and 300 mm/24h (Fig. 3). More specifically,

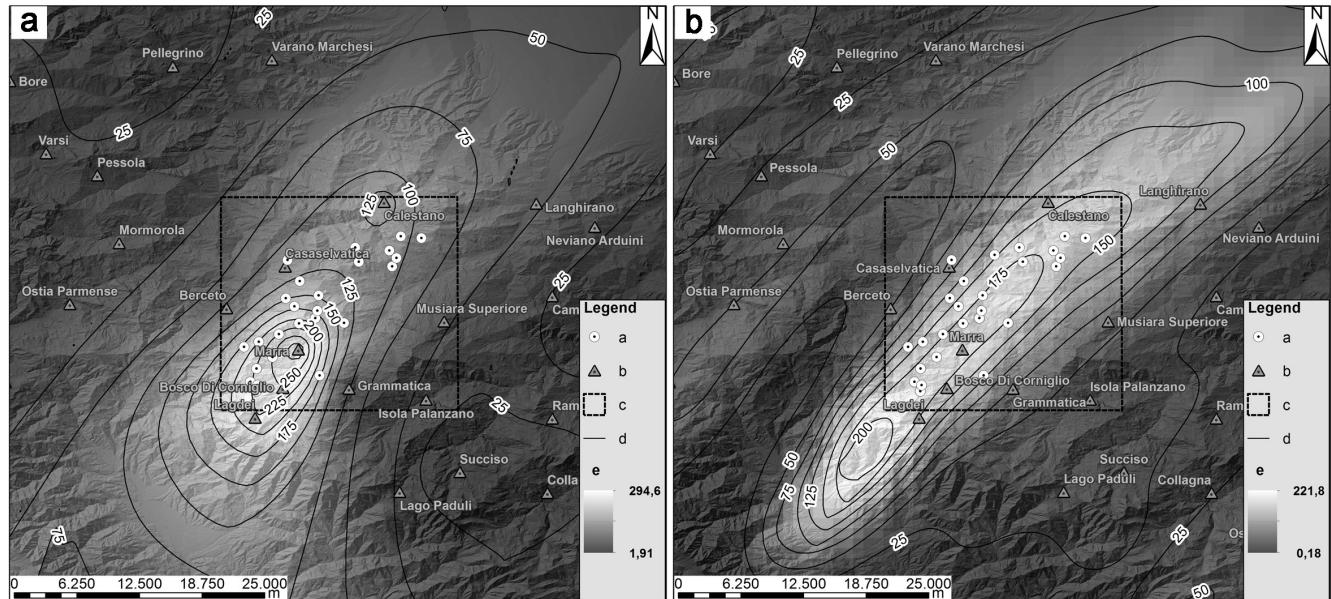
Fig. 4 - a) Cumulative rainfall map, interpolation of rainfall data (8h); b) Radar cumulative rainfall map (8h) by Arpa. LEGEND: a) debris flow triggering zones; b) ARPA meteorological station; c) area affected by debris flow; d) cumulative rainfall isohyets (8h); e) cumulative rainfall values in 8 hours (mm/h)

the raingauge network is not enough dense to resolve the fine spatial distribution. This can be appreciated by comparing it with the 8 hours cumulative rainfall map obtained with weather radar data by ARPA (Fig. 4b). Radar data, collected with 5 minutes temporal resolution, were preprocessed in order extract significant meteorological information, interpolated over a 1 km² grid in order to produce hourly cumulative rainfall maps. The

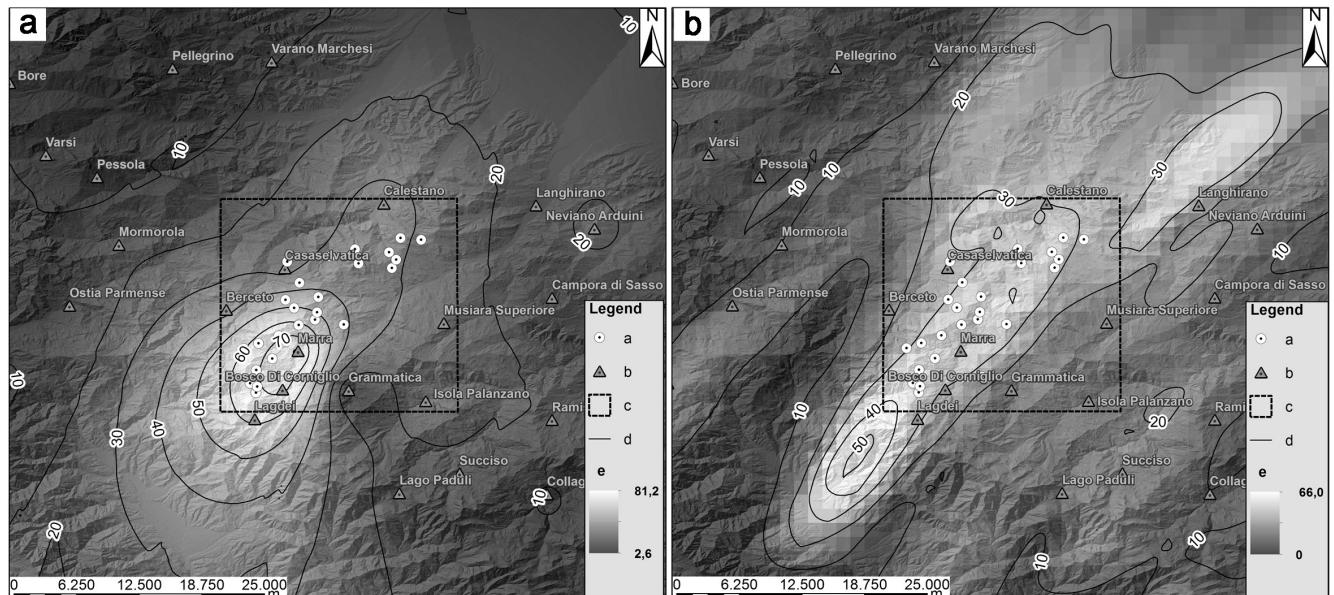
Fig. 5 - a) Cumulative rainfall map, interpolation of hourly rainfall peaks; b) Radar cumulative rainfall map, hourly rainfall peaks. LEGEND: a) debris flow triggering zones; b) ARPA meteorological station; c) area affected by debris flow; d) hourly rainfall peaks isohyets (1h); e) hourly rainfall peaks values (mm/1h)

data show that debris flows have occurred in any location where 30 mm/hour was exceeded (Fig. 5). To obtain the peaks isohyets, the hourly rainfall peaks, recorded by each meteorological station between the 7.00 and 15.00 o'clock, have been interpolated. Moreover, to obtain the map of hourly rainfall peaks measured by Arpa Radar, the maximum values of each cell measured in hourly radar images between 7.00 and 15.00 o'clock have been used.

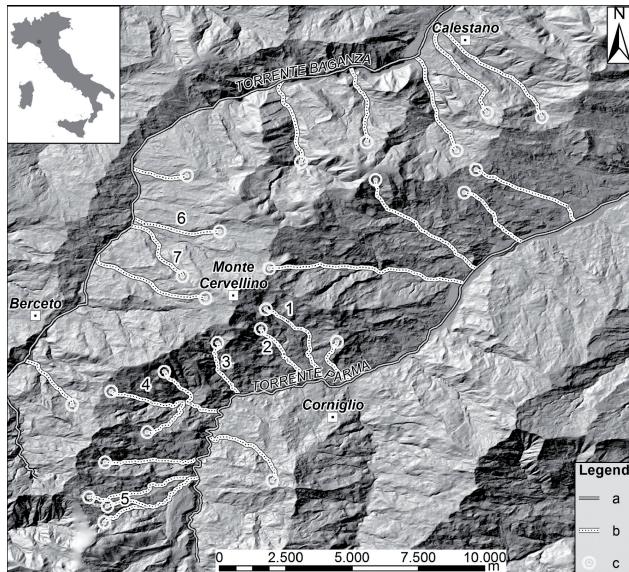
Fig. 6 - Distribution of torrents affected by debris flow in the Mt. Cervellino area (Val Parma and Val Baganza). LEGEND: a) Main streams; b) Torrent affected by debris flow; c) Debris flow triggering zones; 1) Rio Vestana; 2) Rio Graiana; 3) Rio Lombasina; 4) Rio Roccaferrara; 5) Rio Cirone; 6) Rio di Confine; 7) Rio delle Tane

of all the torrents in the Monte Cervellino relief (Fig. 6). The length of the torrent tracks affected by debris flows ranges from approximately 1000 m of Rio Cirone to 3000 m of Rio Vestana. In some cases (Rio Lombasina, Rio Vestana e Rio Roccaferrara) the elevation difference between the triggering zone and the final accumulation zone is up to 600 m, while in other cases (Rio Cirone) is of only 150 m (Tab. 3). Bedrock lithology in the Monte Cervellino relief is flysch and mono-polygenic breccia (Flysch di Monte Caio and Complesso di Casanova) and Argille e Calcaro di Canetolo in the SE slope, while it is flysch (Flysch di Monte Cassio) in the NW slope. Bedrock lithology in the debris flows triggering zone is in 50% of the cases the Flysch di Monte Caio (Fig. 7) over which periglacial processes in the Late Pleistocene and slope processes in the Holocene have deposited widespread slope debris and landslide deposits. In most cases, the triggering zones correspond to areas of slope failure affecting coarse debris deposits in correspondence of marked changes in slope gradient (Fig. 8).

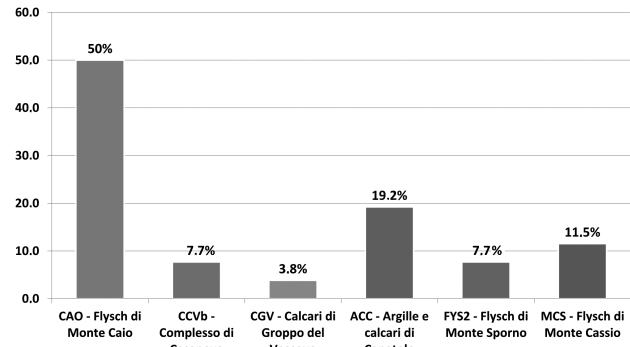
Fig. 7 - Bedrock lithology in debris flow triggering zones: in 13 torrents out of a total of 26, the outcropping lithology is Flysch di Monte Caio

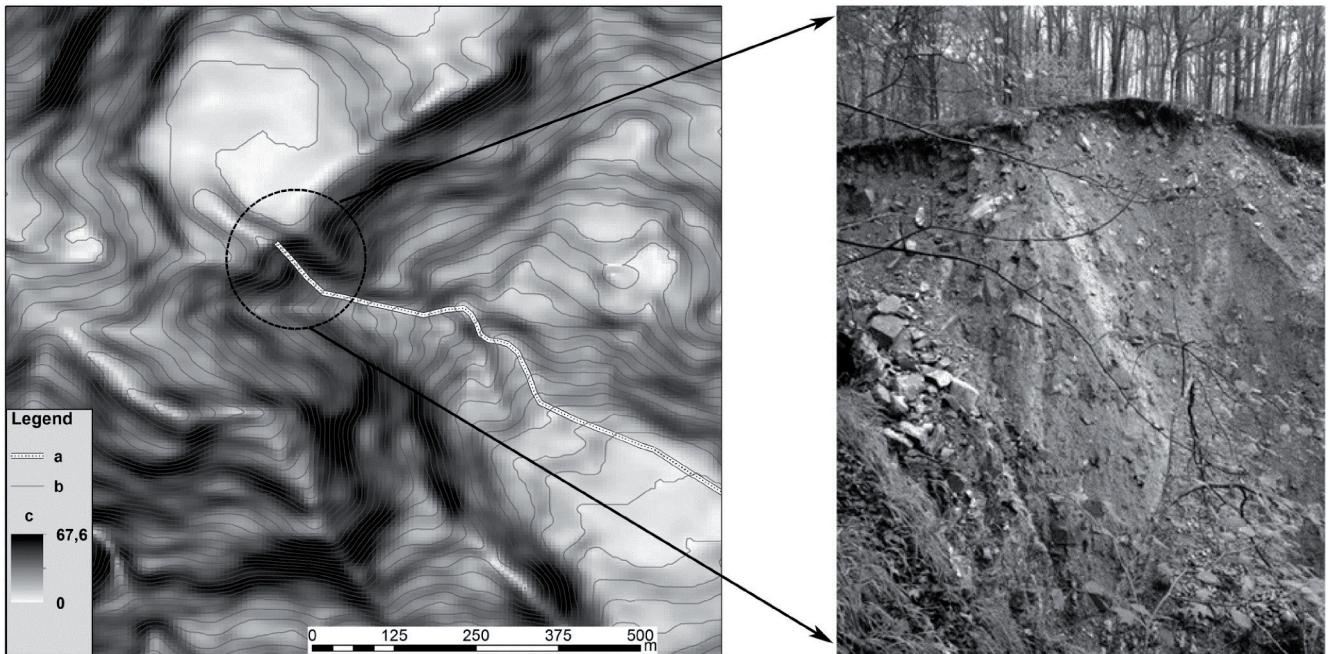
Fig. 8 - Triggering zone of Rio Vestana: Map of slope angles, derived from Digital Elevation Map; triggering of debris flow in correspondence of slope angle changes. LEGEND: a) location of triggering zone shows in the photo; b) contour lines; c) values of slope angle

Field surveys have allowed to map and document several triggering zones, debris flow track channels and deposition areas. In Rio Vestana, slope failure in the triggering zone has affected approximately 10.000 m³ of coarse debris (Fig. 8). A similar situation has been surveyed in many other triggering zones (Fig. 9).

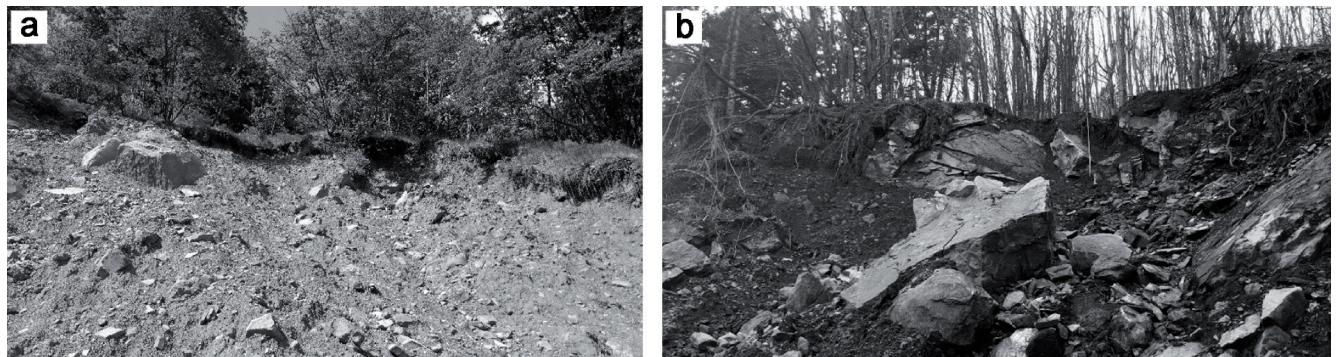
Fig. 9 - a) Triggering zone of debris flow in Rio Roccaferara; b) Triggering zone of debris flow in Rio Cirone

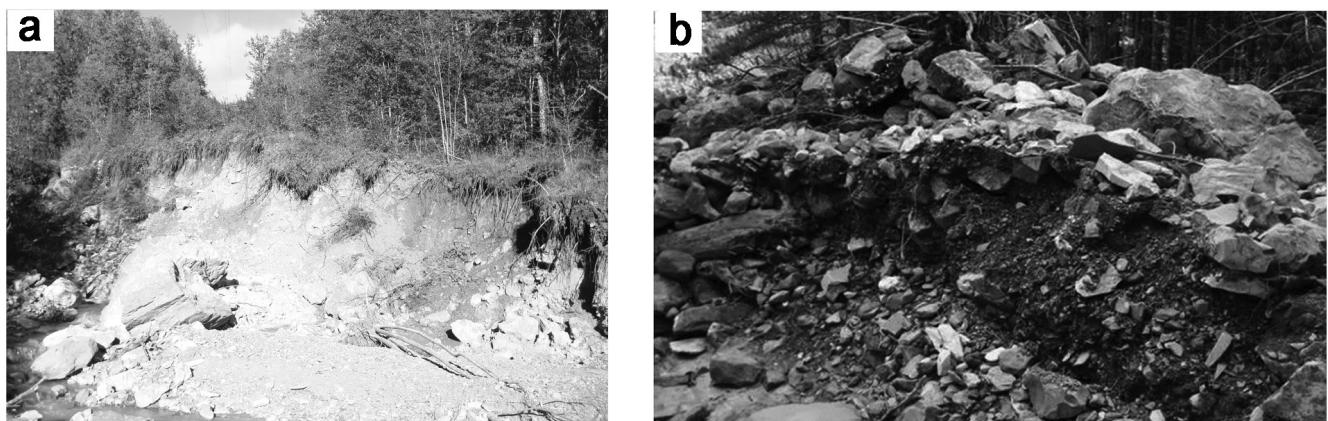
Fig. 10 - a) Track channel of Rio Vestana: evidences of streambed scouring; b) Levees with inverse gradation of debris flow deposits in Rio Vestana

Along the debris-flow track channels, evidences of streambed scouring (Fig. 10a), erosion of materials previously trapped above check dams, partial accumulation in wooden zones at the sides of the track and debris levees showing the typical inverse gradation of debris flow deposits can be observed (Fig. 10b). The maximum height reached by debris flows was about 3 to 4 m, as it is evidenced by marks and scars on the bark of trees (Fig. 11a). In many cases it

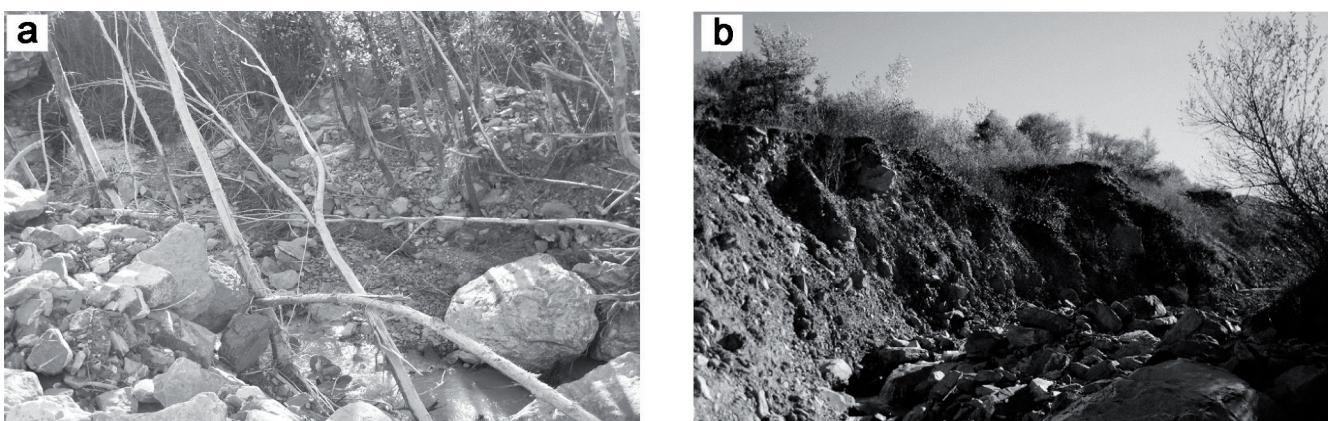
Fig. 11 - a) Track channel of Rio Lombasina: marks on the bark of trees; b) Example of lateral erosion

was observed that, along the track channels, the debris flows were fed by lateral erosion that, consequently, increased the amount of mobilized debris (Fig. 11b).

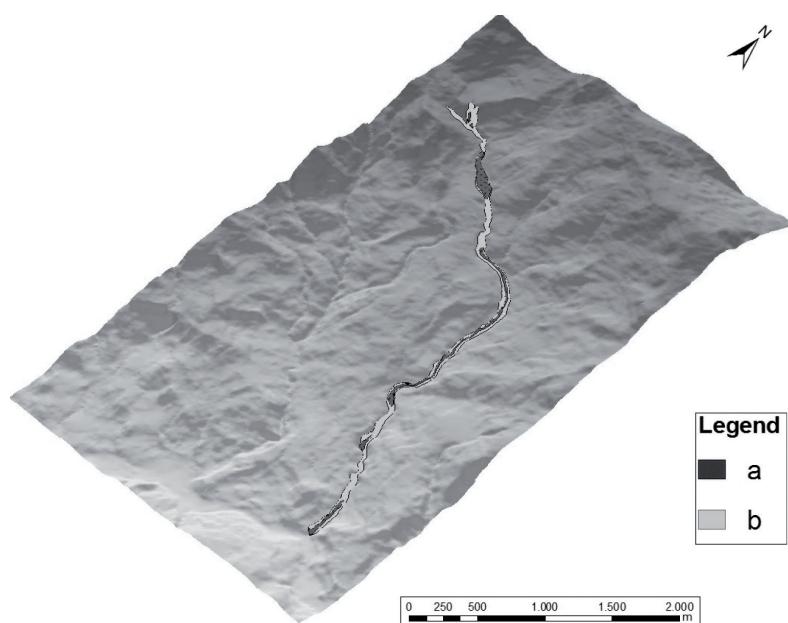
Fig. 12 - Map of deposition (a) and erosion (b) zones along the Rio Vestana

The data collected during field surveys have allowed the erosion and deposition areas to be mapped. For instance, the map of Rio Vestana (Fig. 12) shows dominant erosion in the triggering zone, a partial deposition in the upper part of torrent, and alternated erosion and deposition areas down the track. This pattern is mostly controlled by local topography, i.e. alternation of areas of higher and lower slope gradient.

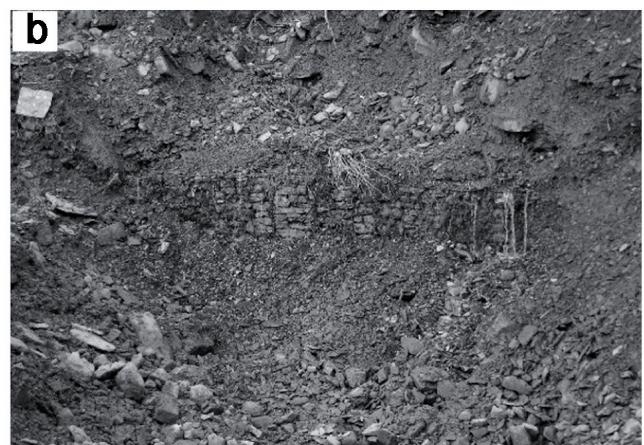
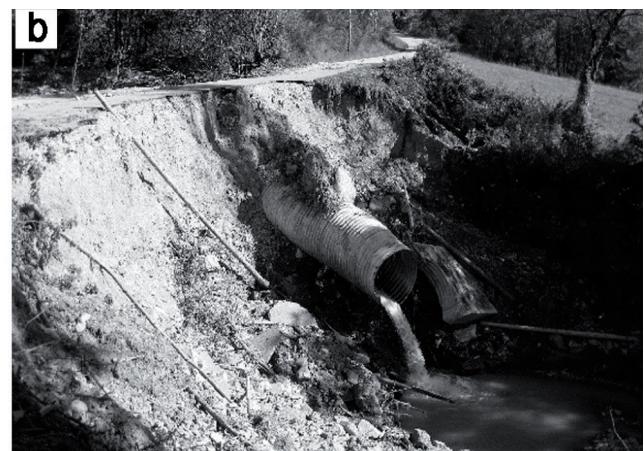
Fig. 14 - Examples of road-crossing area along the track of the torrent: a) Rio Vestana, the pipe for the outflow of the torrent was outburst during the debris flow and significant erosion occurred downslope of the road crossing; b) Rio Roccaferara, the debris flow overflowed the road and significant erosion occurred downslope of the road crossing zone

dams. In the lower portion of the torrents, check-dams were also buried by debris flow deposits (Fig. 13b). Also, almost all of the local roads crossing the debris flow tracks were severely damaged. In practice, in many road crossing areas the torrent had been previously reduced to flow into 1 to 2 m diameter pipes in order to avoid the need for bridges. In these conditions, the flow-pipes were rapidly obstructed by the debris flows: this caused the outburst of pipes, the run of the debris flows on top of the roads and, in many cases, the final erosion and cut-through of the road track and of the areas immediately downslope the road crossing point (Fig. 14). At the base the slopes, large amounts of debris filled bridges and outflow pipes and overflowed main provincial roads. This was particularly severe in the fan-shaped accumulation zones at the confluence of the torrents into the Parma river (Fig. 15a). In some cases, the torrents transported and deposited along roads boulders as large as 5 m³ or more (Fig. 15b).

mobilization of large amounts of debris when cut-through by debris flows. Also, the road network along the slopes is absolutely inadequate to cope with this type of phenomena. Stream crossing points along roads are mostly characterized by the presence of water pipes that were rapidly clogged by debris and that can overburst under the pressure of the debris flows, causing severe damages to the road and surrounding zones.

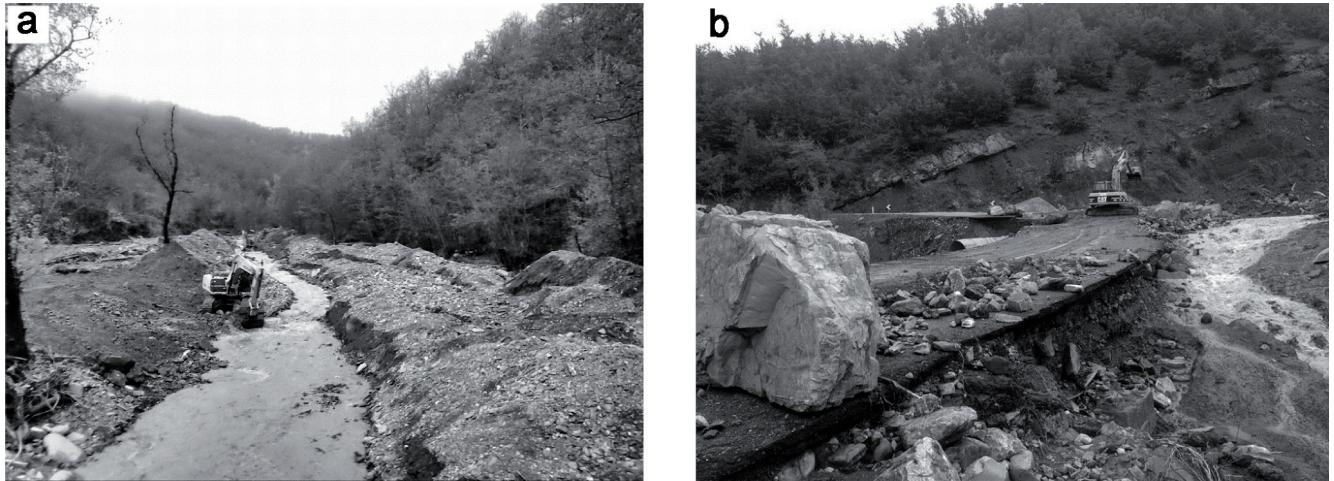
Fig. 15 - a) Parma river, debris transported and deposited by the torrents; b) Rio di Confine, boulders with size of 5 m³ deposited along the provincial road
