IMPACT OF LARGE LANDSLIDES, MITIGATION MEASURES

JEAN F. SCHNEIDER, FABIAN E. GRUBER & MARTIN MERGILI

University of Natural Resources and Life Sciences (BOKU), Vienna, Peter-Jordan-Str. 70, 1190 Vienna, Austria

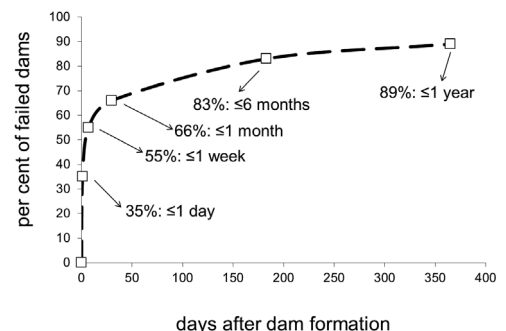
Fig. 1 - Percentage of failed dams plotted against the time after formation (after SCHUSTER & EVANS, 2011)

have shown that most dam failures occur in the first few months after the landslide event. Afterwards, the dam is usually consolidated so far that outburst floods become less likely (Fig. 1). However, impact waves triggered by mass movements into the lake may occur a very long time after dam formation.

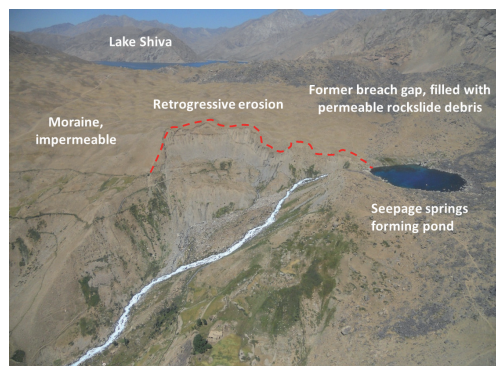
Fig. 3 - Lake Shiva composite dam, view to the W. The depression spring (circular lake, diameter approx. 200 m) and headwater of Arakht torrent in the foreground; to the left of the lake the unstable part of the downstream side of the dam, with a band of much smaller springs, conspicuous because of spots of green vegetation. Moraine deposit in the centre, rock slide deposit in the right part of the photograph, the source of the rock slide is farther right

The dam has since consolidated, and obviously has never been overtopped by the impounded water in the shape it is now (after the possible first break-out). Instead, all the water supplied by the catchment is travelling through the dam by virtue of seepage, and for the most part is channelled through the permeable material supplied by the landslide. On the downstream side of the dam, part of the seeping water emerges in a stable depression spring, thereby creating a small cir-

cular lake (Fig. 3).

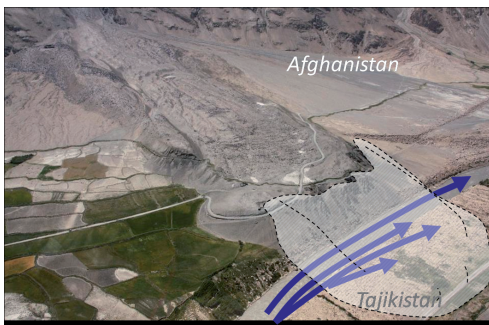
Fig. 5 - Debris avalanche at Dasht-Sulayman upstream Ishkashim in the Wakhan Corridor, Afghanistan. The Panj River eroded the lobe reaching Tajikistan, emptying a temporary lake impounded by the dam. A thin cover of lake sediments exists in the cultivated area on the lower left side and the ruins mentioned in the text are situated on the upper left of the photo. Washed out boulders cover the orographic right side of Panj River as remnants of the lake outburst flood. The eroded cliff on the orographic left side is approx. 50 m high

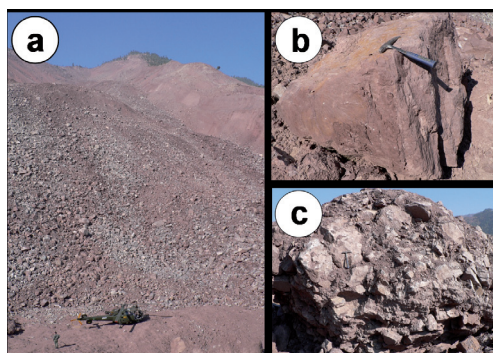
Fig. 6 - (a) Proximal base of the Hattian Bala rock avalanche, helicopter at the location of the future spillway channel. Karli Lake is situated at the left of the photograph. (b) Sandstone block of the Murree formation in the silt- to claystone landslide debris matrix. (c) Cemented debris of a former landslide at the same location

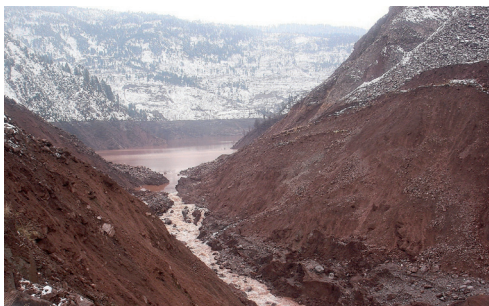
Fig. 8 Eroded breach in the debris deposit of the Hattian Bala landslide below the artificial spillway. Note the landslide scars in the background and the former level of Karli Lake marked by the snow line. Photo taken on February 10, 2010 by Dr. Kausar from the Geological Survey of Pakistan

In February 2010, a process chain including spill over of the dam of Karli Lake and deep retrogressive erosion of the spillway occurred (Fig. 7c and Fig. 8). The following debris flow led to severe damage and one fatality downstream. KONAGAI & SATTAR (2012) conclude that the breach can be attributed to the hydrologic situation (moderate rainfall after dry conditions) in combination with a deteriorating dam body due to weak weathering resistance of the material. Some landslides observed close to the lake were most likely caused by slope destabilization due to the suddenly lowered lake level and the resulting changes in pore water pressure. However, further investigations are required in order to fully understand the process chain that occurred here.

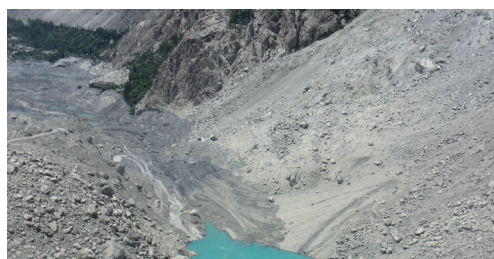
Fig. 9 Rock slide dam of Attabad, looking W. The rock slide originated from the upper right side of the photograph. The photo was taken on May 26, 2010, a few days before overflow started. Note the erosion channel from seeped water and the boundary between the dark lacustrine deposits and the brighter mass of gneiss rock slide debris

Seepage through the dam developed after about 2 months (Fig. 9) and then increased in a nonlinear way. At that point, internal erosion by seepage was considered a potential failure mechanism.

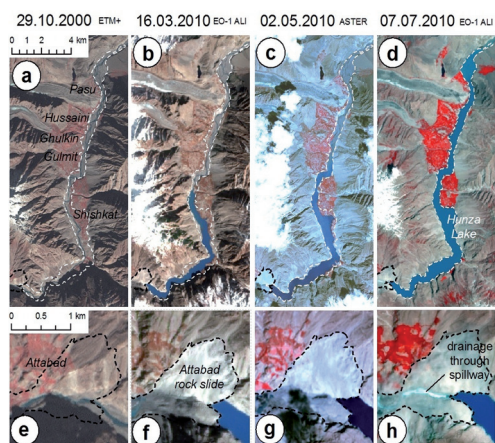
Fig. 10 - Attabad rock slide and the temporal development of Hunza Lake: (a) and (e) Situation before the Attabad rock slide. (b), (c), (f) and (g) Growth of the lake prior to overflow (d) lake extent after overflow. (h) Situation after overflow with drainage through the spillway. The white dashed line shows the extent of the lake on July 7, 2010, the black dashed line shows the extent of the Attabad rock slide. North is up

Figure 10 illustrates the temporal development of Hunza Lake, monitored by the NDMA. Due to the morphology of the valley, which broadens farther upstream of the dam, the filling rate of the lake was initially high and then decreased with time. A slight increase in the filling rate took place in spring 2010 due to snow and glacier melt. In the night of May 28 to May 29, 2010 the dam was overtopped and drained through the constructed spillway. At that point the lake level at the spillway was 111.41 m above the original valley bottom. Overflow increased slowly at first, still allowing for an increase in lake water level of up to 50 cm per day. The spillway underwent retrogressive erosion with almost no basal down cutting. On June 5, inflow and outflow of the lake reached a balance at a lake level of 115.21 m above the original valley bottom. In May 2011, erosion at the outflow of the lake was still

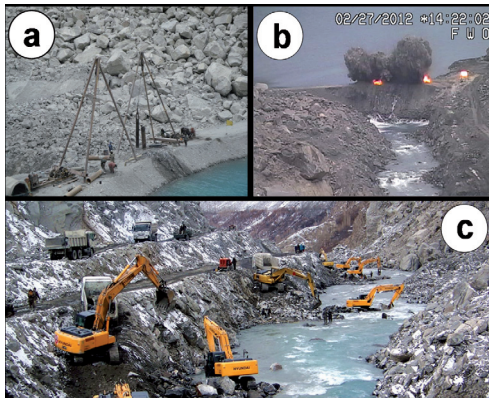
Fig. 11 - Attabad Dam: Front Works Organization (FWO) excavating the overflow channel in order to lower the lake level as well as the hazard of an outburst flood wave. (a) Cofferdam to hold lake water back with drilling rigs for installing explosives. (b) Blasting coffer dam to let the water erode the artificial channel. (c) Excavators working on deepening the channel. The work is slow despite the heavy machinery. It can be done stepwise only during the dry season. Note the large gneiss boulders in a clayey matrix of fine debris mixed with lake sediments, which prevent the channel being eroded. Photos courtesy of FWO

controlled by large boulders in the dam. Blasting efforts did not significantly alter this situation (Fig. 11).

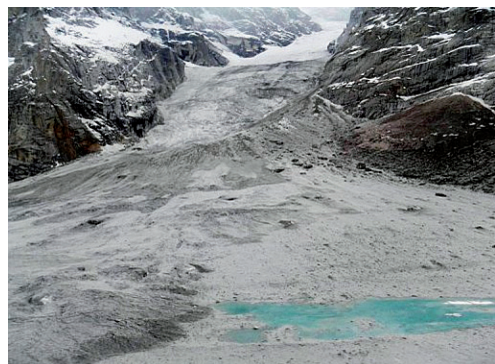
Fig. 12 - Siachen-Gayari ice/rock avalanche, looking NW: the remaining tongue of the glacier, the capped moraine, the ice/rock debris-cone/dam and the beginning of impounding are visible on this photograph. The buried camp is situated on the left side of the picture, where also the spillway was dug out. Photo taken by Pakistan Army shortly after the event

which covered an area of more than 1 km² to a depth of up to sixty metres. Large blocks were embedded in a concrete-like matrix of ice and crushed rock with grain sizes down to silt fraction (Fig. 12, Fig. 13).

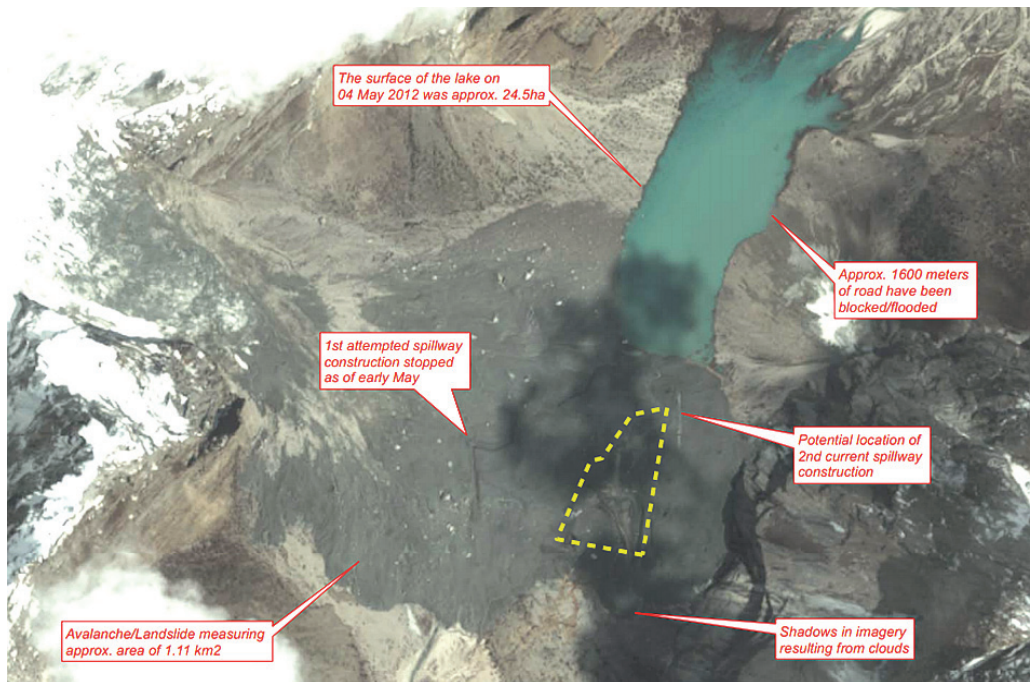
Fig. 13 - UNOSAT poster used as base for decision making. The avalanche originated in the firm area of the Saltoro Range on the left side of the scene, entraining ice from the seracs and till from the lateral moraine on the orographic right side of the valley. The debris cone/dam and the impounded lake are clearly visible on the post-event scene. Imagery: Ikonos, May 4, 2012

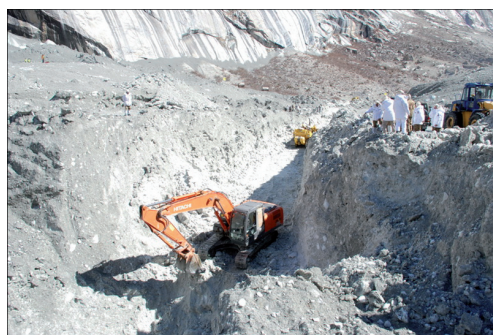
Fig. 14 - Heavy equipment excavating human remains and the artificial spillway. Photo courtesy of ISPR. Note the compacted debris consisting of ice and crushed rocks. Blasting efforts were not successful

Several smaller avalanches from adjacent mountains followed after the main slide. Even though, due to their limited extent, they caused no additional damage, these slides hampered the search operations. The compacted debris cone impounded a lake with a surface area that over time increased to 25 ha. Excavating a drainage channel was necessary in order to reduce the hazard of an outburst flood putting the rescue works as well as the population and infrastructure downstream at risk (Fig. 14). The excavation efforts were successful and an outburst flood was avoided.
