A GEOMORPHOLOGICAL RECONNAISSANCE OF STRUCTURALLY-CONTROLLED LANDSLIDES IN THE DOLOMITES

ALAN P. DYKES^(*), EDWARD N. BROMHEAD^(*), S. MAHDI HOSSEYNI^(**) & MAIA IBSEN^(*)

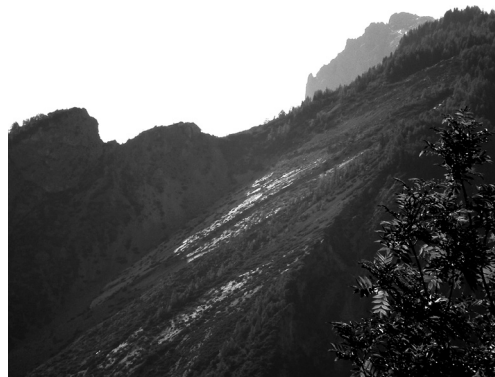
Fig. 2 - The upper part of the scar showing the bedding control and the lateral joint-controlled margin

The major rockslide at Alleghe occurred in January 1771 and was followed later that year by another, smaller one from the same slope (EISBACHER & CLAGUE, 1984; DI BIASIO *et alii*, 2000; COPPOLA & BROMHEAD, 2008). Figure 1 shows the planar form of the (combined) landslide scar, the failure surface being defined by a small number of closely spaced bedding planes in the limestone (Fig. 3). The displaced mass comprised a thick wedge of rock that slipped from a valley side slope that was previously convex in profile and plan. The northern edge of the failure surface marks the line where the critical bedding plane(s) daylighted, whereas the southern margin comprises a high lateral scar defined by high angle joints (Fig. 2).

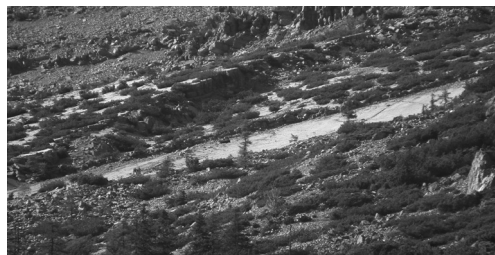
Fig. 3 - Part of the failure surface (seen from below the landslide) showing it to be controlled by very few separate bedding planes

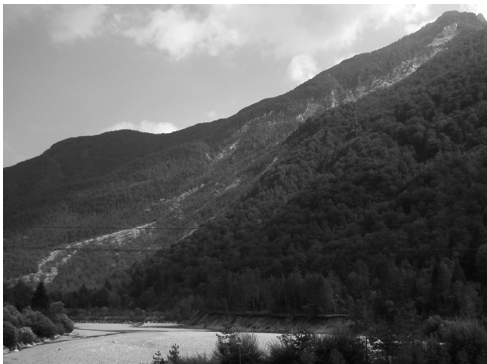
Fig. 4 - The Borta landslide in 2011, seen from upstream

The rockslide that destroyed the village of Borta, on the Tagliamento River near Caprizi, occurred in August 1692. It is similar to the Alleghe slide in many respects, but although the affected slope was significantly longer and higher than at Alleghe (Tab. 2), the failed mass was much smaller with an estimated volume of around 30,000 m³ (COPPOLA & BROMHEAD, 2008). Inspection of aerial imagery (e.g. GoogleEarth) suggests that the failure involved the upper part of a main valley slope that had been dissected by first-order tributary streams. The extent of the steeper upper slope scar can be clearly seen in Fig. 4, where the bedding planes in the dolostone that define the failure surface are clearly visible (Fig. 5). Figures 4 and 5 both show the lateral scar on the eastern side of the failure, controlled by joints.

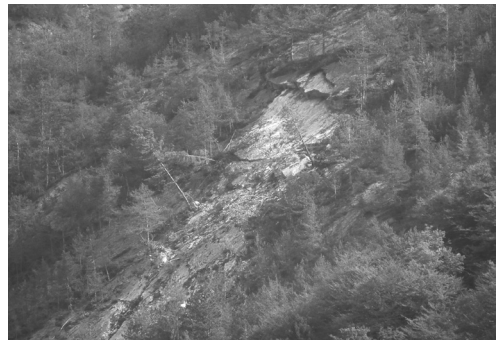
Fig. 5 - Part of the failure surface showing the dolostone bedding planes

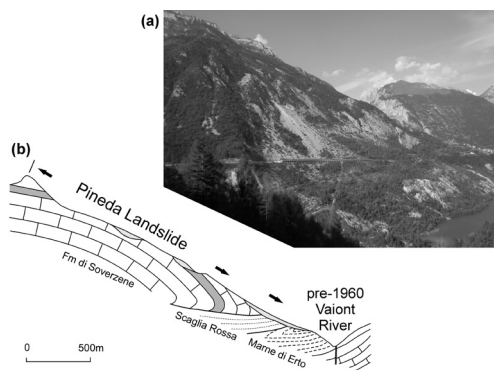
Fig. 6 - The Pineda landslide: (a) seen from the Vaiont landslide in 2012; (b) geology according to BESIO & SEMENZA (RIVA *et alii*, 1990)

The age of the Pineda rockslide is uncertain, but its scale is readily apparent (Tab. 2, Fig. 6). The ridge between the present Vaiont Lake and the Mesazzo Stream has been identified as a deposit of the Pineda slide (e.g. PARONUZZI & BOLLA, 2012), which strongly suggests that a large landslide dam existed for some period of time following the landslide. Unlike the other landslides, the upper scar is less steep than the overall slope but nevertheless it appears that failure of bedding planes in the Soverzene Formation defined the event (Fig. 6b), resulting in a triangular sub-planar scar in the landscape (Fig. 6) similar to the landslides described above.

The Pineda slide is characterised by a lower mean gradient of the bedding plane failure surface compared with the other landslides, although the form of this upper slope unit is slightly convex (Fig. 6b) and a dip of 30° is shown for the lower part of this unit by PARONUZZI & BOLLA (2012). Clearly the geological control over this slope failure is more complex than at the landslides discussed previously, but it seems reasonable to suggest that, as a dip slope, the upper slope unit was susceptible to the development of instability, and that this instability was ultimately brought about

by glacial oversteepening of the lower part of the valley slope. Figure 6a appears to show the landslide scar extending some distance below the upper slope unit. This landslide may therefore have begun with failure of the underlying ‘soft’ rocks (the marly Scaglia Rossa (CANCELLI *et alii*, 1991) and the Marne di Erto which is transitional from the Scaglia Rossa to the Flysch), and retrogressed upslope.

strength of clay layers. However, in deformed strata like this (Fig. 6), flexural slip between beds is likely to have reduced the available shear strength - in this case, of the clay - to its residual value, with the cohesion required for stability probably having been provided by rock-bridges (STURZENEGGER & STEAD, 2012).

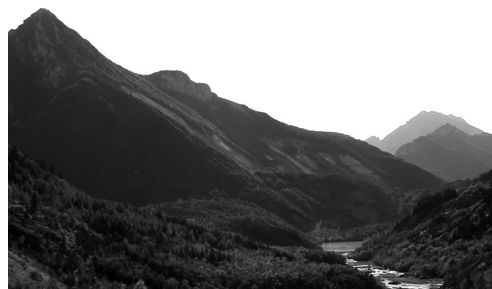
Fig. 7 - The Vaiont landslide in 2011, seen from the east

above. The scar is much wider than those of the other landslides but (i) its pre-failure profile characteristics are similar (Table 2), (ii) it formed a landslide dam (Fig. 7), (iii) it has a joint-controlled lateral scar at its (eastern) lateral margin, and (iv) the visible failure surface has a roughly triangular (actually more of an arch) plan form. The latter feature is easily missed on casual inspection of aerial imagery because of a large forested unit at the extreme southeast corner of the landslide that was displaced but remained on the failure surface. This displaced block clearly resulted from retrogressive development of the landslide. Such retrogression often accounts for the upward-narrowing plan forms of landslide scars, as observed in all of the cases in this paper.

The view of the landslide in Fig. 7 is somewhat misleading in that it does not show how the Vaiont Gorge turned slightly northwards, away from Mt. Toc, where the landslide dam now begins. In any case, cross-sections indicate that the East side failure surface was probably mostly planar. Furthermore, the sides of the gorge were much steeper than the typically 30-40° dip that defines the failure surface and thus the toeslope of the entire landslide was an over dip slope.

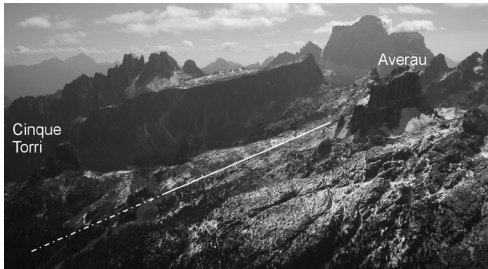
Fig. 8 - The Cinque Torri and Averau, with Pelmo (3168 m) in the distance. The white line indicates the hypothesised failure surface (broken line = concealed at depth). Snow highlights the topographic details

The small rocky outcrop near Cortina d'Ampezzo known as the Cinque Torri ('Five Towers') (Fig. 8) has been demonstrated to be the product of mass movements involving failures of the weak argillaceous rocks under the load exerted by the Dolomia Principale and suggested to be a small part of a much larger-scale landslide system involving bedding-controlled failure(s) (VIERO *et alii*, 2010). The argillaceous rocks (the Travenanzes and Heiligkreuz Formations) are 150-180 m thick and underlain by the Dolomia Cassiana, with the entire sequence having a moderate dip of 30° towards N10°E. VIERO *et alii*

(2010) show everything to the right of our Fig. 8 as a 'reference stable area'.

In our view, the geomorphology of the site indicates a landslide system possibly extending over several square kilometres. The influence of the 30° dip of the bedding can be seen in many parts of the landscape in Fig. 8. The left side of Averau appears to be the head of a large translational dip-slope landslide (Fig. 9) that probably extends northeastwards for up to 4 km down to the Falzarego River with the upper surface of the Dolomia Cassiana as the failure surface. This is consistent with VIERO *et alii's* (2010) suggestion of such a landslide although we think it extends another kilometre further upslope. However, it is unclear what structural forms or failure surface geometry in the lower half of the slope give rise to the low overall gradient of the failed slope (Tab. 2).

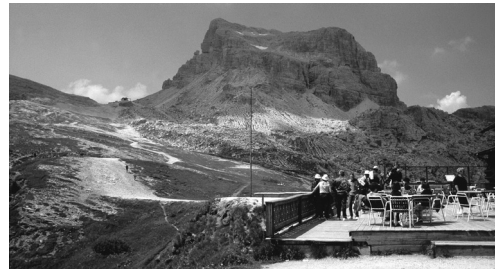
Fig. 9 - View towards Averau from the Cinque Torri. The planar slope on the left is the bedding-plane failure surface highlighted in Fig. 8
