## “REMOTE” LANDSLIDE-RELATED HAZARDS AND THEIR CONSIDERATION FOR DAMS DESIGN

ALEXANDER STROM<sup>(\*)</sup> & ANATOLY ZHIRKEVICH<sup>(\*\*)</sup>

<sup>(\*)</sup> Geodynamics Research Center - Branch of JSC “Hydroproject Institute” - Moscow, Russia  
<sup>(\*\*)</sup> JSC “Hydroproject Institute” - Moscow, Russia

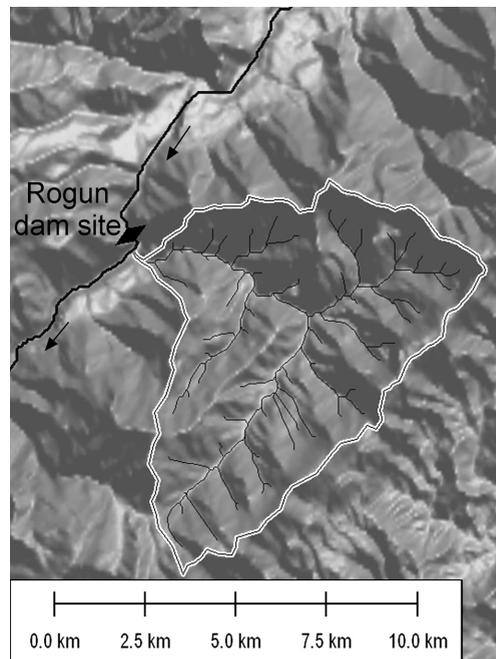
Fig. 2 - Obi-Shur Creek catchment area on 3'' SRTM DEM

falls into Vakhsh River just downstream from the dam site (Fig. 2) had blocked the Vakhsh River channel. It brought diversion tunnels out of operation, caused inundation of the underground power house and breach of the cofferdam that resulted in years-long suspension of construction works.

The 57,4 km<sup>2</sup> Obi-Shur catchment (see Fig. 2) produces regular debris flows. Maximal measured discharge recorded before construction had started, in May 19-20, 1983, was 1150 m<sup>3</sup>/sec. Rough estimates based on the height of debris flow traces on the walls of the Obi-Shur gorge (Fig. 3) gives even higher value of about 1 500-1 700 m<sup>3</sup>/sec for an undated earlier debris flow. Density of debris flow deposits can reach 2.3-2.4 tons/m<sup>3</sup>. According to observations temporary damming of Vakhsh River stream occurs every ten years on an average being caused by debris flows which volume can exceed 2.5 million m<sup>3</sup>.

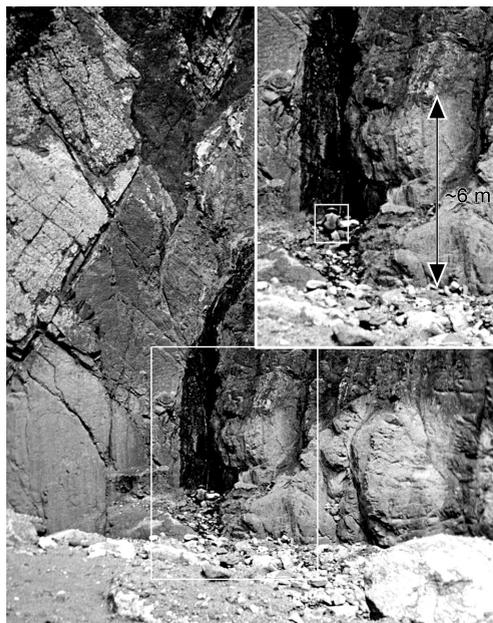
Fig. 3 - Mud pasted by debris flow at the wall of the Obi-Shur gorge. Person sitting in the cavity (see the inset) is about 1.2 m high, thus debris flow thickness (double-head arrow) was about 6 m. Photograph was made in 1978

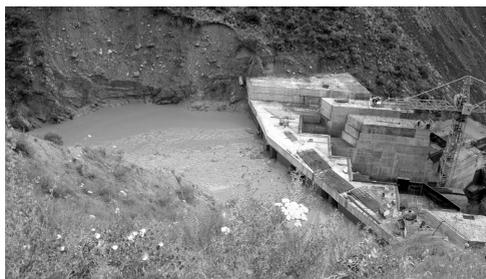
Fig. 4 - June 22, 2012 debris flow in the Obi-Shur Creek stored by the protection dam. Photo courtesy V.S. Panteleev

At present, after construction recommencement, special measures are undertaken to prevent similar phenomena. They include construction of the cellular concrete dam at the lower reach of the Obi-Shur Creek aimed to intercept the coarsest fraction of debris, that forms the skeleton of blockage and allowing water and fines that can be easily removed by the river to pass through the holes in the dam. On June 22, 2012, before completion of this protection dam, it stopped debris flow that lasted for about 7 minutes only, but with estimated peak discharge of ca 1 300-1 400 m<sup>3</sup>/sec. 290-350 m<sup>3</sup>/sec of it passed through the dam and was carried out by Vakhsh river and about 280 000 m<sup>3</sup> of debris was accumulated upstream from the dam (Fig. 4).

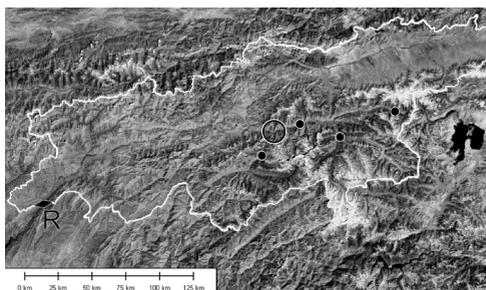
Fig. 5 - Vakhsh River catchment area for the Rogun dam site (R). Site of the Muksu River potential rock-slide damming is marked by open circle; black dots mark sites where river damming by surging glaciers could be anticipated

The entire catchment area of Vakhsh River upstream the Rogun dam site (Fig. 5) was checked using the remote sensing data available (Landsat ETM7 with 15 m and KFA-1000 with 5-10 m spatial resolution) to identify sites where large-scale river-damming resulting in lake formation can be anticipated.

Several sites where main stream could be blocked by surging glaciers were identified (see Fig. 5) based on the history of glacier rapid advances in the past (OSIPOVA *et alii*, 1998). Though at present such phenomena are hardly possible due to intensive glaciers retreat in the Vakhsh River basin (KOTLYAKOV, 2006), its potential hazard must be analysed with due regard to centuries-long life time of large hydraulic project such as the Rogun HPP. Maximal volume of lakes considered as the worst scenario in case of such surges was estimated as ca 170 Mm<sup>3</sup>.

The largest anticipated blockage could occur in the middle reaches of the Muksu River valley in Northern Pamirs (see Fig. 5). Here, at 39°7' N, 71°45' E, several large rockslides had occurred in the past on the 1.0-1.5 km high steep slopes causing river damming (BESSTRASHNOV *et alii*, 2013). None of these dams survived. Such clustering typical of large-scale bedrock landslides in many parts of Central Asian mountains (STROM & ABDRAKHMATOV, 2004) can be considered as indication of increased probability of future failures within such node.

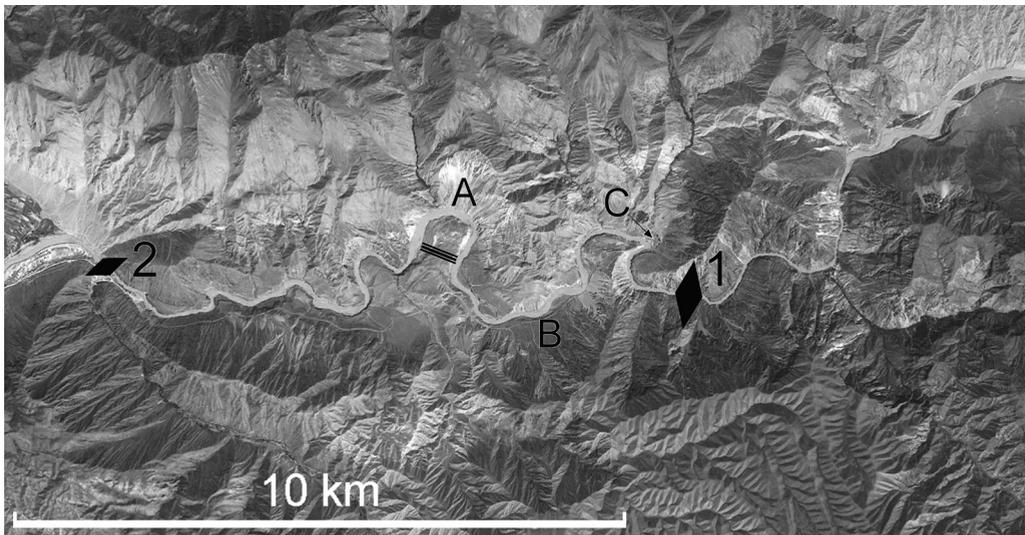
Fig. 6 - Position of the potentially unstable slopes between the Kambarata-1 & 2 dam sites. 1 - the proposed Kambarata-1 dam; 2 - Kambarata-2 dam constructed in 2009; triple black line - bypass channel under construction. Brief description of sites A-C is given in the text

Several sites of the potential river-damming events that could result in inundation of the Kambarata-1 powerhouse have been found between the Dam 1 and Dam 2 sites (Fig. 6). Large-scale bedrock landslides caved from the slopes marked by 'A' and 'B' in the past, which is proved by the presence of rock avalanche deposits. At both sites rock avalanche deposits rest at the opposite banks of the Naryn River indicating that the stream had been blocked. At site 'A' blockage occurred twice - in Late Pleistocene and in Holocene by rock avalanches up to 10-15 Mm<sup>3</sup> each (Fig. 7), though, most likely, for a short time, since no lake

Special technical measures aimed to prevent such effects include excavation of the bypass channel across river meander shown as triple black line on Fig. 6. If local topography does not allow such a solution, like at site 'B' on Fig. 6 where river-damming rock-slide had occurred in the past too (STROM, 2012a) and evidence of present slope instability could be found above this ancient headscarp (see Fig. 8) landslide monitoring and, if necessary, slope stabilization measures should be anticipated to minimize possible negative effects.

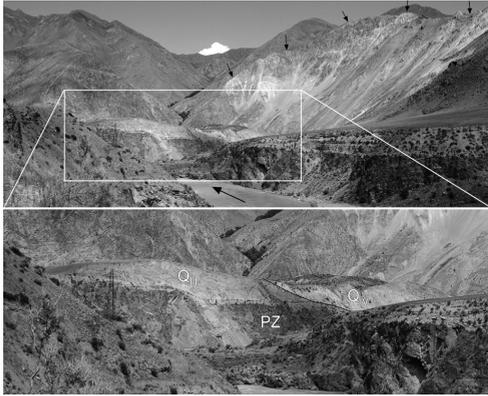
Fig. 7 - Past rock avalanche deposits between the Kambarata-1 and 2 dam sites. Headscarp marked by small arrows is shown as site 'A' on Figure 6. The younger -  $Q_{II}$  rock avalanche deposits partially overlay those of the  $Q_{III}$  rock avalanche

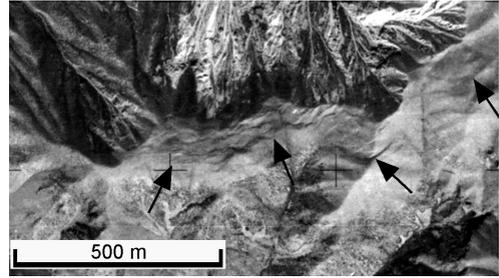
Fig. 8 - Small scarps (marked by arrows) on top of the ridge above slope 'B' on Figure 5 indicating its ongoing instability

sediments were found upstream. Nevertheless, if similar slope failure will occur here in future, that can be assumed based on the evidence of present-day slope instability (Fig. 8) even temporary blockage several dozens meters high could inundate the Kambarata-1 powerhouse about 5.5 km upstream. Besides, an inevitable breach of such dam could severely affect the downstream Kambarata-2 dam, which freeboard is not large enough to accommodate such outburst flood.

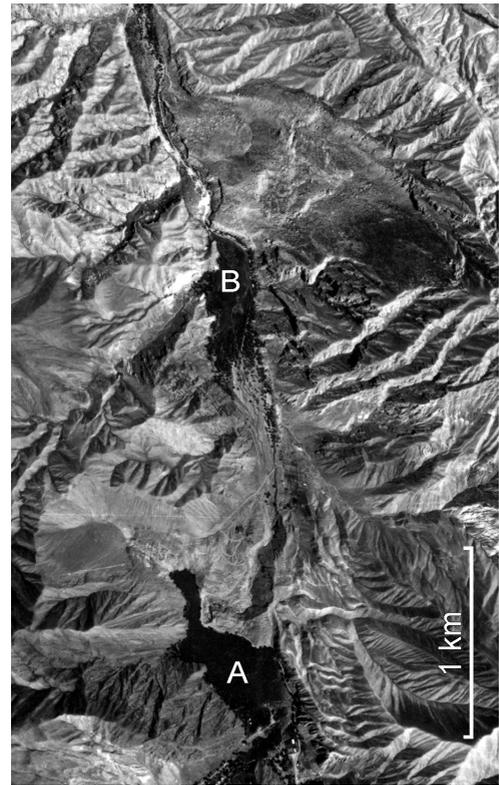
Fig. 9 - Aerial photograph of rockslide dammed lakes in the Unkursay River valley. A - the existing Ak-Kiol lake; B - swampy area of the drained Lower Ak-Kiol lake

One potential source is a drained lake in the Unkursay River valley - left tributary of the Kokomeran River, nearly 2 km down-stream from the existing Ak-Kiol Lake (Fig. 9). This Lower Ak-Kiol dam ( $41^{\circ}42.4' N, 74^{\circ}16.8' E$ ), was breached rather recently. A distinct stripe of fossilized lake algae about 15 m above the present day valley bottom indicates its single-event emptying that had released 2-3 million cubic meters of water (STROM, 2012a). The Ak-Kiol lake ( $41^{\circ}41.1' N, 74^{\circ}17' E$ ), that stores 2.7  $Mm^3$  of water (TORGOEV & EROHIN, 2012) being located about 85 km from the Kambarata-1 dam site, could be breached catastrophically producing flood and debris flow formation that would devastate lower reaches of the Unkursay River (TORGOEV & EROHIN, 2012).

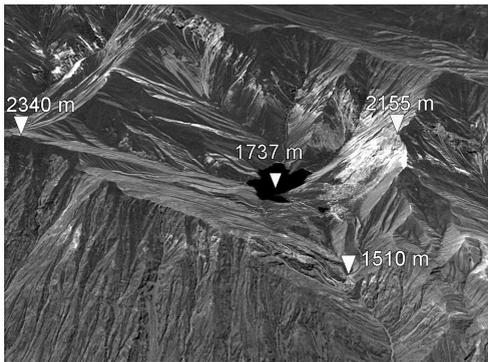
Fig. 10 - 3D view of the Aik-Kiol rockslide dammed lake about 500×700 m in size and its catchment area. Distance between points with elevations of 2340 m and 2155 m is about 2.8 km

One more relatively large Aik-Kiol rockslide-dammed lake in the valley of a small unnamed left tributary of the Kokomeran River about 55 km upstream from the Kambarata-1 dam site ( $41^{\circ}43.5' N, 73^{\circ}57.6' E$ , Fig. 10) stores about 3-4  $Mm^3$  of water. The *ca* 220 m high Aik-Kiol dam located in hardly attainable valley have not been studied yet with such deathliness as the above mentioned Ak-Kiol dam. Its morphology shows that at present the dam is stable,

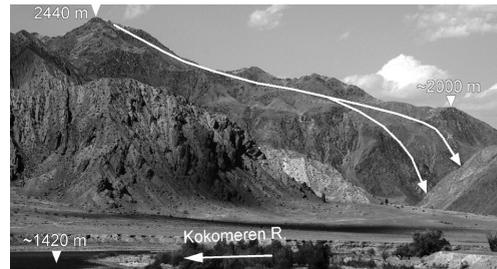
Fig. 11 - Overview of the Lower-Aral rock avalanche. White arrows show its travel path from the headscarp on top of the ridge towards the depositional zone in the more than 500 m deep gorge of Kokomeran River

valley and, finally, caved into deep gorge splitting into two parts (Fig. 11); the upstream one formed the 70-m high dam that created a lake about 12 km long storing up to 200 Mm<sup>3</sup> of water. Its catastrophic release years after the impoundment (which follow from the presence of laminated silt more than 5 m thick 7 km upstream) caused outburst flood with peak discharge up to 28 000-30 000 m<sup>3</sup>/sec (STROM, 2012b).
