EFFICIENCY OF STABILIZATION TECHNIQUES IN ACQUALORETO LANDSLIDE AREA (UMBRIA, ITALY)

LUCIO DI MATTEO^(*), LUCIANO FARALLI^(**), NELLO GASPARRI^(**), RICCARDO PICCIONI^(**),
DANIELA VALIGI^(*) & LUCA DOMENICO VENANTI^(**)

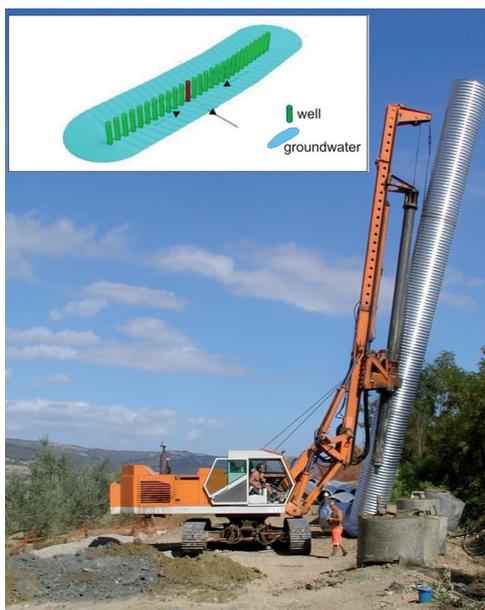
Fig. 5 - Detail of installation of drainage wells in landslide A. Scheme of well groups from BALDUCCI *et alii* (2013)

Due to the size of landslide A (up to 500 m long and 150 m wide) and considering that the main crown is very close to buildings and roads (Fig. 2), a group of 28 drainage wells 1.20 m in diameter and at a distance of 6 m from each other was built in the upper part of the landslide at altitudes between 380 and 390 m a.s.l. Each well reached a maximum depth of about 15 m (Fig. 5). In order to redirect groundwater outside the landslide mass, the wells were linked to form an interconnected subsurface and surface drainage network (Figs. 2 and 5).

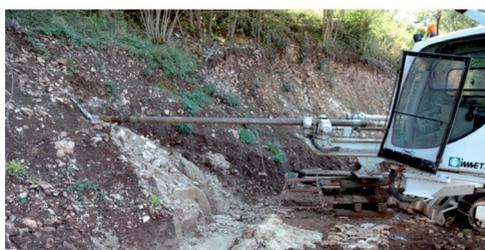
Fig. 6 - Sketch of HDD Techniques (modified from BALDUCCI *et alii*, 2013) and detail of drainage works in landslide B

For efficient drainage of the body of landslide B, HDD technology was applied (Fig. 6), with the implementation of controlled Paratrack and Vector Magnetics devices, which allowed the pilot well to be targeted with an error of less than 5 cm. A system of drainage pipes up to 140 m long was distributed throughout the central/upper part of landslide body, for increased drainage efficiency. Planimetric and altimetric locations of drains and their interactions were designed according to well-known methods (HUTCHINSON, 1977; DI MAIO *et alii*, 1988). HDD technology was applied to install two orders of drainage pipes on two pitches at 323 and 343 m a.s.l., at about 100 m from each other. For maximum efficiency, the tubes were placed in the portions of the sliding surface where soil permeability was higher.

The drains were placed parallel to the landslide axis, at 10 m from each other. Two orders of drains were overlapped, to limit groundwater rising in the transition area between the two groups of drains, to
