## GEOMORPHOLOGICAL ANALYSIS APPLIED TO ROCK FALLS IN ITALY: THE CASE OF THE SAN VENANZIO GORGES (ATERNO RIVER, ABRUZZO, ITALY)

TOMMASO PIACENTINI<sup>(\*)</sup>, ENRICO MICCADEI<sup>(\*)</sup>, ROSAMARIA DI MICHELE<sup>(\*)</sup>,  
NICOLA SCIARRA<sup>(\*)</sup> & GIOVANNI MATALONI<sup>(\*\*)</sup>

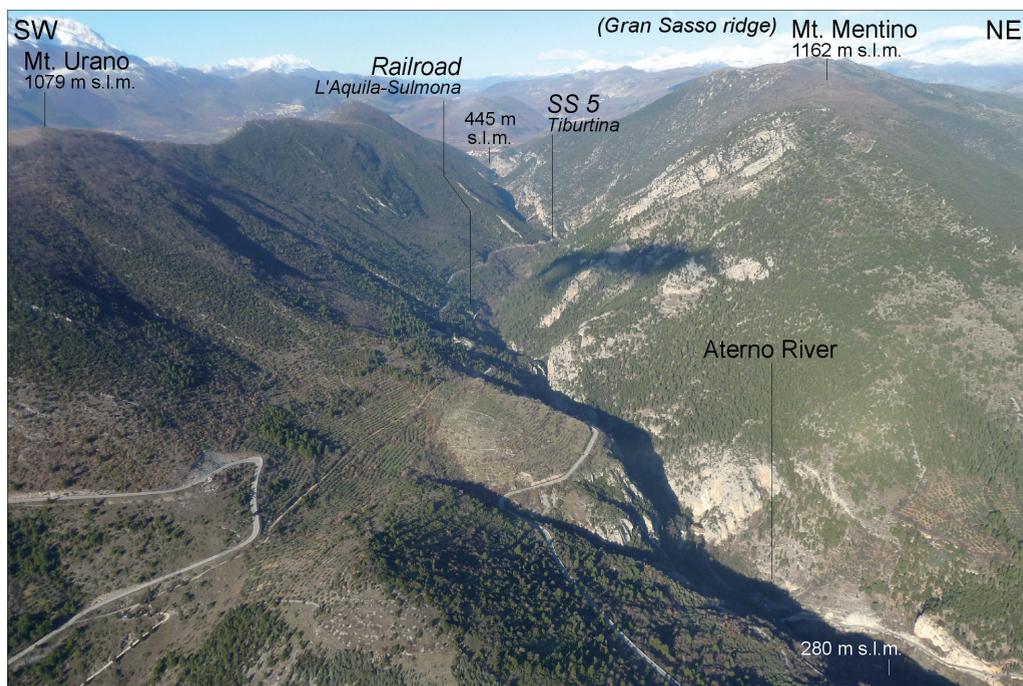
Fig. 2 - Panoramic view of the San Venanzio gorges, along the Aterno river valley

The San Venanzio gorges are located along the Aterno river valley, between the L'Aquila basin and the Sulmona basin (Fig. 2). They are 9 km long, within an asymmetric valley with NW-SE orientation, between the Mt. Mentino ridge (1164 m a.s.l.) towards NE and the Mt. Urano-Le Spugne ridge (1080-1046 m a.s.l.) towards SW. The elevation of the Aterno river bed decreases from >400 m (at Molina Aterno) to <270 m a.s.l. (at Raiano in the Sulmona basin). The transversal profile is asymmetric, with a steep NE slope with > 200 m high rock scarps, and a moderately steep SW slope with a transversal steps-like morphology.

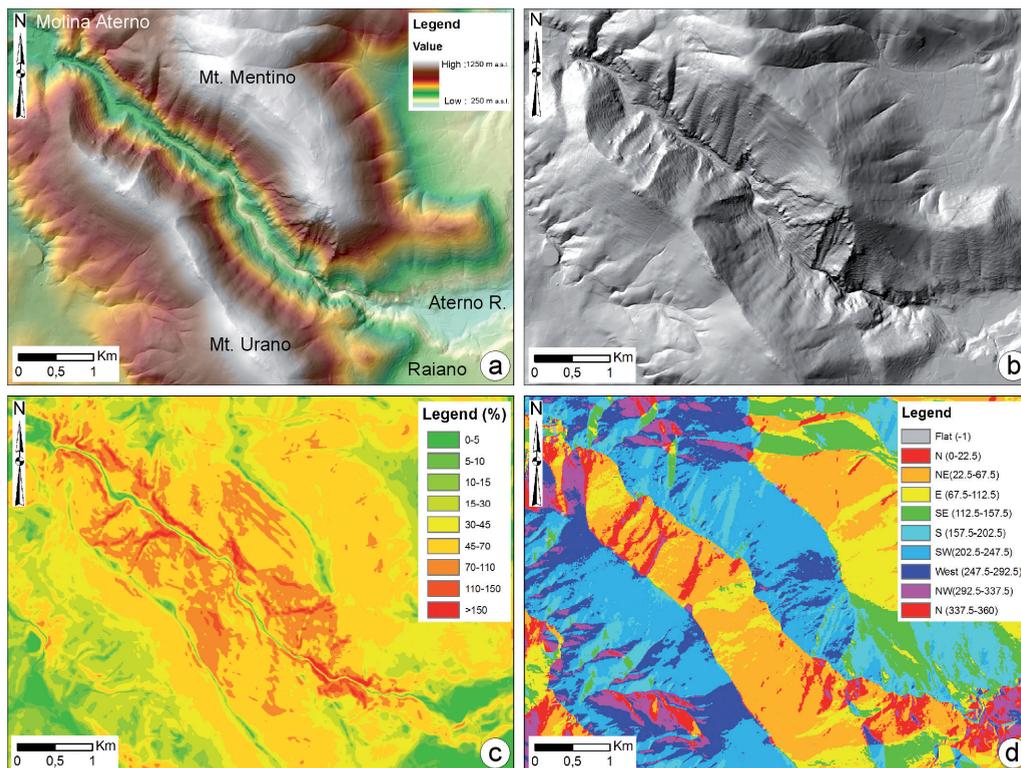
Fig. 3 - San Venanzio gorge physiography: a) Elevation map; b) shaded relief image; c) slope map; d) aspect map

Within the gorges elevation ranges from 1164 m a.s.l. on the NE side (Mt. Mentino) to 270-400 m along the incision, to 1080-1046 m a.s.l. on the SW side (Mt. Urano-Le Spugne) (Fig. 3a,b,d). The main rock scarps are 20-50 m high on the SW slope and up to >200 m high on the NE one.

The slope is very high on both sides (60-150%)

(Fig. 3c). However the NE slope is step-like with steep subvertical scarps and gentler intervening slopes (45-110%), while the SW one is more regular (45-110%) and is broken only by minor transversal scarps. The overall features outline an asymmetric NW-SE valley.

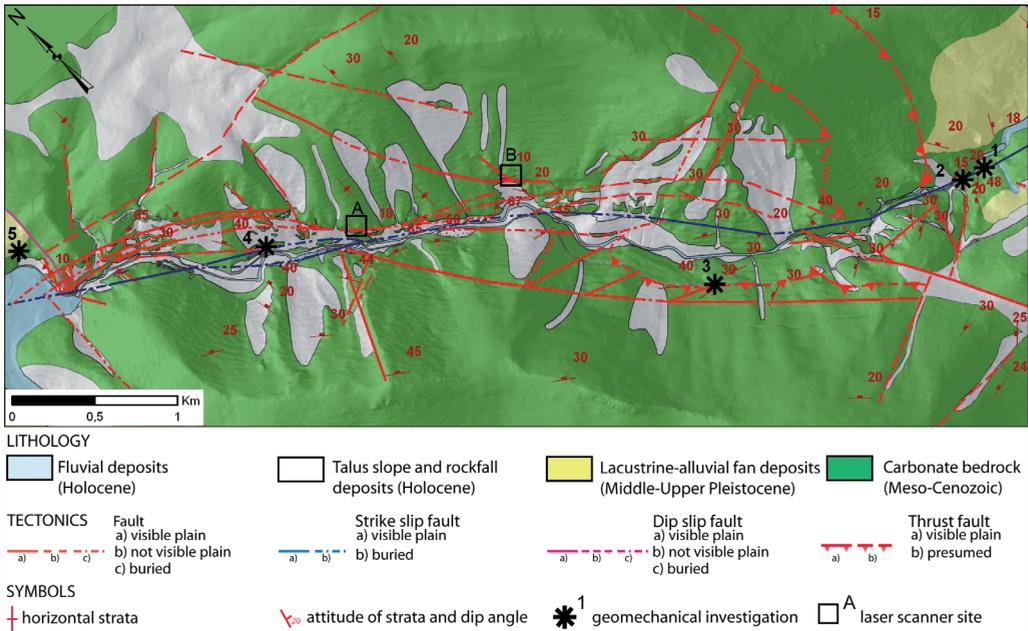
Fig. 4 - Geological map of the San Venanzio gorges

The San Venanzio gorges are located between two main NW-SE oriented and NE dipping calcareous homoclines (Fig. 4). Mt. Urano is a ~35° NE dipping NW-SE homocline made up of a slope-to-basin calcareous succession. Mt. Mentino is a faulted NW-SE to N-S homocline passing towards E to an overturned thrust anticline. Along the gorge, however, the calcareous strata are mostly 30-40° ENE dipping. This structure is cut also by E-W vertical strike slip and dip slip faults.

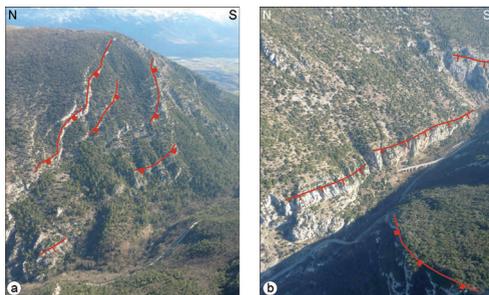
Fig. 5 - Steps-like slopes with structural scarps and fault scarps on the NE slope of the San Venanzio gorges (for scarp legend see Fig. 6): a) SE part; b) central part

The landform distribution is strongly controlled by the morphotectonic setting of the area, which induced variable slopes with scarps and step-like slopes (Fig. 5). The step-like slopes are related to the strata attitude (on the dip slope side) and to tectonic elements (on the fault slope).

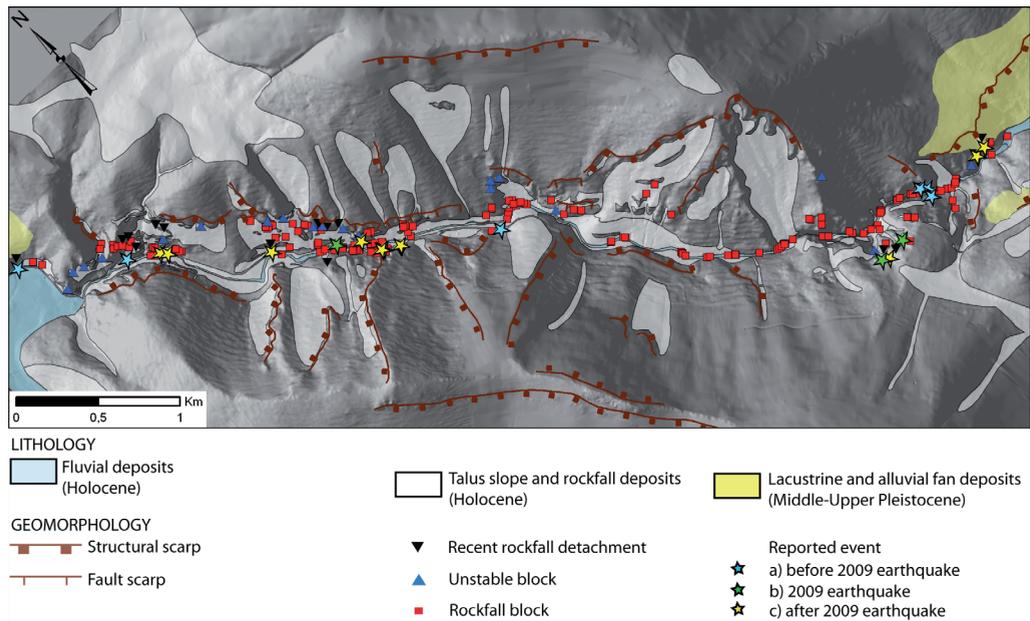
Fig. 6 - Geomorphological and rock fall map of the San Venanzio gorge from reported events and field survey

The main landforms within the gorges include the following (Fig. 6): structural landforms, slope landforms and mass movement, fluvial landforms (along the main gorge). Karst landforms are widespread along the calcareous slopes and on top of the ridges.

Field survey allowed for the mapping of the following rock falls features (Fig. 6): a) recent rock fall detachment scars, b) rock fall bodies or single blocks, and c) unstable blocks, which in two sites were investigated with laser scanning, together with d) reported events pre-, sin-, and post-2009 earthquake.

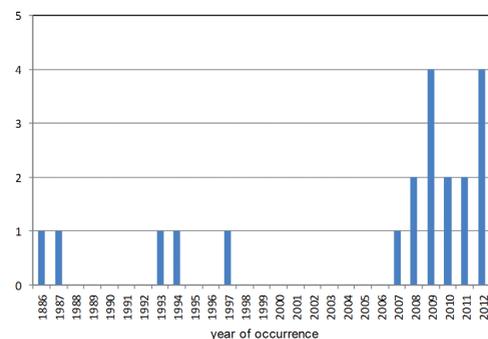
Fig. 7 - Rock falls reported events time distribution

The reported event time distribution (Fig. 7) shows, on average, one event every 1-10 years before 2009, four multiple events on 6 April 2009 (L'Aquila earthquake main shock) and 2-4 events per year after 2009.

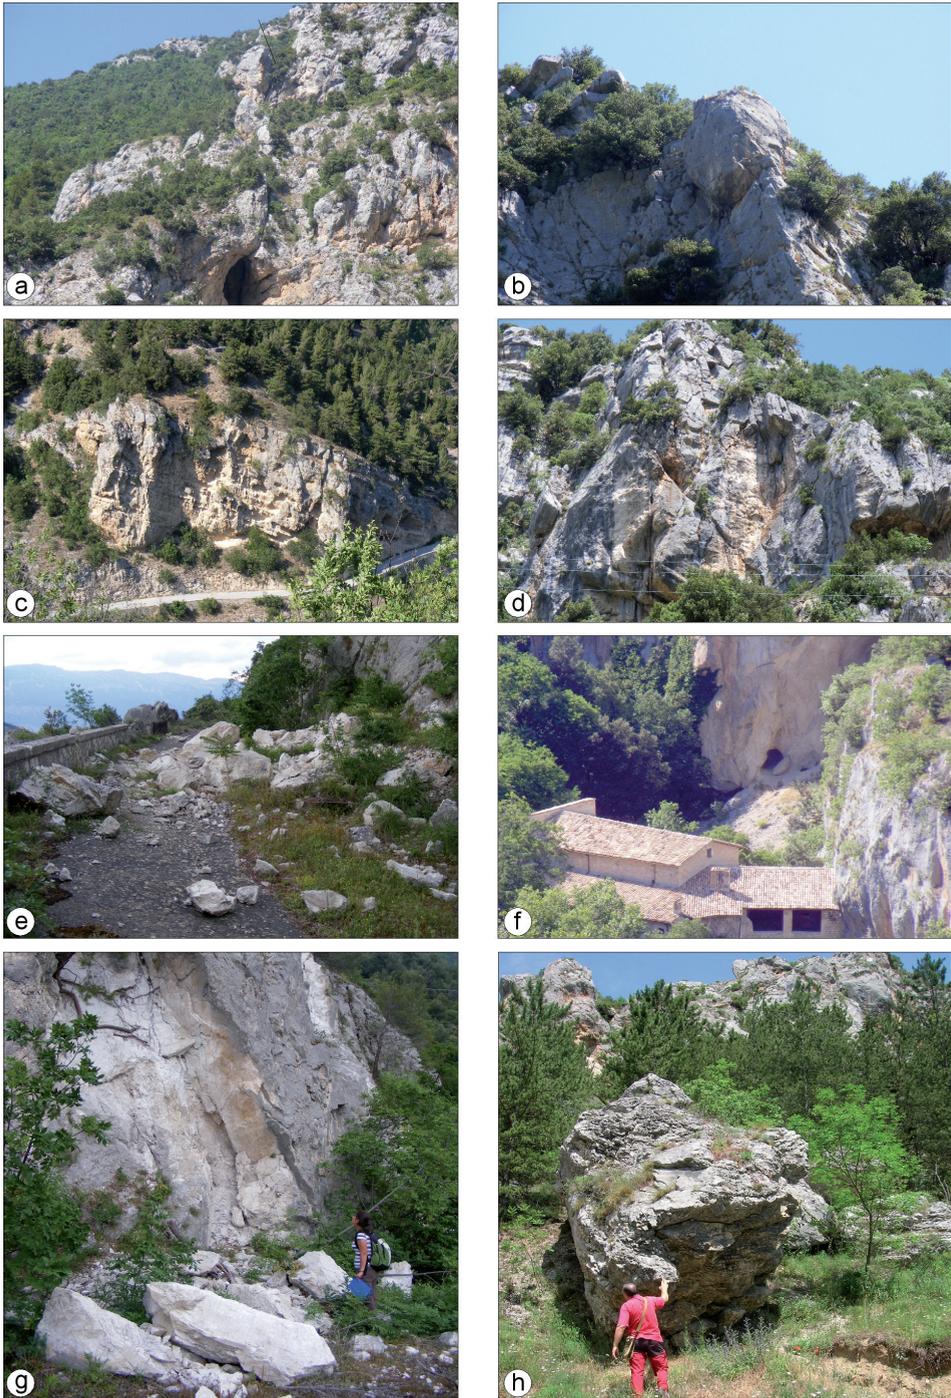
Fig. 8 - Unstable blocks and rock falls occurred in the San Venanzio gorges (Aterno river): a) central sector NE slope, unstable blocks along a N-S vertical joint; b) SE sector NE slope, prismatic unstable blocks with possible sliding on strata; c) outlet of the gorges NE side, unstable blocks and scars on conglomerates and breccias of the Quaternary continental deposits; d) NW sector NE slope, unstable blocks with possible wedge sliding; e) SW sector SW slope, multiple rock falls; f) San Venanzio hermitage, rock fall scar and deposit; g) NW sector NE slope, rock falls on N140 open joints; h) central sector NE slope, large rock fall blocks

Field survey outlined variable jointing along the main scarps, isolating unstable blocks having a moderate (<1 m<sup>3</sup>) to large size (>2-3 m<sup>3</sup>) (Fig. 8a,b,c,d). The main unstable blocks are due to: 1) large rock slices surrounded by edge joints from which large blocks could slide or topple, 2) highly jointed rock peaks and pinnacles, from which moderate size rock volumes could fall, 3) multiple blocks along the main joints, from which multiple falls could occur.

calcareous blocks within a pebble to cobble matrix, with size generally increasing down slope. The large blocks (>1 m<sup>3</sup>) are scattered along the slope, mostly in the lower part and occasionally in the intermediate part (stopped by natural or anthropic obstacles) (Fig. 8e,f,g,h).

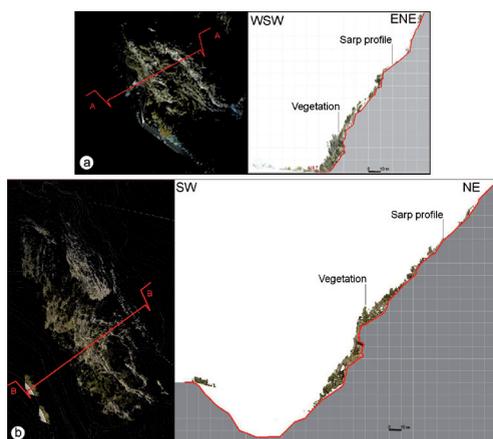
Fig. 9 - Detailed morphometric cross section from laser scanner imaging: a) site A; b) site B (location in Fig. 4)

On two of the main scarps in the middle part of the gorges (along the SS5 road; location in Fig. 4) laser scanner imaging has been performed (acquisition with Topcon GLS 1000, Long Range terrestrial Laser Scanner; processing with ScanMaster) in order to analyze in detail the scarp morphology and geometry as well as the size of unstable blocks. The first site (SS5 at km 163,400, NE slope of the gorges; A in Fig. 4) is a 150 m high and 200 m wide scarp showing a clear step-like morphology, directly overhanging the SS 5 road. The laser scanner allowed to outline vertical segments up to 20 m high and overhanging segments up to 5 m high and 2 m deep; unstable blocks are up to >3-5 m<sup>3</sup> (Fig. 9a).

The second site (SS5 at km 164,500, NE slope of the gorges, B in Fig. 4) is 200 m high and 300 m wide, showing again a step-like morphology. In this case vertical segments are up to 30 m high and overhanging segments are up to 15 m high and >5 m thick; unstable rock volumes are up to 30-50 m<sup>3</sup> (Fig. 9b).

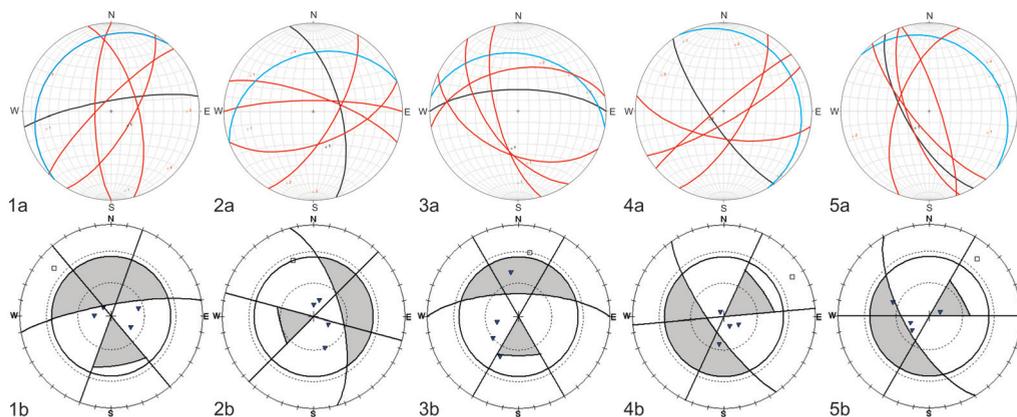
Fig. 10 - Geomechanical investigations data. a) Plots of the main discontinuity sets (strata and joints; lower hemisphere projection) along the San Venanzio gorges from SE to NW (for investigation sites' location see Fig. 4); black line: slope orientation; blue line: strata attitude (S0); red line: joints (F1, 2, 3, 4). b) Markland test plot: quadrangle: strata; triangle: joints

Susceptibility of the slopes to rock falls was analyzed by investigating the geomechanical features of the slopes (I.S.M.R., 1978) and outlining possible movement mechanisms and block dimensions. Investigations were carried out on the main rock scarps affected by rock falls along the SS 5 road. Litology, joint density and weathering and discontinuity sets were analyzed together with their relationship with the rock scarp attitude and main fault planes, in order to define blocks susceptible to fall. The five investigation sites are located all along the gorges from SW to NE and were selected according to their geological and geomorphological features and their position along the SS 5 road. In all the sites open or closed pervasive joints are present, with a high to very low joint density and variable attitude. The statistical analysis of discontinuity orientation and spacing and their relationship with slope orientation allowed to define the main discontinuity sets and the fall mechanism (Tab. 2; Fig. 10).

In the SE part of the gorges on the SW side of the valley (1 in Fig. 10) the intersection of strata attitude (S0-N220/20) and scattered joint sets (N345/65, N30/70, N180/75, N225/80) induces the instability of small-medium size wedge blocks (<1 m<sup>3</sup>) with slide and topple mechanisms.

On the SW side of the gorges, again in the SE part (2 in Fig. 10), strata attitude (S0-N250/35) and joints (N270-290/75-80 and N30-70/75-60) define oblique wedge blocks susceptible to toppling and fall on NW-SE, NE dipping slopes (N345/65). The physical and karst weathering of rock and joints weaken the rock masses and increase, together with shrub and tree roots, rock fall susceptibility.

In the central sector (3 in Fig. 10) on the SW side of the valley, parallel strata (S0-N280/30) and slope orientation (N270/70), with strata dip angle less than slope angle, enable the development of sliding. Sliding and fall are also controlled by N140-160/70 joints (several metres long, 5-20 cm open, low roughness, 20-30 cm spaced) that cut strata transversally.

In the NW part of the gorges on the NE slope (4 in Fig. 10) the intersection of several high angle discontinuity sets (N30-60/75-80 and N230/85) and strata (S0-N330/15) enables wedge sliding along NW-SE slopes SW dipping (N145/77) and locally toppling.

In the extreme NW part of the gorges, again on the NE slope (5 in Fig. 10) the most critical discontinuity set (N140-160/70-72) is parallel to the main slope (N150/68) and enables toppling mechanisms.

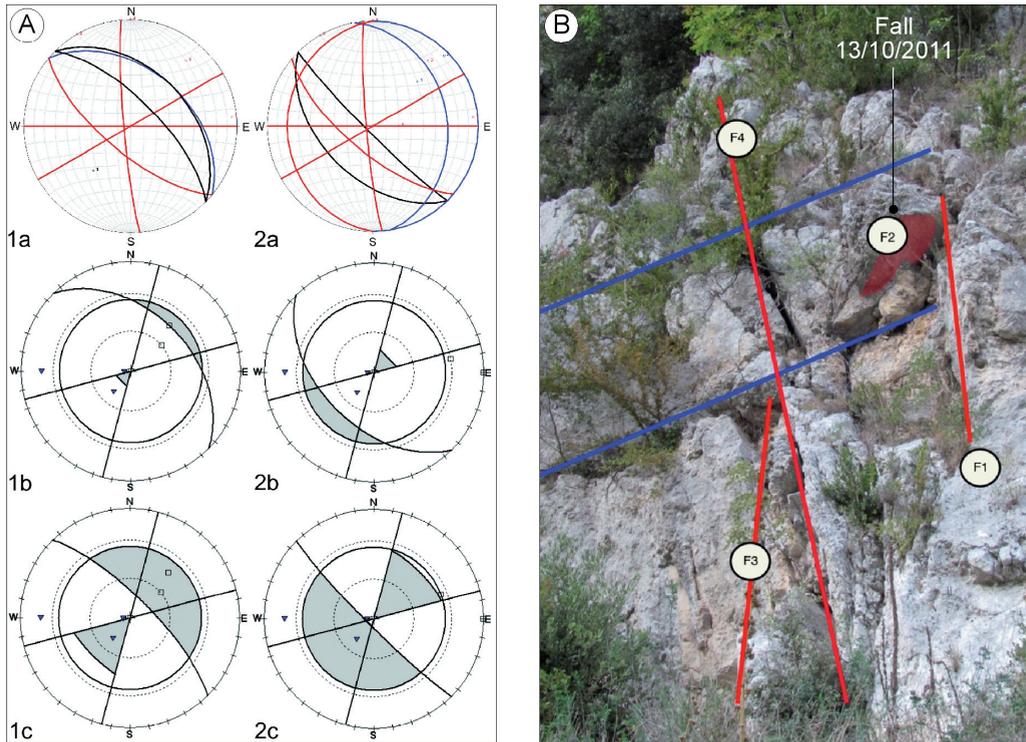
Fig. 11 - A) Plots summarizing the stability conditions: 1) on the SW slope (a: main discontinuity sets; b: Markland test for medium angle slopes; c: Markland test for high angle scarps); 2) on the NE slope (a: main discontinuity sets; b: Markland test for medium angle slopes; c: Markland test for high angle scarps). B) Rock scarps summarizing the main discontinuity set affecting the San Venanzio gorges area: S0-N330/15; F1-N120/80; F2= N220/65; F3-N120/90; F4-N270/80. At the intersection of the main joints and strata a rock fall occurred on 13 October 2011 involving the block outlined in the image

The geomechanical investigation and the comparison with main tectonic features outline that instability mostly affects N300-350 NE dipping strata (S0), intersected by N175 vertical and N130/70 discontinuities, on the SW side of the valley on high angle slopes, inducing slide mechanisms. On the NE side of the valley instability mostly affects N330-350 NE dipping strata (S0), intersected by N175 vertical and N130/70 discontinuities a) with a slide mechanism when the dip angle is less than the slope, b) with a topple mechanism when the dip angle is more than the slope, c) with wedge sliding when intersecting N060/90 and N090/90 discontinuities transversal to the slopes (Fig. 11).

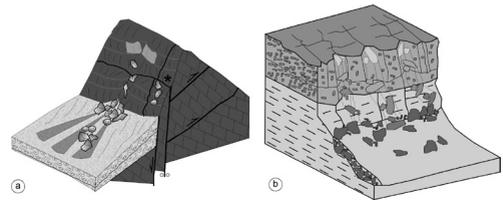
Fig. 12 - Morphostructural scheme of rock falls: a) on calcareous faulted homocline ridges forming talus slopes and cones (NE slope of the San Venanzio gorges, asterisk indicates the discontinuity intersection and the related scarps as in Fig. 5b and 11b); b) on structural scarps on faulted breccias and conglomerates of Quaternary continental deposits (NE slope of the San Venanzio gorges at the outlet into the Sulmona basin, see also Fig. 8c)

Abruzzo Region and analyzed at the light of the relationship between landslide distribution and morphostructural setting, resulting from the regional landslide inventory. In the San Venanzio gorges rock falls occur on: a) calcareous faulted homocline ridges; b) structural scarps on faulted breccias and conglomerates of Quaternary continental deposits (Fig. 12).
