# GEOMATICS FOR SLOPE STABILITY AND ROCK FALL RUNOUT ANALYSIS: A CASE STUDY ALONG THE ALTA TAMBURA ROAD IN THE APUAN ALPS (TUSCANY, ITALY)

RICCARDO SALVINI & MIRKO FRANCONI

University of Siena - Department of Environment, Earth and Physical Sciences and Centre of Geotechnologies - Siena, Italy

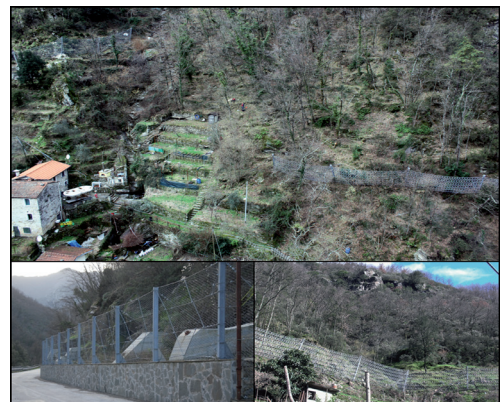
Fig. 2 - Examples of protectionary measures executed by the Massa Municipality

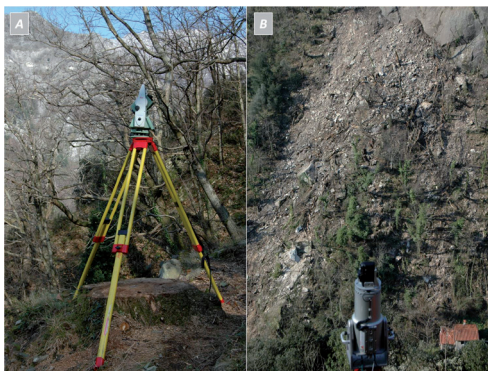
Fig. 4 - Topographic surveying with the total station (A); TLS during data acquisition (B)

tion and two Leica™ System 1200 GPS receivers were used for the topographic survey (Fig. 4A). Through the GSM connection to the Leica Geosystems™ SpiderNet network, differential GPS techniques were applied with the aim of determining the absolute coordinates of the system origin, and that of the azimuth zero direction. By this technique, since the total station allowed for determination of the relative coordinates of surveyed points (X, Y and Z) through the measurement of angles and distances and trigonometric calculations, absolute coordinates of ca. 100 GCP were calculated and used for the absolute orientation of the images within LPS module of ERDAS™ IMAGINE software.

Moreover, a Riegel™ Z420i TLS (Fig. 4B) was used to acquire a point cloud necessary for the 3D modelling of the slope. The distance between the slope and the instrument ranged from 250 to 400 m and the spatial resolution of the point cloud was set to 7 cm at a distance of 300 m, corresponding to a scanning angle of  $0.013^\circ$ . The point cloud was stored and processed using Leica™ Cyclone software. The described topographic survey was also utilized for the registration to absolute coordinates of the TLS point cloud.

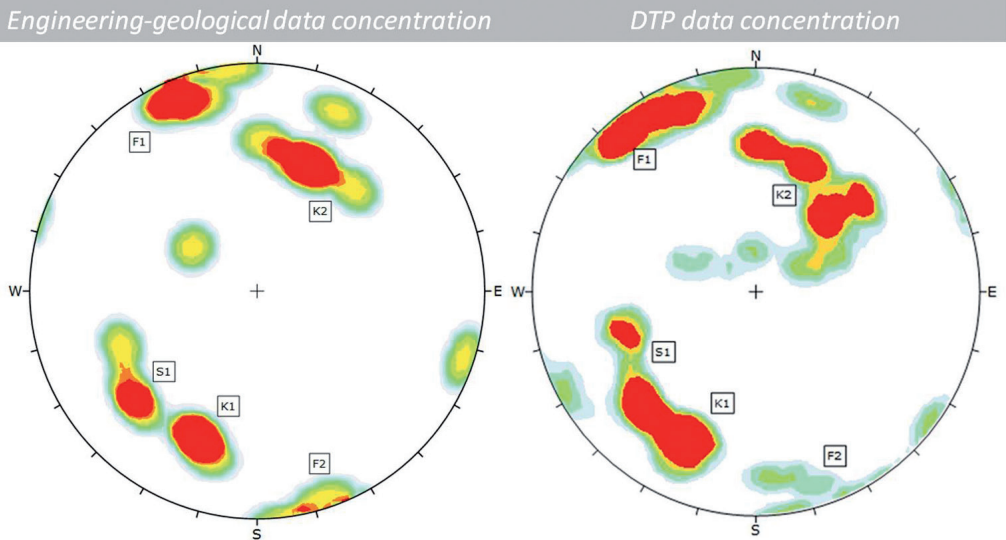
Fig. 5 - Contour plots of joint systems from engineering-geological survey and DTP. Data is presented using stereographic projection through the Schmidt equal-area method

The integration of geomatics and traditional engineering-geological surveys allowed for the determination of the attitude of joint systems and slopes. Measurements from DTP were compared with fieldwork data by means of a density analysis of attitudes in stereographic projection (Fig. 5). As shown in the figure, similarities between the joint distribution obtained through engineering-geological surveys and DTP are evident, even if the photogrammetric data have a greater dispersion. This is because the engineering-geological survey was carried out in accessible outcrops, whereas DTP photointerpreted joints refer to the whole 3 ha wide slope. The larger the area under study, the more the attitude of joints may vary. Nevertheless, the mean attitude derived from the two methods corresponds well with data variability that is always less than  $10^\circ$  (Tab. 2).
