DEBRIS FLOWS AND LANDSLIDES CAUSED BY TYPHOON MORAKOT IN TAIWAN

ABSTRACT

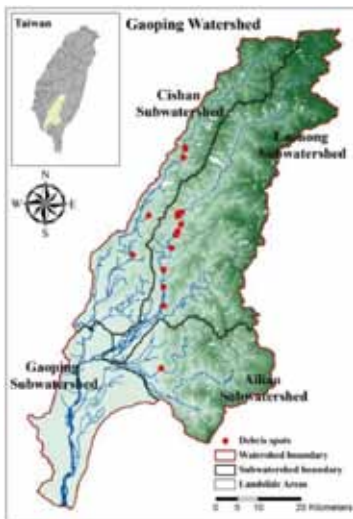
Gaoping River is the largest river in southern Taiwan with a 3257 km² drainage area and a 171 km long main stream in southwest Taiwan (as shown in Figure 2). The river originates in the south of the Jade Mountain with high altitude of 3952 m and has four main tributary drainages, Cishan river watershed, Laonong river watershed, Ailiao river watershed and Gaoping downriver watershed, whose drainage areas are 833 km², 1375 km², 623 km², and 414 km², respectively

Fig. 2 - Location map of the Gaoping river watershed, locations of landslides and 20 debris flow events caused by Typhoon Morakot.

The strong rainfall during Typhoon Morakot caused 370 km² landslide areas in central and southern Taiwan. Over 50% landslide areas occurred in Gaoping river watershed, for example, Xiaolin, Xinfu, and Nanshalu Villages having a lot of severe catastrophic disasters are also involved in this watershed. The positions and distributions of landslide areas after Typhoon Morakot were showed in Figure 2.

tershed, such as, Nanshalu, Xinfa, and Maya Villages. The positions and distributions of debris flow events after Typhoon Morakot were showed in Figure 2.

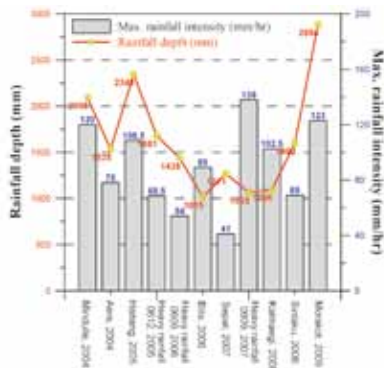
Fig. 3 - Rainfall depth and maximum rainfall intensity brought by Typhoons in Taiwan from 2004 to 2009

Typhoons and heavy rainfalls are major agents of sediment-related hazards in Taiwan. The rainfall data of typhoon events was collected and analyzed from 2004 to 2009, as shown in Figure 3. The results show that the rainfall characteristics, rainfall depth and rainfall intensity have an increasing trend in recent years. The rainfall depth of Typhoon Morakot reached 2884 mm, which is the largest rainfall depth within a single typhoon event from 1960 to 2009. According to the estimation from SWCB (Soil and Water Conservation Bureau), the number of severe debris flow events and landslide disasters in Taiwan has increased, as shown in Table 2.

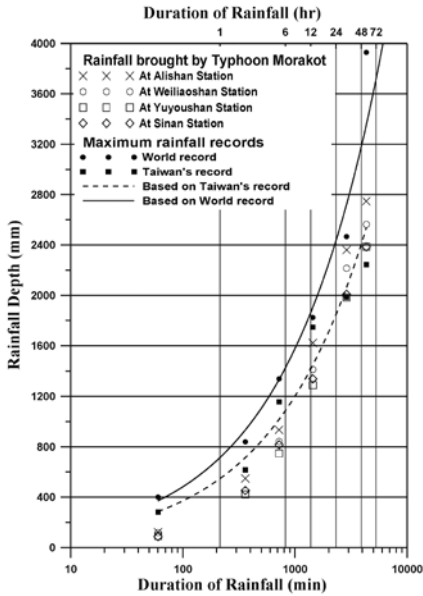
Fig. 6 - Magnitude-duration graph of rainfall at Alishan, Sinan, Welliaoshan and Yuyoushan rainfall stations during Typhoon Morakot

were 123 mm, 548.5 mm, 934.5 mm, 1,623.5 mm, 2,361 mm and 2,748 mm, respectively (see Figure 6). The previous rainfall records in Taiwan, 48-hour rainfall (1,986 mm) and 72-hour rainfall (2,243 mm) were broken. The 24-hour and 48-hour recorded rainfall approach the world records (2,467 mm and 1,825 mm, respectively). For comparison, Sinan, Welliaoshan, and Yuyoushan rainfall stations within Gaoping river watershed were plotted in Figure 6 as well.

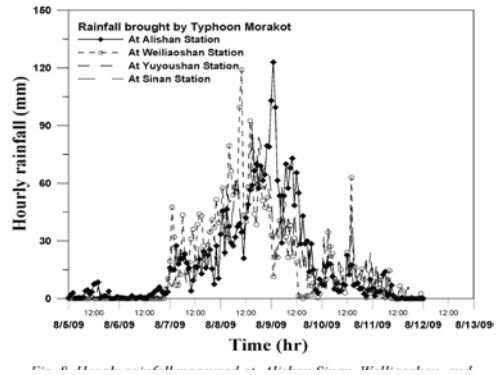
Fig. 8 - Hourly rainfall measured at Alishan Sinan, Welliaoshan, and Yuyoushan rainfall stations during Typhoon Morakot

over a period of 108 hours during Typhoon Morakot. This total amount equals about 70% of the regional annual rainfall at Alishan Station. The hourly rainfall exceeding 78 mm persisted for 12 hours, from 16:00 on August 8 to 03:00 on August 9, 2009, at Alishan Station (see Fig. 8). The maximum hourly rainfall exceeded 120 mm at Alishan and Welliaoshan rainfall stations.

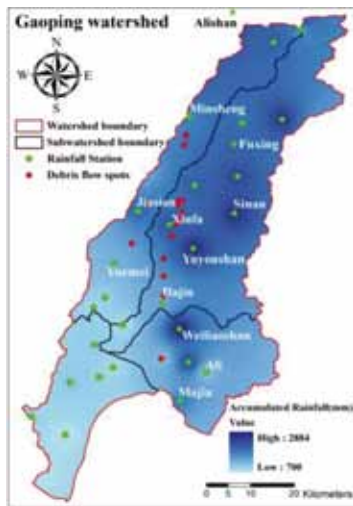
In Figure 9, the Isohyetal map was plotted in dif-

Fig. 9 - Isohyetal map of the 108-hour rainfall during Typhoon Morakot from August 6 to August 11, 2009

ferent gradation of blue colors to show the rainfall depth from 27 rainfall stations records in Gaoping river watershed during Typhoon Morakot from August 6 to August 11, 2009. According to the estimation from CWB (CENTRAL WEATHER BUREAU, 2009), there are 8 rainfall stations with rainfall depth of over 2,000 mm. The maximum rainfall depth reached to 2,701 mm at Weiliaoshan Station. Its return periods for 1-hour to 72-hour rainfall exceeded 200 year. Considerable rainfall depth, high intensity and long duration caused a lot of landslides and disasters in Gaoping river watershed. The most miserable hazard of all landslides is in Xiaolin Village in Cishan river watershed see Figure 10 and 11. It caused the deep-seated landslides with 190 ha landslides and 160 ha sediment deposited which destroyed 200 houses, 3 bridges, 3 km road, 490 deaths, and about 3.5 km² inundation areas. Typhoon Morakot also brought significant landslide hazards in other villages as well, see Tab.3.

The relationship between the rainfall depth and landslide areas is analyzed as well as topographic conditions to understand the impact of Typhoon Morakot. By mans of the Isohyetal map (in Fig. 9), the representative rainfall depth can be calculated from isohyetal map and landslides map in overlap program with GIS (Geographic Information System) system.

From the rainfall data brought by Typhoon Morakot in Fig. 9 or Tab.5, the record-breaking rainstorm mainly concentrated on the upper region of Gaoping river watershed (Laonong river watershed and Cishan

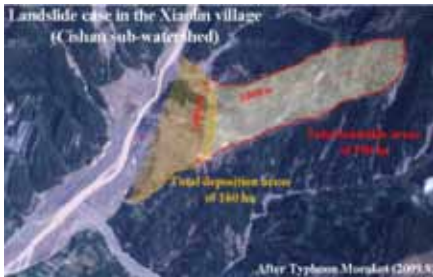
Fig. 11 - The catastrophic deep-seated landslides in Xiaolin Village in Gaoping river watershed after Typhoon Morakot

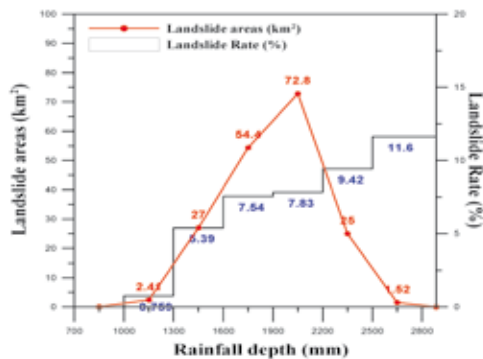
Fig. 12 - The relationship between accumulated rainfall and landslides in Gaoping river watershed

increasing trend with rainfall depth. In Figure 12, the maximum landslide areas is 72.8 km² with rainfall depth of 1900~2200mm. The maximum landslide rate is 11.6% with rainfall depth over 2500 mm. The high landslide rate indicates that landslide areas within high Isohyetal areas are more than low Isohyetal.

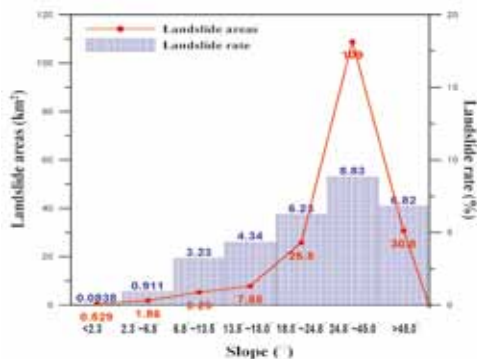
The slope and landslide areas are selected to study as well. From Figure 13, the results show that the landslide areas increase as the slope rises. While the slope is between 24.8° and 45.0°, both landslide area and landslide rate are at maximum values, which are 109 km² and 8.83%, respectively. The relationship

Fig. 13 - The relationship between stlop and landslides in Gaoping river watershed

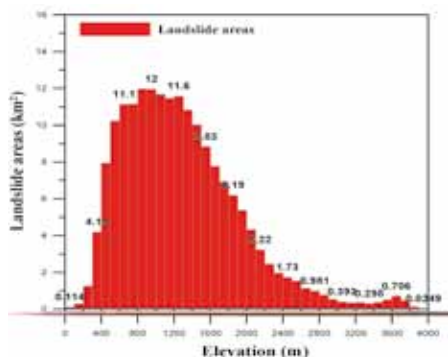
between elevation and landslide areas was shown in Figure 14, in which the major landslides took place at the elevation from 400 m to 2000 m, and the maximum landslide rate is within 800~1000 m, 12%.

Fig. 14 - The relationship between elevation and landslides in Gaoping river watershed

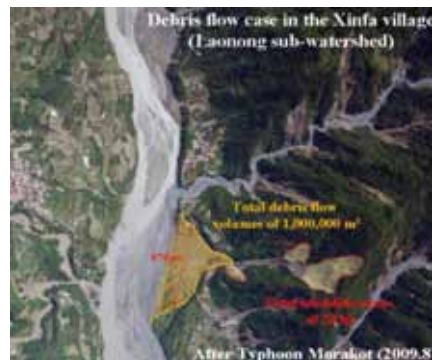
Fig. 15 - The debris flow hazard in Xinfa village in the Laonong river watershed in Gaoping watershed after Typhoon Morakot

river watershed), where 20 debris flow disasters occurred. The most wretched hazard of all debris flows is in Xinfa Village in the Laonong river watershed (see Fig. 10 and 15). The debris flows with 20 ha landslides and 1,000,000 sediments deposited which damaged 80 houses, destroyed 1 km roadway, 41 deaths. Furthermore, Typhoon Morakot also brought significant debris flow hazards in other villages, see Tab.5. The running path and widespread sediment deposition volume of debris flows play an important role to endanger the habitants who live close to the debris flow potential streams, high probability of debris flow occurrence streams. In order to further understand the debris flow deposited volume, the catchment areas and the debris flow deposited volume are selected to analyze and estimate the relationship of catchment areas and deposited volume (FRANZI & BIANCO, 2001).

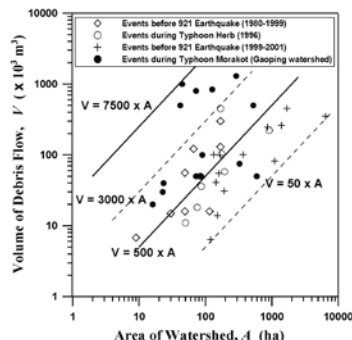
Fig. 16 - The relationship between watershed area and debris flows deposited volume in Chenyoulan and Gaoping river watershed

The debris flow deposited volume is roughly proportional to the catchment in Chenyoulan river watershed, and get the empirical functions at low limit

$V=50A$ and up limit $V=2,000A$, as showed in Figure 16 (JAN & CHEN, 2005). To comprehend the impact of Typhoon Morakot on debris flow deposited volume in Gaoping river watershed, the deposited volume events during Typhoon Morakot were plotted in Figure 13. The results show that the low and up limits in Figure 13 have an increasing trend, which are $V=500A$ and $V=7,500A$, respectively.
