DEBRIS FLOWS IN MEIGU COUNTY OF SICHUAN (SW CHINA): GEOMORPHOLOGY AND HAZARDS

ABSTRACT

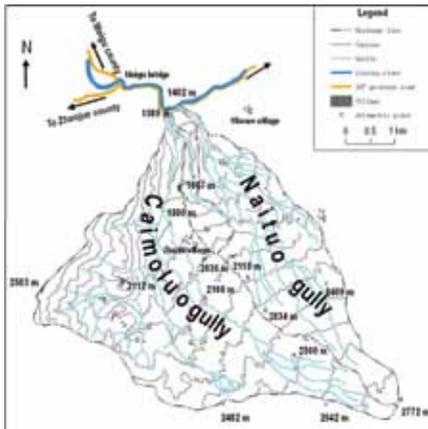
Fig. 1 - Sketch map of the topography of debris flow gullies

The Caimoluo gully and Naituo gully that we surveyed for this study are located in the right bank of Liutong river, they are ranked the first-branch trenches. Liutong river is the first tributary of Jinsha river. The distance between both gullies is 0.5 km. Base on the Global Position System (GPS), Caimoluo gully is positioned at 28°06.394'N, 103°01.681'E and Naituo gully is positioned at 28°06.461'N, 103°01.859'E. Both gullies belong to Maluo village of Luoeyigan town, which is the boundary between Meigu and Zhaojue county (Figure 1).

According to on-site measurement by GPS and the topographic map with the scale 1:50000 (Fig. 1; Fig. 3), the topographic and geomorphologic data of Caimoluo gully and Naituo gully can be obtained (Tab. 1). It can be seen that the topography and geomorphology of Caimoluo gully and Naituo gully have two favorable conditions. For one thing, this topographic configuration is conducive to a rapid concentration of runoff, and when combined with intense rains, it can lead to high peak discharge and erosion rates. For another thing, it provides potential energy for debris flows.

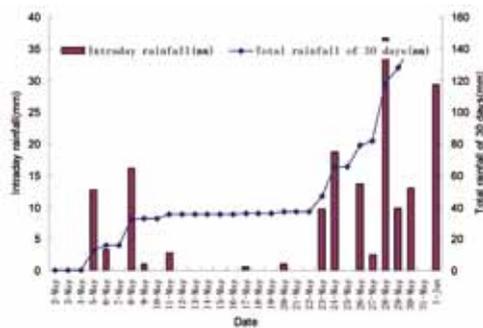
Fig. 2 - Daily and cumulative rainfall during May 2005 recorded at Meigu county station

precipitation are important factors for triggering debris flows (CAMPBELL, 1975). Rainstorm with short duration and high intensity is crucial for the debris flow occurrence within study area. At about 10 o'clock in the night of May 31, hails suddenly struck the upper reach of Caimoluo and Naituo drainage basins. An hour later, heavy rain fell also mixed with hail, the flux of both gullies increased rapidly. Heavy rain kept on about two hours before debris flows occurred. According to the records from meteorological station of Meigu county, on June 1 debris flows occurred, the daily rainfall amount is 29.3 mm and during the past 30 days from May 2 to May 31 before debris flows occurred, the total rainfall was 140.8 mm (Fig. 2).

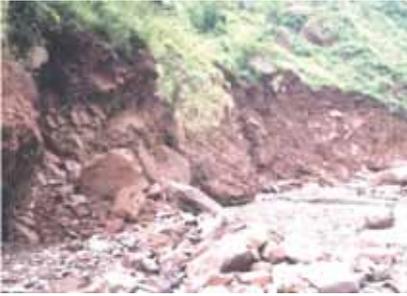
Fig. 4 - Loose materials on the right slope of Caimoluo gully

gully is the same as that of Naituo gully, the slope characteristic and the supply mode of solid materials are different. The bedrock on left bank of both gullies is exposed, whereas the rocks and soils on the right bank usually fall into the channels in the way of collapse because of the well-developed vertical joints (Fig. 4). For example, a large-scale landslide is located on the right bank in the middle reach of Naituo gully, potato and walnut have been cultivated on the landslide. There are a lot of cracks which are about tens of centimeters width on the landslide (Fig. 5). More and more solid materials fall into the channel in the way of collapse and slide. Therefore, the cracked strata, lithology, as well as geologic structure in Caimoluo and Naituo drainage basins contribute to the debris flow occurrences by providing source materials

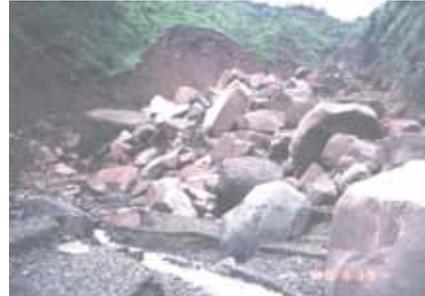
Fig. 6 - Serious blocking in the gully bed of Caimoluo gully

are unstable, especially for the right one. The channels are jammed badly with abundance of solid materials (Fig. 6). As seen in Figure 6, the sidewall of channel exhibits extensive areas of freshly exposed where we can see the red soil, steep to near vertical walls. And there likely was less than 0.5 m material mantle on the surface, which is one of reasons why the solid materials are loose. Therefore, one clear characteristic of drainage basin is that the transportation area is also an important supply source of solid materials, which provide lots of loose materials for debris flows so as to increase the magnitude and damage ability.

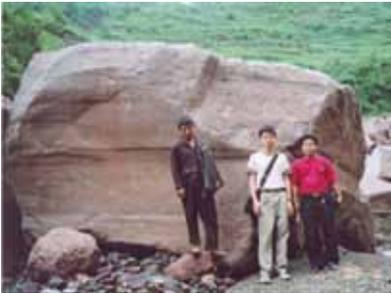
Fig. 7 - Large boulder carried by the debris flow in Caimoluo gully

range from clay to boulder. Huge boulders were carried to near gully mouth by debris flows. The size of the largest one is about $4.5 \times 4 \times 3$ m³ (Fig. 7) in Caimoluo gully and that is about $4 \times 3 \times 1.7$ m³ in Naituo gully.

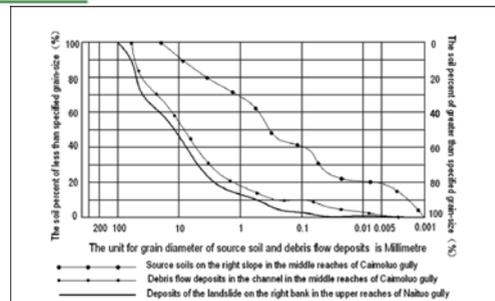
Fig. 8 - Grain-size curve of source soil and debris flow deposits in study area

Grain samples are source soils derived from right slope, in-channel debris flow accumulation in the middle reach of Caimoluo gully, landslide earth derived from right bank in the lower reach of Naituo gully, all these were collected and tested by geo-technology in the laboratory. Under the preconditions that the water content accounts for 10% and the density is 1.65g/cm³, the test results of the source soils from Caimoluo gully are as follows: internal frictional angle 31.3°, cohesive force 12 Kp_a, liquefaction limit of the viscous grains 33.2%, plasticity limit 19.8% and the plasticity index 13.4. The peak of grain-size distribution curve leaned to right. According to soil texture classification published by the United States Department of Agriculture (BRADY, 1974), the weight content of fine silt (0.005—0.002 mm) and clay (<0.002 mm) accounts for 19.3% (Fig. 8). As to the in-channel debris flows accumulation in the middle reach of Caimoluo gully, under the preconditions that the water content accounts for 7.7% and the density is 1.62g/cm³, the test results are as follows: the internal frictional angle 38.2°, cohesive force 12 Kp_a. The weight content of fine silt

(0.005-0.002 mm) and clay (<0.002 mm) is 2.2% and the grain-size distribution curve has three typical peaks appearing on the percentage content of silt, sand and gravel respectively (Fig. 8). The landslide lying in the right bank of the lower reach of Naituo gully was induced by debris flows, and it also provides a great deal of solid materials for debris flows. According to the geotechnical testing on the accumulation of the landslide front, on the precondition that the water content accounts for 7.4% and the density is 1.76g/cm³, the internal frictional angle and cohesive force are 35.8° and 5 Kp_a respectively. The grain-size distribution curve has only one peak (Fig. 8).

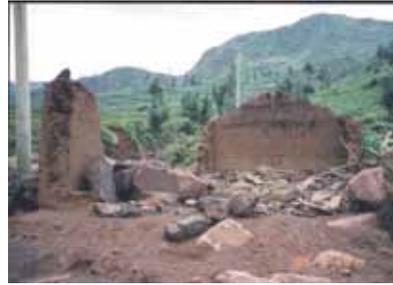
Fig. 11 - Destroyed house by the debris flow

roads, bridges, communication facilities and hydro-power facilities were damaged seriously (Fig. 11 and 12), vegetal cover and surface soil on the slopes and in the channels were washed away by flood, which result in the ecological environment further deteriorated.

tions against natural disaster, for example, they built a floodwall with the height of 2 meter, unfortunately, the floodwall did not take effect during this catastrophe. Therefore, some technological and civil engineering measurements should be taken into account in order to mitigate debris flows hazards in Meigu county.

Several suggestions can be adopted in the study area from this study case. Firstly, the important interaction between human and natural environment indicates that local residents should improve protection consciousness for the ecological environment, excessive deforestation and farming must be prevented. Secondly, local residents can move out of the dangerous area of the debris flows and the infrastructures should be put in the safe region with finance support by governments. Thirdly, the meteorological monitoring in areas prone to debris flows activity could help predict debris flow hazards. Fourthly, a variety of geomorphic methods, including repeat photography, dendrogeomorphology, lichenometry, plant succession, and stratigraphic analyses, could be employed in the study of debris flows so as to understand the mechanism and process of debris flows better.
