HYDROLOGIC CONDITIONS AND TERRESTRIAL LASER SCANNING OF POST-FIRE DEBRIS FLOWS IN THE SAN GABRIEL MOUNTAINS, CA, U.S.A

K.M. SCHMIDT^(*), M.N. HANSHAW^(*), J.F. HOWLE^(**), J.W. KEAN^(***), D.M. STALEY^(****),
J.D. STOCK^(*) & W. BAWDENG W. ^(****)

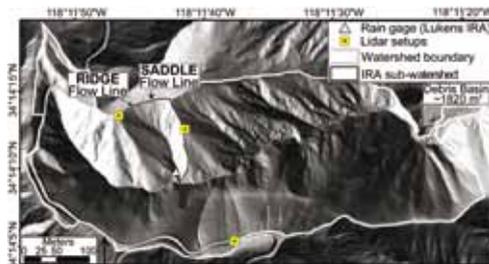
Fig. 2 - Lukens IRA sub-watershed with instrument locations on hillshade derived from airborne lidar. Two surface-flow lines (Saddle and Ridge) were monitored near the drainage divide. Rain gage (Lukens IRA) also denotes location of channel-monitoring array

To examine the hydrologic conditions leading to debris-flow generation, we selected a burned, dominantly soil-mantled, unchannelized low-order valley (Lukens IRA, Figg. 1 and 2) in the Station burn area that was hydrologically unaffected by nearby roads. The watershed had convergent steep slopes >30° with

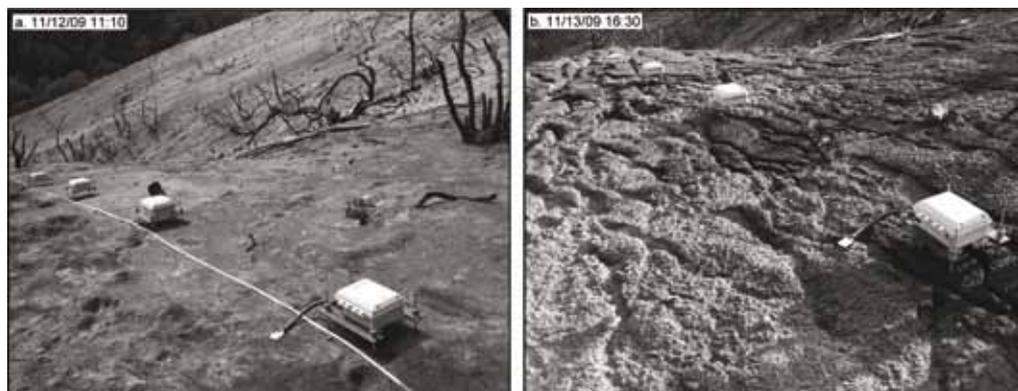
Fig. 4 - Before (a) and after (b) photographs of the overland-flow sensors (Saddle flow line). Note the rainsplash-induced pockmarks and cm-scale width semicontinuous rill network in (b) extending to within 0.5-2.0 m of the diffuse convex drainage divide

ing deposits ~0.6-1.2 m thick. Numerous flows also blocked both lanes of the Angeles Crest Highway (e.g., Fig. 1c), but some stopped abruptly upon exiting steep, confined valleys (Figure 1f). Figures 3 and 4 illustrate how surface morphology was altered at the site by runoff-induced surface flow in response to this short, intense rainfall burst.

Figures 5 and 6 reveal a short response time between the onset of rainfall and the inception of measurable overland water flow. Overland-flow response along the Saddle and Ridge flow lines, originating from the drainage divide, was delayed only by 10 to 20 minutes after the onset of rainfall; accumulated rain totals during this time were merely 5-10 mm. The Ridge line sensors reacted first, preceding the first Saddle line response by more than 8 minutes, likely a reflection of topographic location within a larger contributing drainage area, higher gradient of contributing area, and possibly differences in hydrologic response of surficial materials. Analysis of our TLS-derived topography showed that the farthest upslope sensor on the Ridge line had a drainage area of ~1-2 m², compared to <1 m² on the Saddle line. Within an individual flow line there was no discernable downslope increase in recorded flow depth over the 10-m long interval. Post-storm erosional paths were observed to be irregular, concentrated within anastomosing networks (Fig. 4) that possibly varied in position and discharge throughout the storm.
