THE 2005 LA CONCHITA LANDSLIDE, CALIFORNIA: PART 1 - GEOLOGY

This is Part I of a two-part causation analysis of the January 10, 2005 La Conchita, California, USA landslide. This paper describes the geology and geomorphology of the event, which killed 10 persons and damaged or destroyed 36 residences. The landslide is located in a complex and active tectonic setting. It was triggered by two weeks of heavy rainfall, which initiated a failure in the backscarp of a large slump that had occurred ten years earlier. The 2005 landslide displaced older landslide deposits derived from Tertiary sedimentary rocks. Over 30,000 m³ of wet debris was mobilized in the event, which formed two distinct lobes of debris. The main lobe, comprising 90% of the deposit, rapidly transformed into a large scale debris flow, eroded and entrained over 4,000 m³ of material along its path, overran a temporary wall, then flowed into the residential community. This lobe exhibits characteristic debris flow textures, including raised lateral levees and a surface pattern of ridges and troughs. The minor lobe, comprising about 10% of the total landslide volume, was deposited in pulses that arrived from different direc

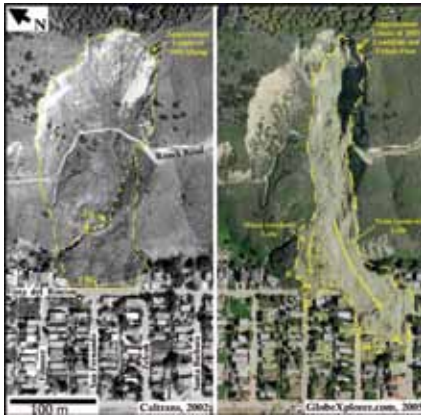
Fig. 1 - Comparison of aerial photos of the La Conchita area taken in 2002 (left) and 2005 (right). The photo at left shows the approximate limits of the 1995 slump failure, the location of drainage improvements (DI) to convey water across the slump (yellow dotted line), and the location of a temporary wall (TW) constructed in 2000 to allow reopening of Vista del Rincon Avenue (solid yellow line). The photo at right defines the main (eastern) and minor (western) lobes, shows the inferred movement direction of the debris in these lobes, the location of a breach (B) in the wall caused by impact of the debris, and locations affected by emergency grading after the event (E)

affected a much larger portion of the slope in 1995 (Fig. 1). Material from the initial slope failure rapidly transformed into a large-scale debris flow. The majority of the debris flow (main lobe) traveled down the swale between the 1995 slump and the adjacent intact slope area, and entered the residential community of La Conchita. This lobe of the debris flow traveled about 100 m through the community, destroying approximately 30 homes and resulting in the deaths of 10 persons (GURROLA, 2005). A second lobe of the debris flow, containing about 10% of the total mobilized volume of debris (minor lobe), traveled down the heavily vegetated slope to the west of the main lobe. The minor lobe impacted and partially breached the central part of a temporary retaining wall located along Vista del Rincon Avenue (see Fig. 1), but caused no additional personal property damage or loss of life. Remarkably, a television news crew that was in the area to cover earlier rain-related highway and rail line closures videotaped the incipient failure and much of the debris flow as it descended the slope.

The slump failure was never remediated. By early 1996, the Ranch had performed minor earthwork to convey stormwater from the truncated uphill portion of Ranch Road across the slump to a point along the toe of the 1995 slump at the northern end of Fillmore Avenue. These drainage improvements (DI) are indicated on Fig. 1. Also shown in the figure is a steep-sided channel incised by surface runoff draining toward the western side of the slump by 2002.

superelevation as the debris flow banked to the left in the mid-slope area (Fig. 1). The overflow appears to have occurred before the main lobe incised its bed, which subsequently lowered its level relative to the surrounding slope area.

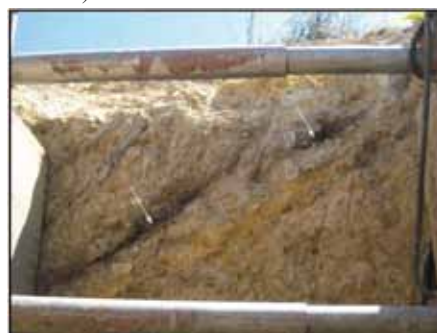
Fig 4 - View of stratigraphy exposed in test pit excavated into minor lobe of the landslide. Arrows indicate layer of vegetation sandwiched between pulses of debris

Test pits excavated into the minor lobe of the La Conchita landslide behind the temporary wall encountered pale yellow-brown, low plasticity silt exhibiting a massive, ungraded texture (Fig. 4). The test pits also exposed slope-parallel layers of pulverized vegetation located at approximately 1.2 m vertical intervals. This evidence indicates that the minor lobe was deposited in discrete pulses.
