DEBRIS FLOW DANGERS OF THE 21ST CENTURY IN THE NORTHERN CAUCASUS (RUSSIA)

E.V. ZAPOROZHCHENKO & N.S. KAMENYEV(*)

Sevkavgirovodhoz Institute - Kirova 78 - Pyatigorsk, Russia - E-mail: skgvh@skgvh.ru

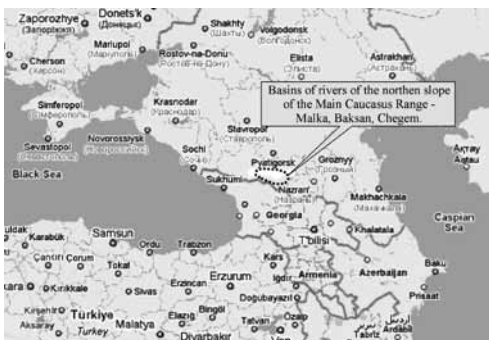
Fig. 1 - Study area

(in 1983), GERHOZHAN (in 2000), GENALDON (in 2002), MALKIN (in 2006), CHEGEM (in 2007 and 2010) (Fig 1)

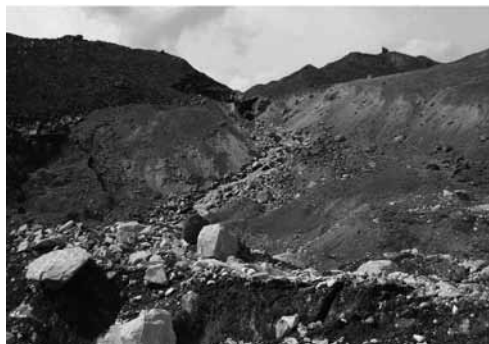
Fig. 2 - 10 September 2009. The state of the breakthrough passage of the ice crossbar at the Birdzhalychiran lake at the site of discharge of water masses on 10 August 2006. View from the downstream. The source of the Birdzhaly-Su river

nario of the discharge process of waters accumulated near the marks of tongue parts of the same glacier (Birdzhalychiran): ~3060 m a.s.l. in 1909 and ~3300 m a.s.l. in 2006 (Fig. 2)

casted an outburst of a lake neoformation (fell ~550 thousand m³) in the Birdzhalychiran ice cup through overflow of ~400 thousand m³ and destruction of an ice riegel-crossbar, to be accompanied by formation of a debris flow, capable of reaching the “Dzhyly-Su” spa. The forecasted scenario became a reality in a natural manner on 10-11 August 2006. The sweeping swell reached the outlets of the “Dzhyly-Su” springs at 4 a.m. on 11 August 2006. Deposits of the debris flow, that had a sediment-water composition, covered the area of 9750 m² with a layer of an average thickness of 3.4 m. The volume of hard deposits was 33 thousand m³. Taking into account the material that got into the Malka river, in the morning of 11 August 2006 the total of ~50 m³ was transported to the mouth of the Birdzhaly-Su river.

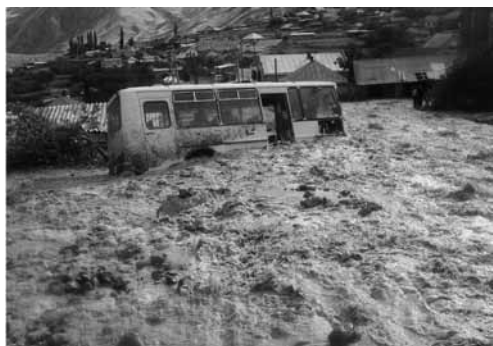
Fig. 3. 3 August 2007. The debris flow on the street of the village of Bulungu

On 3 August, 2007, at 00.15 a.m., a high density debris flow came down the river channel to the fringes of the south-western part of the village of Bulungu. The underbridge span was almost immediately clogged by blocks and drowned wood and the debris flow mass, “dumped” on the right hand of the course, ~250 m above the bridge, went through residential houses and adjoining plots of land (Fig. 3).

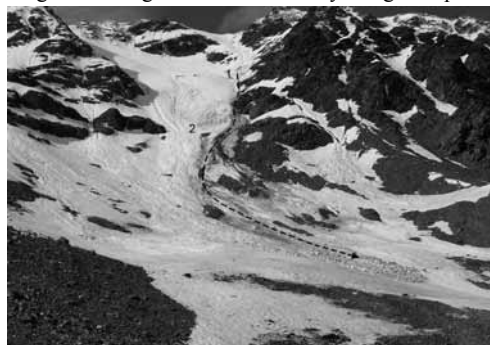
Fig. 4 - 15 July 2008. The Western Korgashinlitau glacier. The source of the Rakyt-1 river: 1 – the area of origination of the 2 August 2007 debris flow and the path of movement of outburst water masses from an intraglacial hollow; 2 – the outflow grotto, formed in 2008

– the area of the outer western part of the Western glacier under the peak of Rakyt at true altitude of ~3650 m a.s.l. (Fig. 4) was the source of the water component (water impulse) of the debris flow; there, apparently, an almost instant discharge of a great volume of water (~20 thousand cubic metres ± 10 thousand cubic metres), that had been concentrated inside intraglacial hollow(s), with a further outflow (possibly, a short-time one) and building-up of the outflow volume, took place;

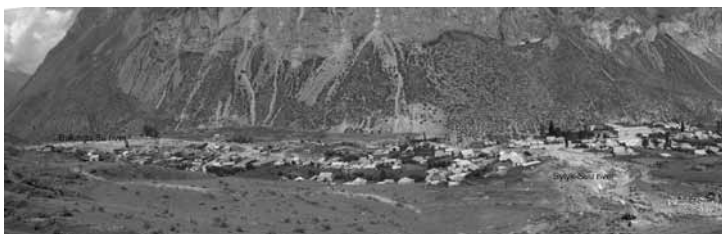
Fig 6 - 27 July 2010. View on the village of Bulungu (Upper Chegem)

On the right bank of the Chegem river, in the narrow strip of the terrace above the flood-plain lies the village of Bulungu, whose south-eastern outskirts suffered from the 2007 debris flow, which went down the Bulungu-Su river. The centre of the village is divided by the Sylyk-Su river. The last but one debris flow on the Sylyk-Su river took place 12 July, 1995, causing casualties and destruction. The last one happened 20 July 2010 (Fig. 6). It was forecast with an 8-hour earliness.

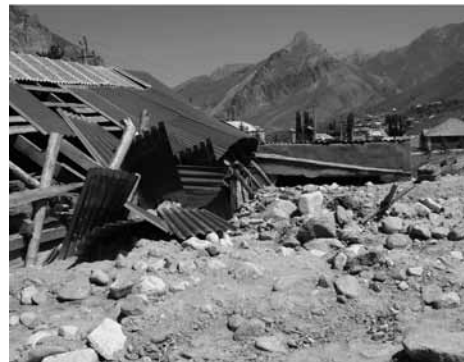
Fig.7 - 26 July 2010 The village of Bulungu. A destroyed house. The household plot is covered with debris flow deposits

The foremost swell of the 20 July 2010 mud-and-stone flow reached the vortex of the debris fan at about 8 p.m. The first approximately 100 m of the river channel did hold the incoming masses, but downstream the debris flow discharge surpassed the capabilities of the natural section, overflowed onto the village and through buildings and household plots reached the receiving river of Chegem (Fig. 7).

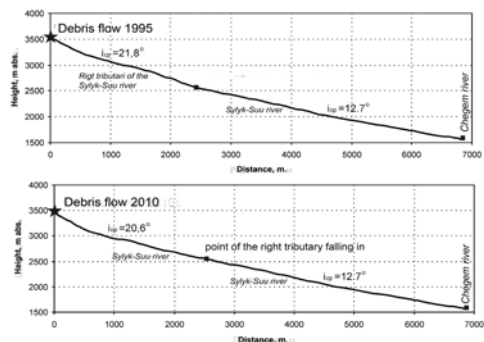
Fig.8 - The Sylyk-Su river basin. Profiles of the 1995 and 2010 debris flow channels

The volume of the material deposited within the village was estimated at 5000 m³. There was no erosion of the natural river channel upstream from the overflow site. The peak discharge of the flow determined at two representative profiles on this reach measured up to 190 m³/s (Tab. 3). Profiles of the 1995 and 2010 debris flow channels are given in Fig. 8.

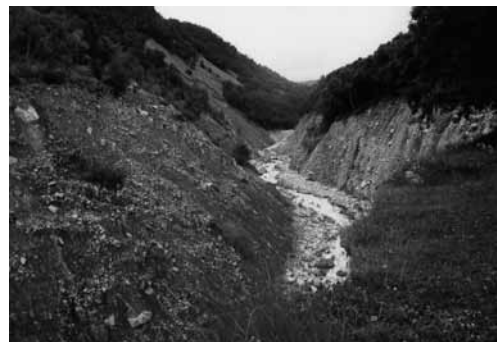
Fig. 9 - 31 August 2001. «Buzulgan» landslide (left side) which blocked the debris flow on 19 July 2000

Debris flows, originated in proglacial zones, before they come out to the mouth parts of movement channels (usually to the vertices of debris fans of similar processes of previous years), under the conditions of Central Caucasus region travel over a distance of up to 10-15 km. The flows re-form, disintegrate or on the contrary get enriched with hard material: it depends on morphological, engineering and geological peculiarities of bottoms and slopes of transit valleys. That's where they are "surrounded" with dangers of being blocked by sliding masses, caused by bottom and lateral erosion. Failure to take into account such circumstances may lead to an erroneous prediction of negative consequences and prescription of erroneous engineering protection measures. Thus, the damming of the Gerhozhan-Su river (the undercutting of the tongue part of the "Buzulgan" landslide 4 km above the outfall mouth section of the river with the first wave of the debris flow), the backing and further breach of the temporary earth dam led at the same time

to a more powerful (second) wave of the flow with disastrous consequences for the town of Tyrnauz, the deepening of the bottom of the river at the landslide front up to 20m to uncover the bedrock of crystalline shale and phyllite (Fig. 9). The long-living landslide massif is composed of strata of a tectonic fragmentation zone. (ZAPOROZHCHENKO, 2002; 2003).

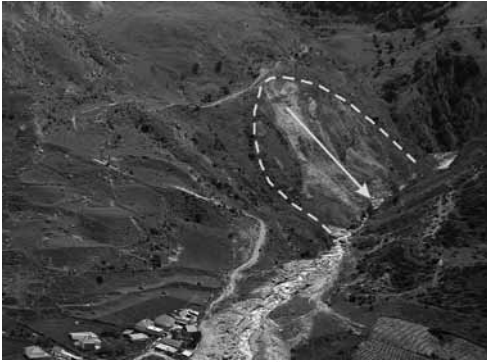
Fig. 10 - 3 August 2007. Active flank part of the "Bulungu" landslide. The right bank of the Bulungu-Su river at the debris fan near the village of Upper Chegem

The "Bulungu" landslide (limestone, marl) on the southern flank continuously advances into the channel at the vertex of the debris fan of the Bulungu-Su river (Fig. 10). As the opposite bank is composed of non-erodible hard rock here, the scale of surges may be such so that the river will not cope with the wash-out of landslide masses moving into it.

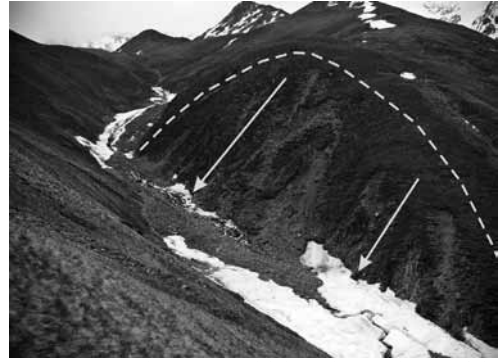
Fig. 11 - 17 July 2009. Landslide in the mouth part of the Rakyt-2 river at the time of activation, caused by the bottom and lateral erosion, creates backwater of surface runoff

A landslide (of clay slate) in the channel of a Rakyt river tributary (Fig. 11) was a triggering cause for a debris flow in the summer of 2008; it reached the mouth of the Bulungu-Su river and jammed the underbridge clearance of a motor road.

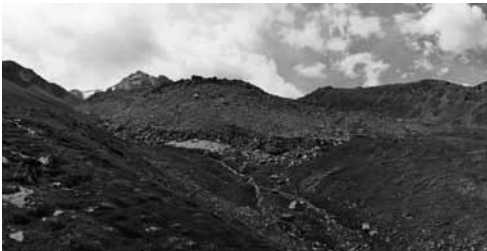
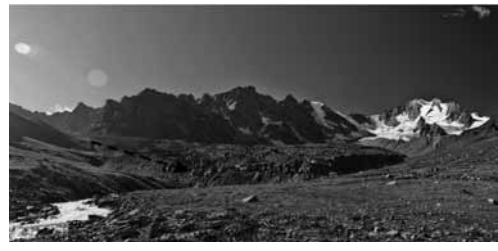
Fig. 12 - 17 August 2010. The moraine-ice complex advancing and blocking the C. Rakyt river valley.

Fig. 13 - 19 August 2010. The upper reaches of the Koru river. A moraine-ice complex advancing on the foreground and slopes of the valley. -----> direction of movement.

– a potential debris flow danger lurks in the interior of the so-called "dead ice" in the upper reaches of the C. Rakyt and Koru rivers. The advance of the "dead ice" onto the slopes and bottoms of the valleys, whereas generally there has been a retreat of open ice surfaces for the last 50 years, is evidenced from the turn of the century (Figs. 12, 13).
