## A STUDY ON THE PROPERTIES OF THE 12 MAY WENCHUAN EARTHQUAKE-INDUCED DEBRIS FLOW

**KEY WORDS:** debris-flow, field observation, development feature, Niujuan Gully

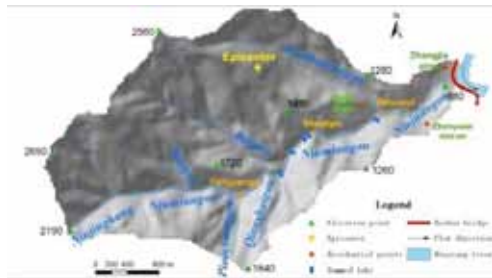
Fig. 1 - Three dimensional digital terrain map of Niujuan Gully

The Niujuan Gully is located in the transition zone from Longmen Mountains to Sichuan Basin, which is in the east edge of Tibetan Plateau and within the main fault belt of Longmen Mountains. The study area is dominated by alpine gorges within the coverage of E103°25'12"-103°28'31" and N31°01'21"-31°03'16". It is a vital traffic line, close to Wolong panda protection zone and 78 km away from Chengdu city. The terrain in the study area has a general trend of increasing altitude from south to north, with the difference in relative height more than 1833 meters. This area ranges in altitude ranging from 860-2693 meters and contains Alpine peaks and river valleys. The Niujuan Gully has a total drainage area of 10.46 km<sup>2</sup>, an altitude ranging from 860-2693m, 5.8 km of main channel length and a main channel mean slope of 3.16 percent. The Niujuan Gully includes 6 branch gullies that include Niujuinhang gully, Dao gully, Piao-chang gully, Qingshui gully, Bai gully and Lianhuaxin gully. Lianhuaxin gully, as the epicentre of Wenchuan Earthquake, is 3.77 km long with a average gradient of 3.16 percent, with high mountains, steep slopes and deep valleys (Figg. 1 and 2).

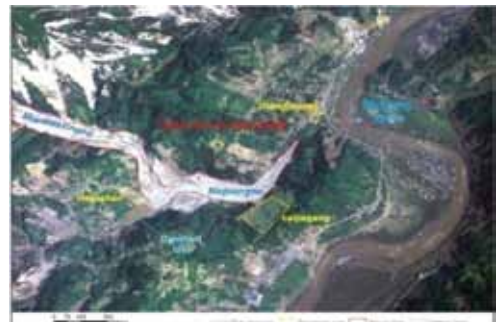
Fig.2 - ADS40 remote sensing image of Niujuan Gully, acquired on May 15, 2008
