VAL GENASCA LANDSLIDE (NORTH ITALY): AN EXAMPLE OF THE METHODOLOG USED FOR THE IDENTIFICATION OF THE LANDSLIDE MAIN FEATURES AND ITS MONITORING

EXTENDED ABSTRACT

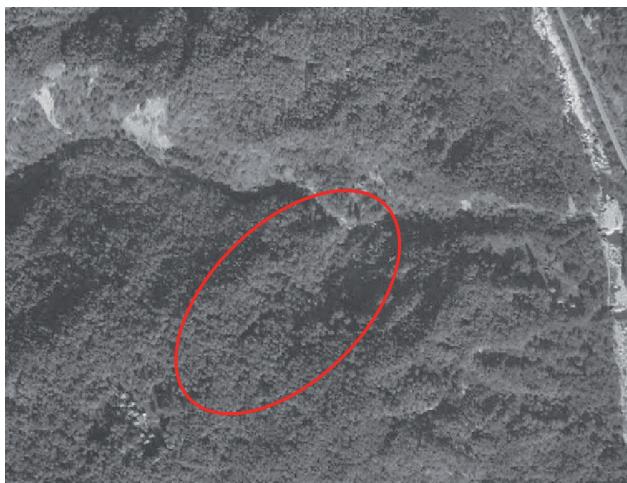
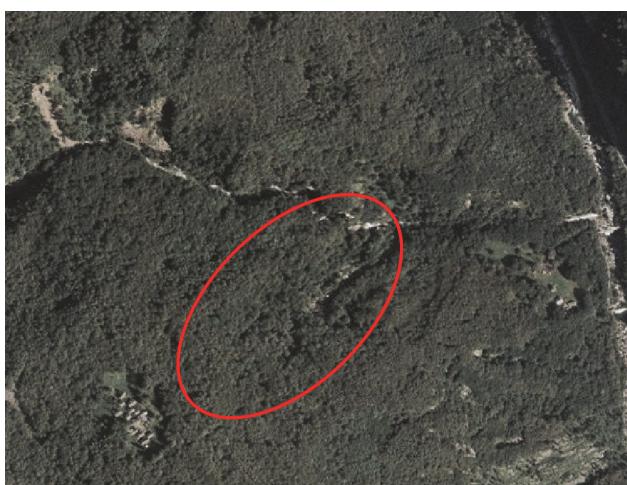
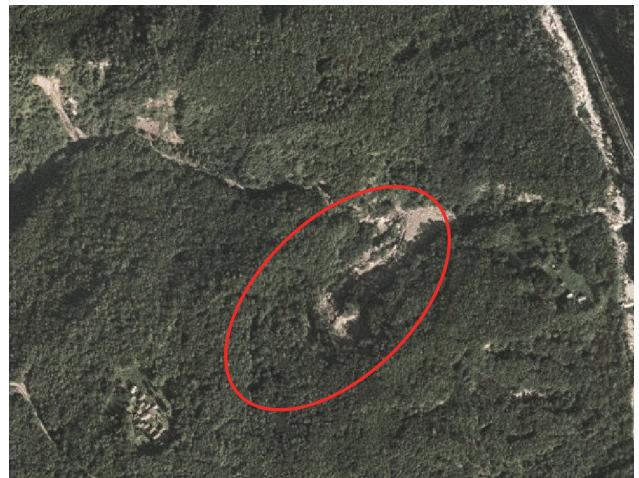
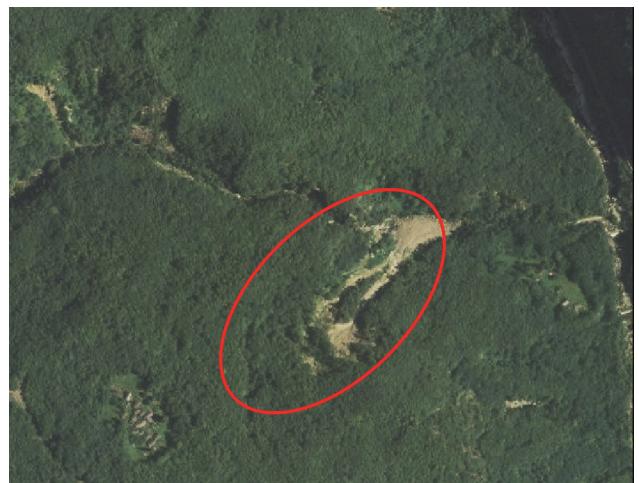
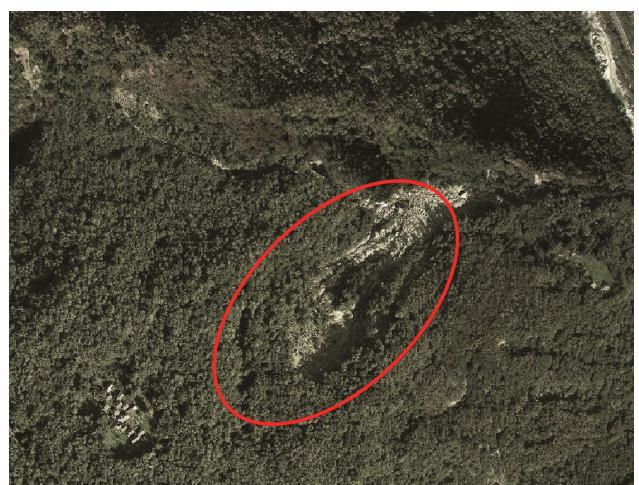
Fig. 2a - Aerial view 1994: orthophoto Environment Ministry

Fig. 2b - Aerial view 1999-2000*: orthophoto IT 2000 (* photo Blom CGR Spa)

Fig. 2c - Aerial view 2003*: orthophoto IT 2000 (* photo Blom CGR Spa)

Fig. 2d - Aerial view 2006*: orthophoto IT 2000 (* photo Blom CGR Spa)

Fig. 2e - Aerial view 2008: Aerial photo, DB Sondrio Municipality

A summary of these events is attempted on the basis of aerial photographs by the University of Milan (Prof. T. APUANI), in relation to the agreement with ARPA Lombardia concerning activities of geotechnical modelling and identification of critical thresholds, which states that the first event of slippage has started between 1994 and 2000 (Fig. 2a-e). Subsequently, the instability has evolved involving portions of the slope upstream and along the sides, showing in the end a trend of evolution as retrogressive landslide and in enlargement.

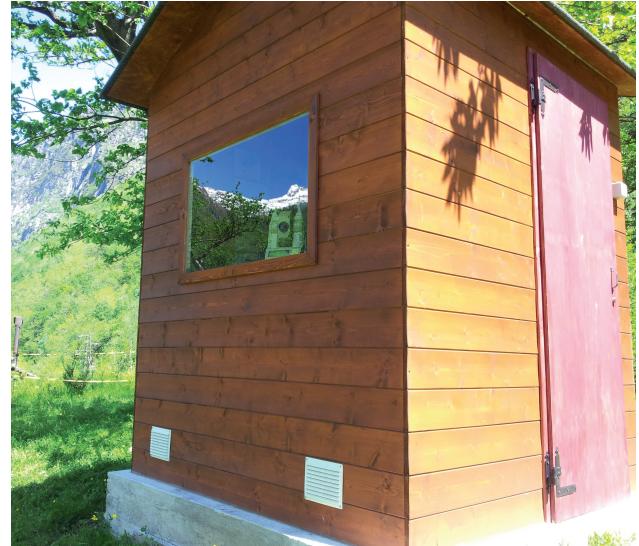
Fig. 3 - Automatic topographic station

The location of topographic measurement has been structured to perform continuous measurements for a more extensive control of the landslide surface. In this regard, after bringing the power line to the point of measurement, a shelter for the station with an anti-theft system (Fig. 3) was built. A series of measurement points on the area of the landslide have been implemented so as to be able to monitor, in addition to the whole landslide, even the areas nearby.

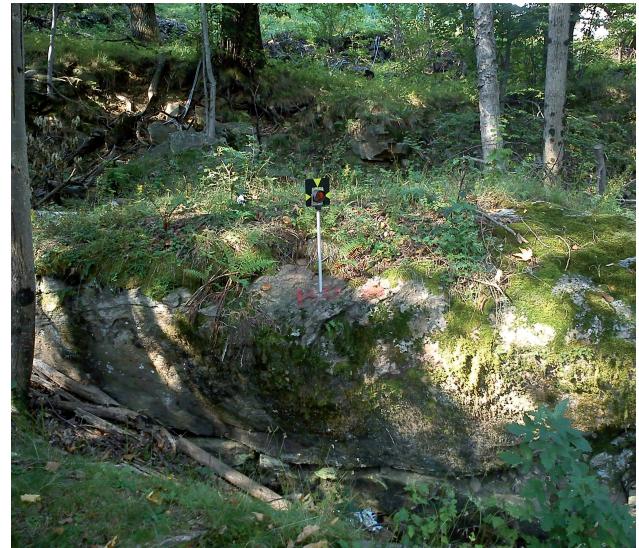
Fig. 4 - Topographic target in landslide

STEPS 1 and 2: after a careful survey of the slope movement it was possible to place 5 distometric chains to control the movements of the upper side, located in the middle part of the main scarp and on both sides, left and right parts of the landslide. These distometric chains, positioned along the line of maximum movement (substantially N-NE, orthogonally to the individual micro areas isoline), have taken into account the possibility of measuring in a different way both the movements of the main scarp (if present) and the back fractures. At this stage, with the support of Mountain Guides, a series (Fig. 4) of optical reflectors (both inside

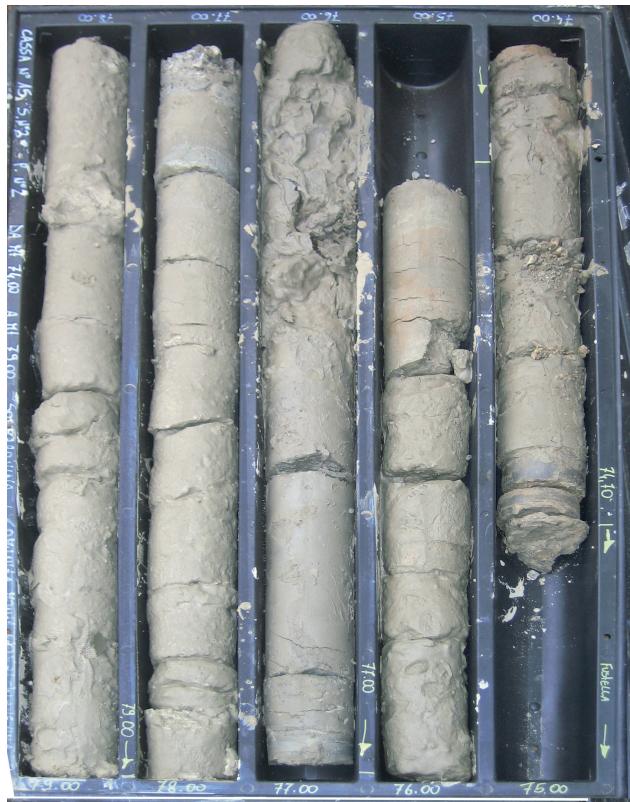
Fig. 8 - Silty layer found in the center landslide drilling at depth between 67.00 and 82.50 m

ARPA has developed a drilling project that would allow to investigate and subsequently equip with inclinometer tubes, piezometric tubes and DMS column, some vertical drills upstream and within the landslide. The stratigraphy, obtained from continuous core drilling, relative to the survey site upstream of the main scarp of the landslide (survey up to 130 meters from the ground level) and within the landslide (survey up to 102 meters from ground level) showed a powerful non-consolidated coverage both upstream and downstream of the scarp where a layer underlies, interpreted as an ancient slide deposit, consisting primarily of crushed rock and broken blocks with interbedded sand and silt. In both holes, before reaching the weathered rock (consisting of mica schists and altered paragneiss) and the bedrock, there is a level, with a bigger thickness in the landslide, which consists mainly of silt (Fig. 8).

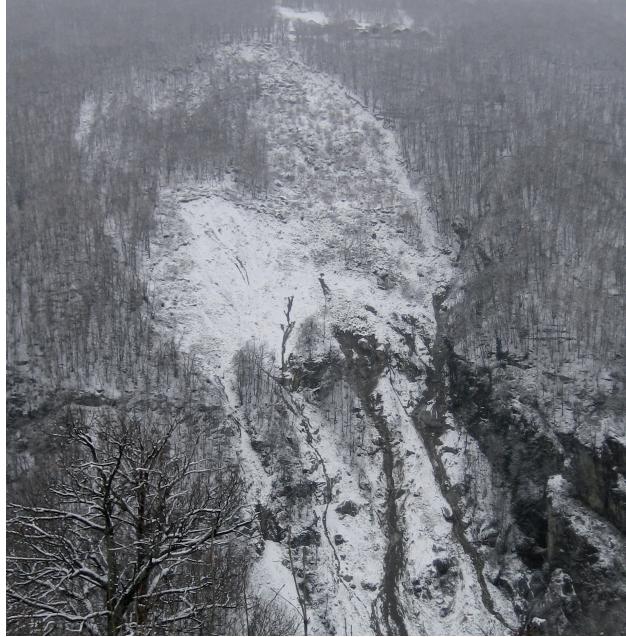
Fig. 25 - Frontal view of landslide; snow highlights springs in the lower sector

stratigraphy, bounded downstream from contact with the bedrock close to the water springs (Fig. 25) is present on the bottom. On the basis of this model, the volume of paleo-landslide has been
