## GALLIVAGGIO LANDSLIDE: THE GEOLOGICAL MONITORING, OF A ROCK CLIFF, FOR EARLY WARNING SYSTEM

LUCA DEI CAS<sup>(\*)</sup>, MARIA LUISA PASTORE<sup>(\*\*)</sup> & CARLO RIVOLTA<sup>(\*\*\*)</sup>

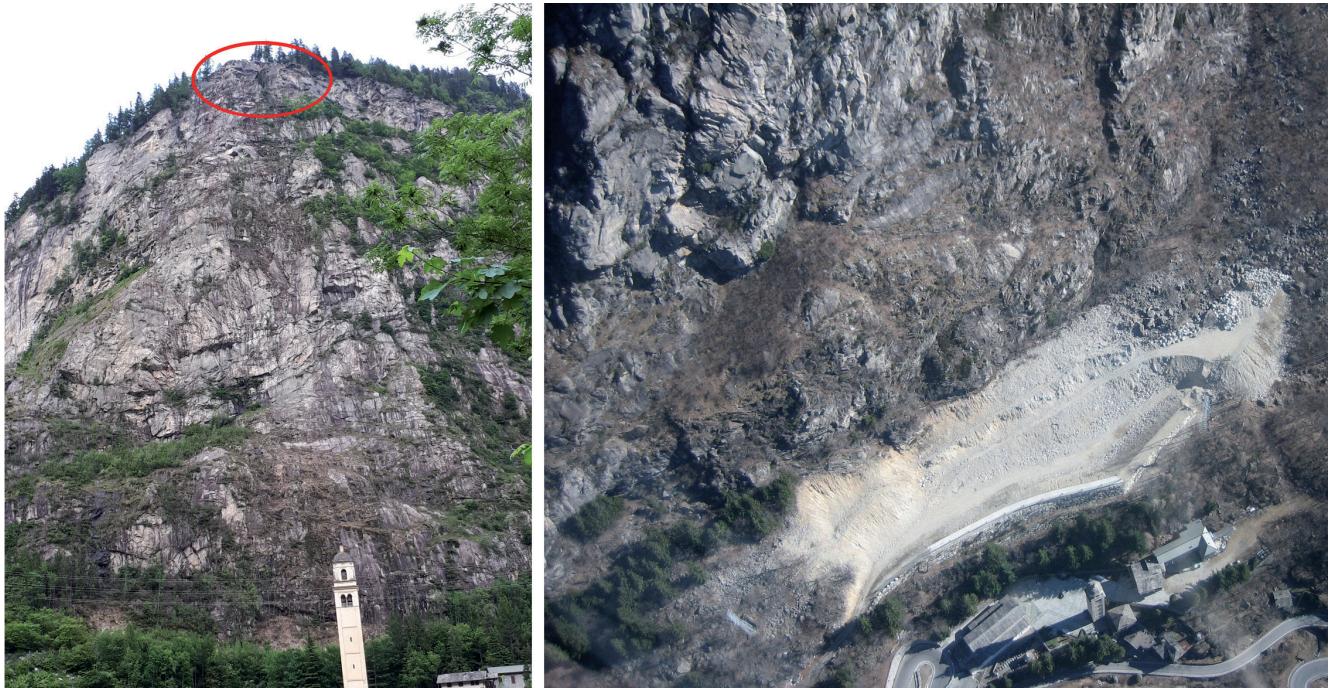
Fig. 2 - Pictures of the entire failing slope. The photo on the left shows rock cliff behind Sanctuary of Gallivaggio's bell tower and the red oval highlights the landslide detachment area. The photo on the right, taken from helicopter, shows rock cliff, Sanctuary of Gallivaggio and national route 36

occurred (FERRARI *et alii*, 2011). The aim of which was to protect the important heritage site of the Sanctuary of Gallivaggio, the houses, restaurant and road (national route 36) (Fig. 2)

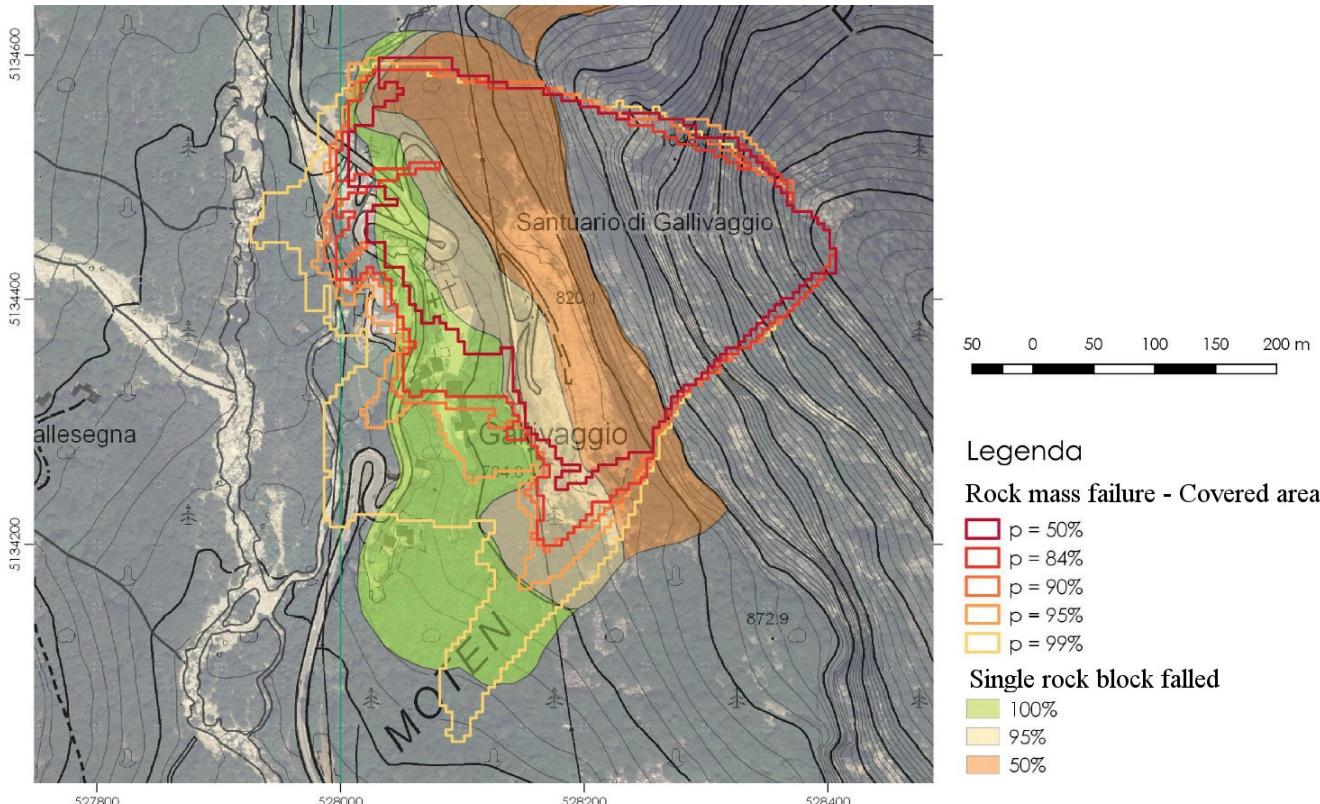
Fig. 3 - Cartography forecast for rock mass failure and single rock block failure (CANCELLI *et alii*, 2017)

The first scenarios consist of the falling of 5-6000 cubic meters of bedrock (Truzzo granite complex) present at the top of the rock wall and marked by a large fracture. The forecast of the areal distribution of the deposit was made by DAN3D software (MORGAN, 2005). The most realistic analyses - which signifies, the most precautionary one - reveals areas overlaid with a probability (CORMINAS, 1996) of not exceeding 95% or 99% for mass collapses (Fig. 3).

As you can see in Fig. 3, the different coloured lines represent

the landslide's changeable probability boundary. It is clearly evident why the infrastructure and cultural heritage Sanctuary are threatened by treacherous proximity the rock mass failure. The scenario triggers were fixed with three velocity thresholds (Tab. 1):

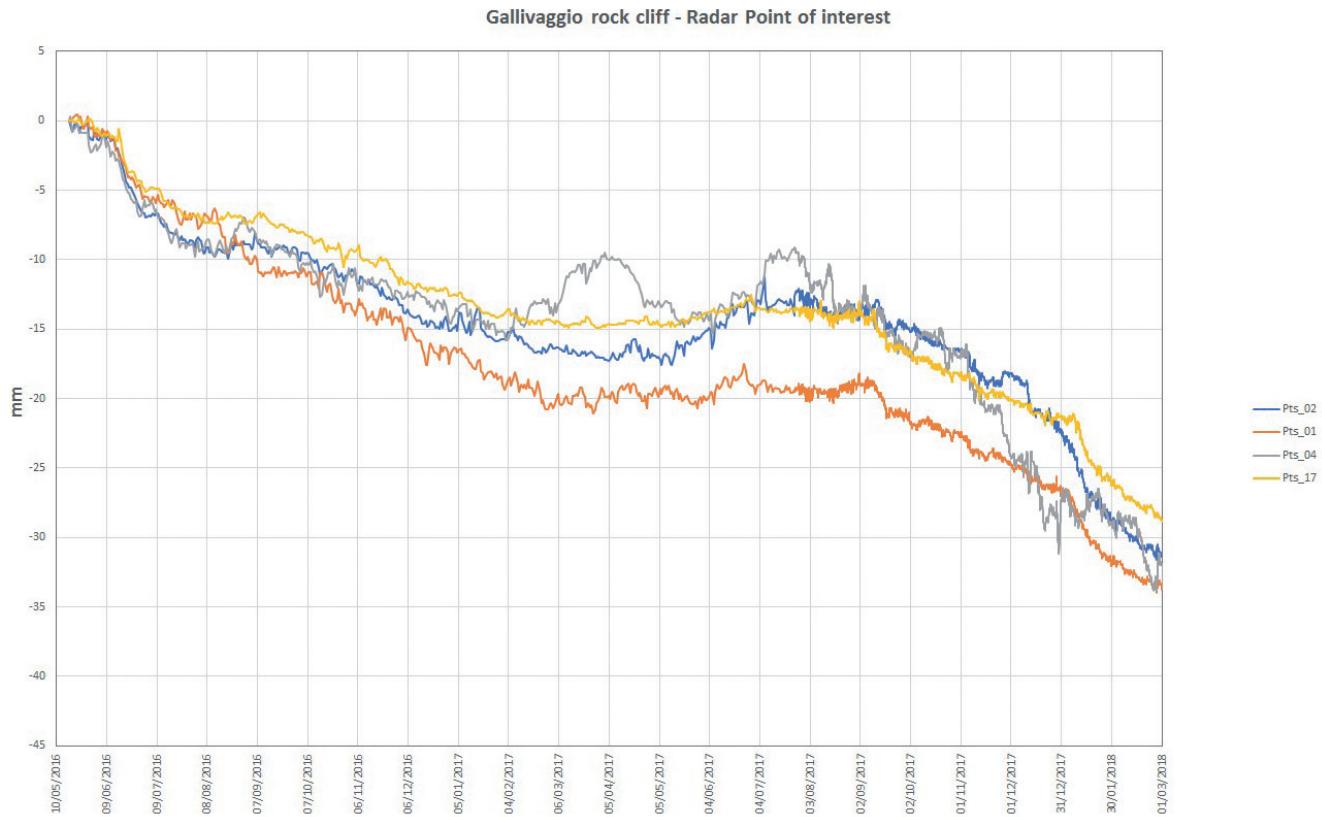
Fig. 4 - Correlation between noticed capacity and calculated capacity

During the autumn of 2017 the data analysis values acquired by the ground based SAR radar, enabled CMG to notify the Lombardy Region Civil Protection of a dangerous acceleration of movement of about  $460 \text{ m}^2$  of rock area. Rock activity, is shown in selected points of interest during winter 2017/2018 in Fig. 4.

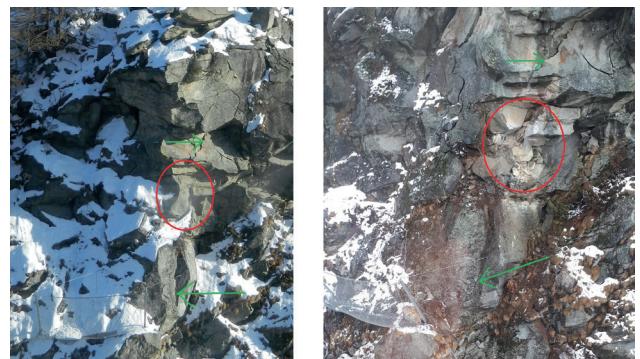
Fig. 5 - Area of rock block detached April 13<sup>th</sup>. The photo on the left, was taken on December 2017 by G. Merizzi and the photo on the right was taken on 13<sup>th</sup> April. The red oval highlights the area affected by the detachment, the green indicators are highlighting the same places

At 8 o'clock that morning, a single block of about 2 or 3 mc, detached from the upper part of the rock cliff (Fig. 5), rebounded and stuck the Sanctuary, the bell tower and the road below.

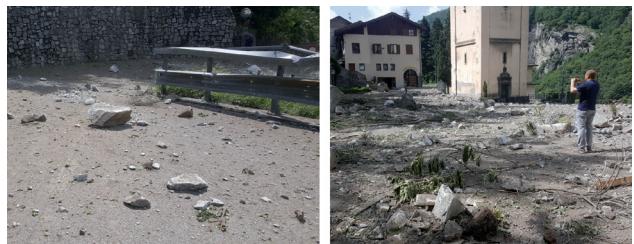
Fig. 6 - On the left: the road after the event. On the right: the area outside the Sanctuary

On 24<sup>th</sup> of May the ARPA's Geological Monitoring Centre sent the Civil Protection, notice that the trigger thresholds had been exceeded (at first moderate and then high criticality) and the road was closed indefinitely. At 4 p.m. on the 29<sup>th</sup> of May, the CMG send the last notice in which they informed the Civil Protection that the rock mass was close to failure. 35 minutes later the landslide came down (Fig. 6).

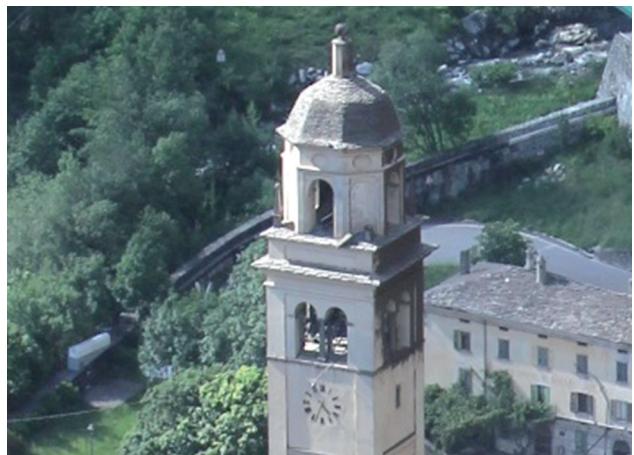
Fig. 7 - The bell tower at 6 p.m. of 29<sup>th</sup> May

It was interesting to observe (Fig. 7) how the forcible pressure of the dust cloud, made an evident mark high up on the bell tower. The dust cloud was also responsible for stopping the clock.

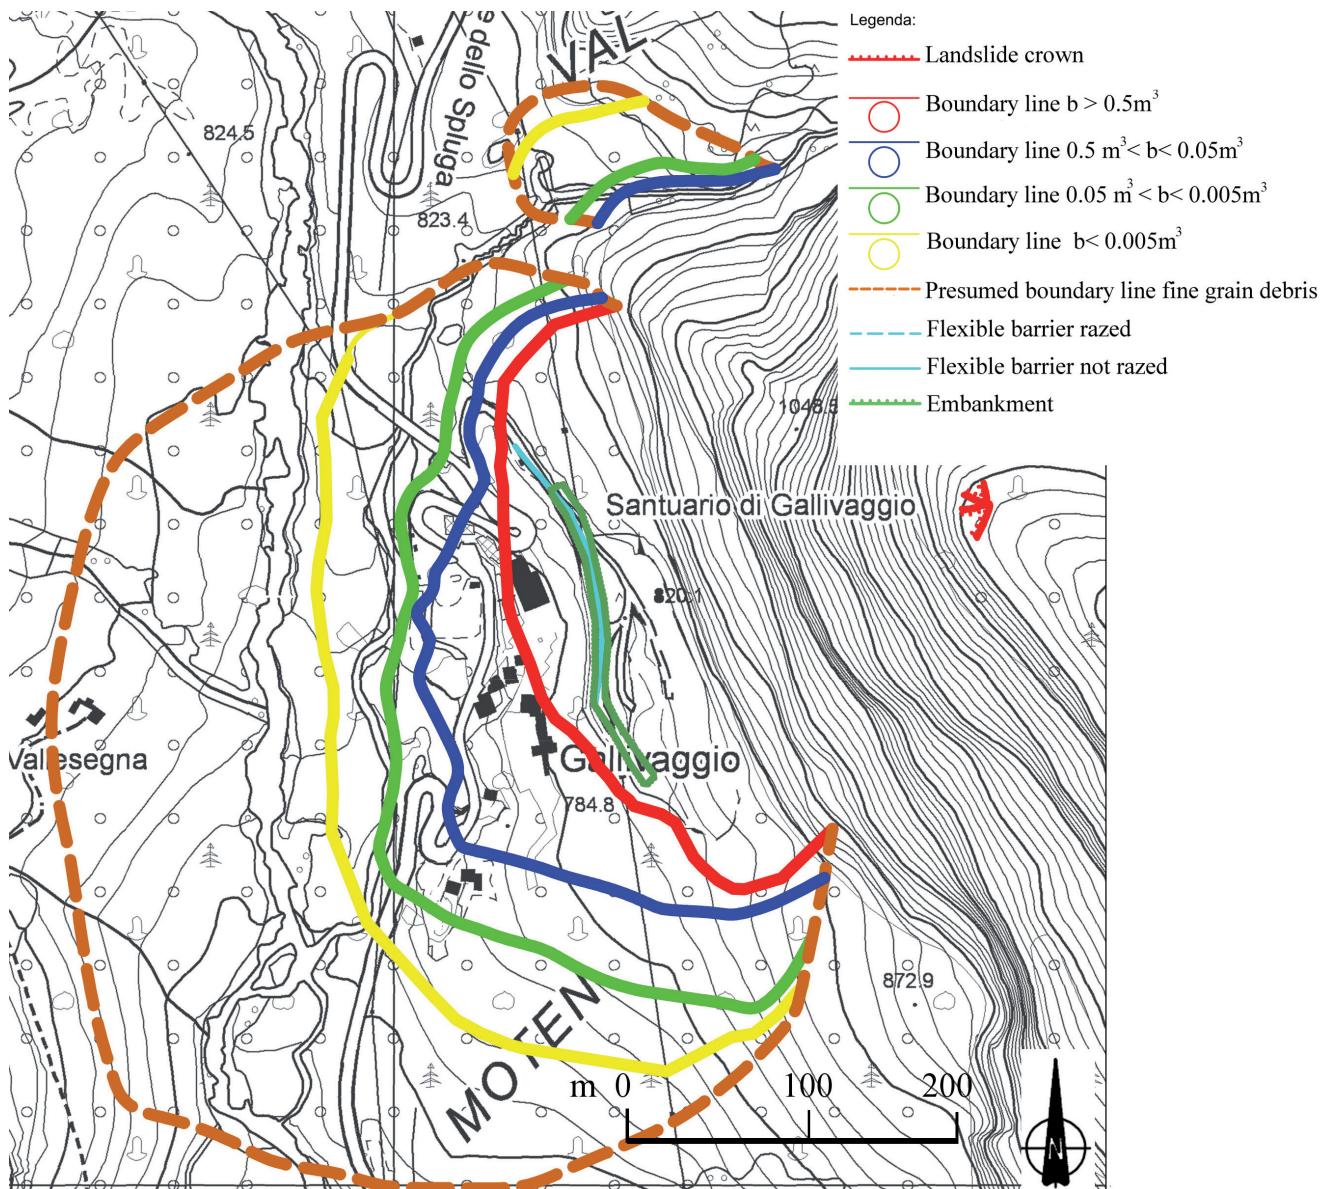
Fig. 8 - On the left: the road after the event. On the right: the area outside the Sanctuary

presented an accurate distribution description of the size of the blocks (Fig. 8).

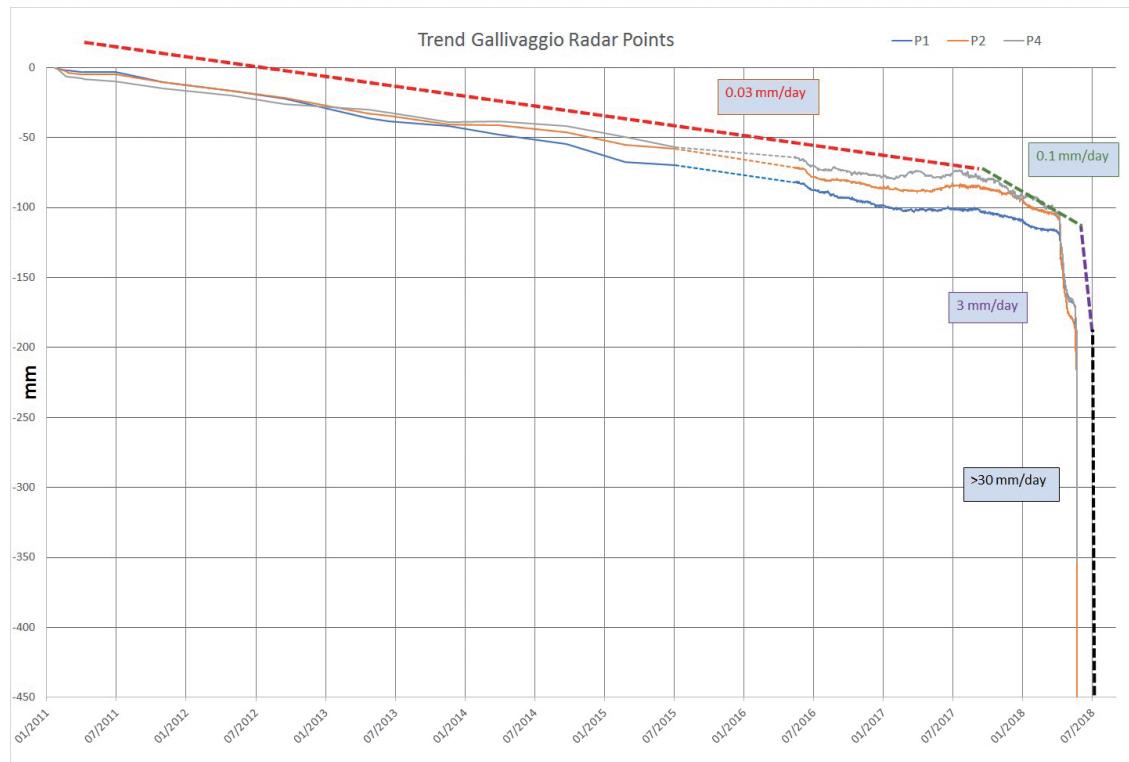
Fig. 9 - Graph pluriannual displacement at some single virtual points on the rock cliff. With red, green and black dashed line the average displacement

shown in the next graph (Fig. 9), represent the displacement at some points located in the active area of the rock cliff. It represents only a few data values, acquired in each scan by the ground based SAR, out of thousands of values measured on the maps. When the displacements were small (under 16 mm/y) “extremely slow” (CRUDEN & VARNES, 1993) the interferometric analysis was set every 2 hours and 30-40 minutes even if the system revisiting time was 2.5 mins. This method of processing “radar scans” removed excessive environmental noise. With displacement rate from 0.03 mm/d to 0.1 mm/d (as from 2011 to winter of 2018) the data updated was set every 6 hours in

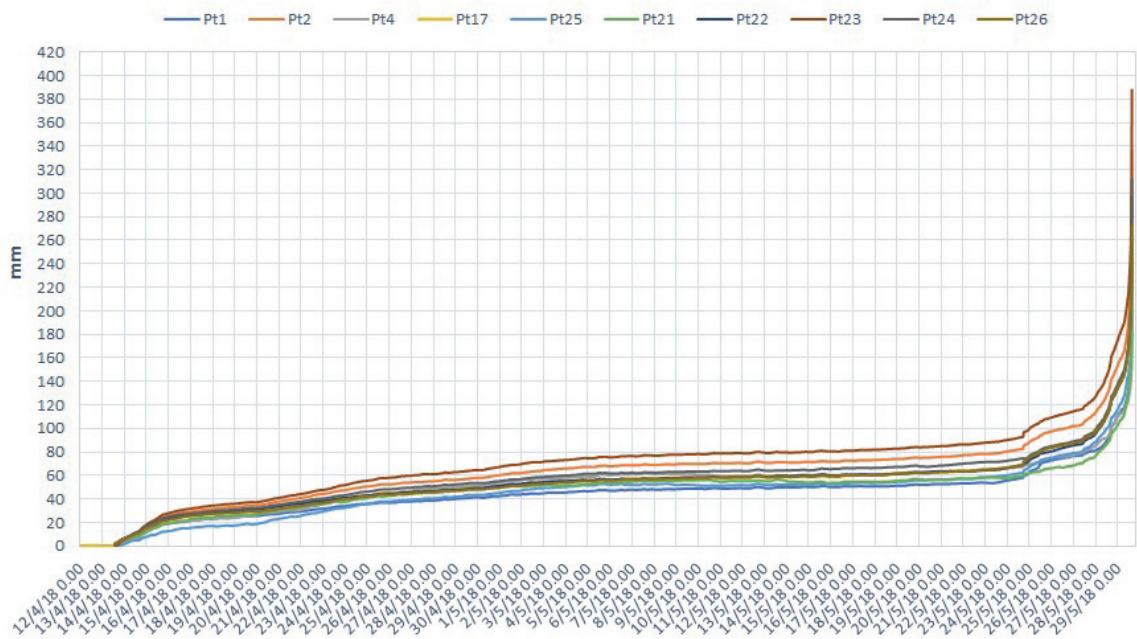
### Gallivaggio Radar Points Displacements from 12nd April 2018 to 29th May 2018

Fig. 10 - Displacement (measured on the radar Line of Sight) of some single virtual points on the rock cliff during the period April 12<sup>th</sup> to May 29<sup>th</sup>

between 24.1 cm and 38.8 cm. (Fig. 10)

It is also possible to see how the different points of interest have the same movement trend. They don't have the same data values because the orientation between LOS and movement direction is different or because they belong to different parts of the moving area affected by differential movements. In Fig. 10 it's interesting to notice that the displacement shows the typical asymptote curve of the falling landslide.

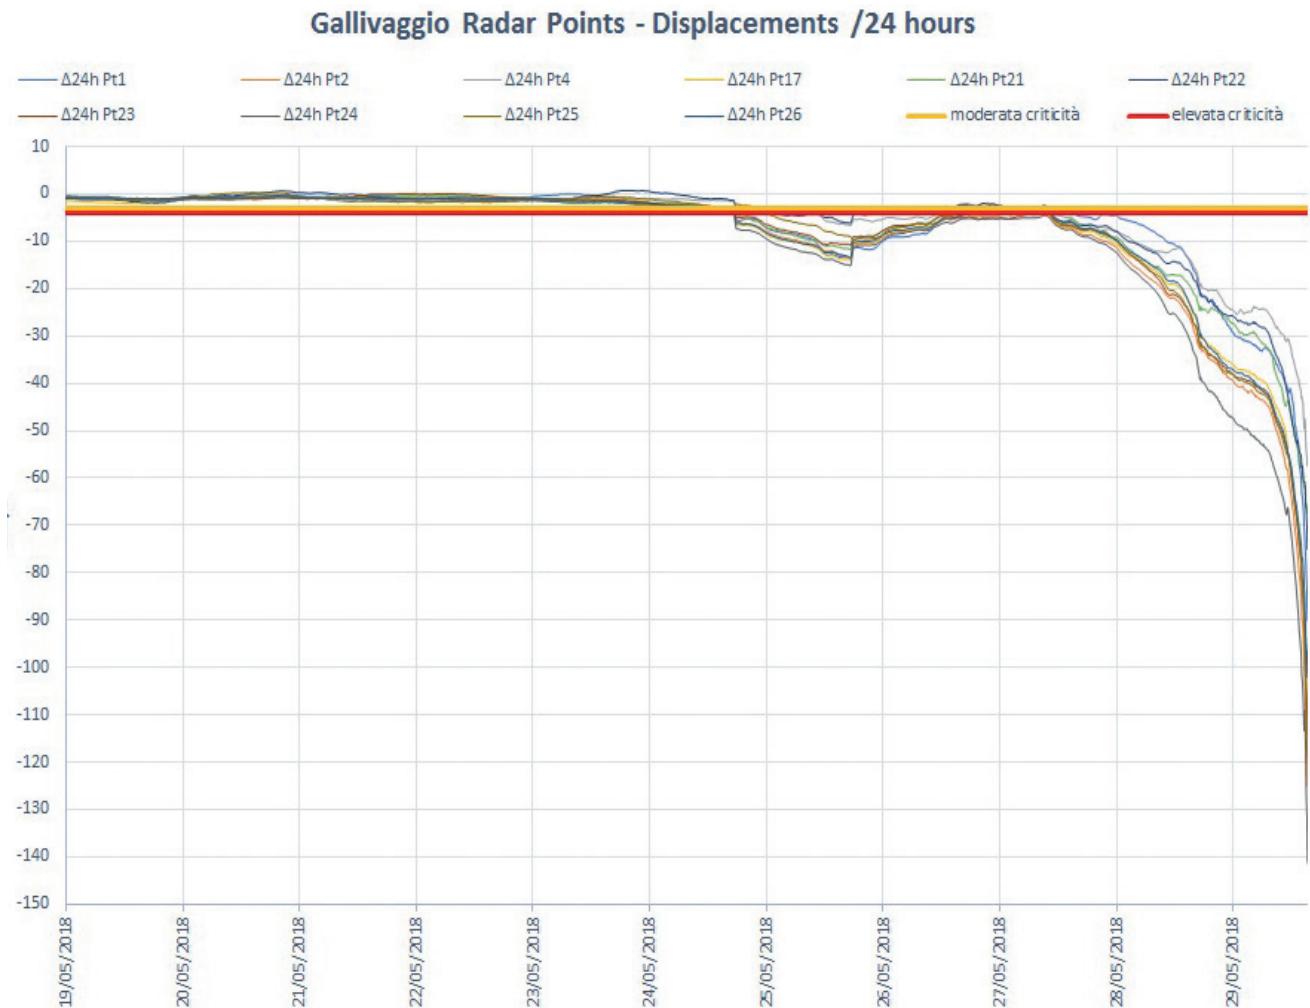
Fig. 11 - Displacement at some virtual points during last 10 days. Using red and yellow horizontal lines highlighting the velocity trigger thresholds

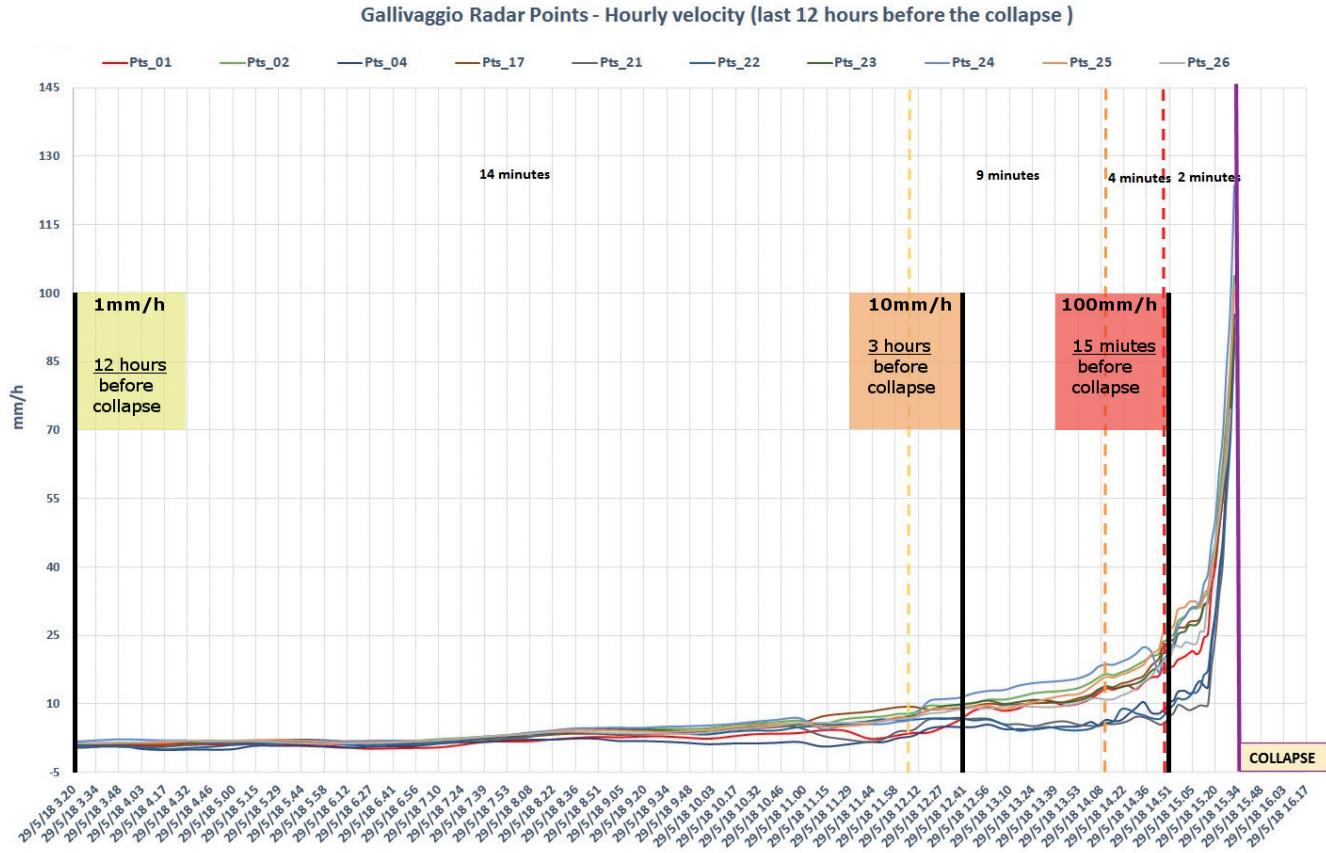
Fig. 12 - Hourly movement velocity, measured on the radar Line of Sight, at some single virtual points on the rock cliff. The highlighted dotted lines indicate periods of different interferometric frequency analysis

In the minutes prior to failure, see the end of the lines in Fig. 12, the SAR data measurements updated the frequency, increasing to a new value every 2 minutes and 30 seconds using every single radar scan. During the very last minutes (aprox. 20) when the failure was imminent, the displacement velocity was so high that even with a revisiting time, of only 2 minutes and 30 seconds, the values were affected by phase wrapping effect.

After the unwrapping process, the real hourly velocity graph can be drawn (Fig. 12). The graph line shows us the exponential increase (1 mm/h at 4.20 a.m., 10 mm/h at 1.25 p.m. and 100 mm/h few minutes before failure); in the last hour the displacement of different virtual points were between 7.5 cm and 12 cm with average hourly velocity of about 10 cm/h.

If we use the Preonzo trigger threshold (official alarm) with the data values acquired by Gallivaggio monitoring system, we can see (Fig. 12) that we should have informed population about landslide at 9 o'clock a.m. of the May 29<sup>th</sup> (about 7 hours and 30 minutes before the failure). With the Gallivaggio trigger threshold we informed population about the landslide 5 days and 8 hours before collapse.

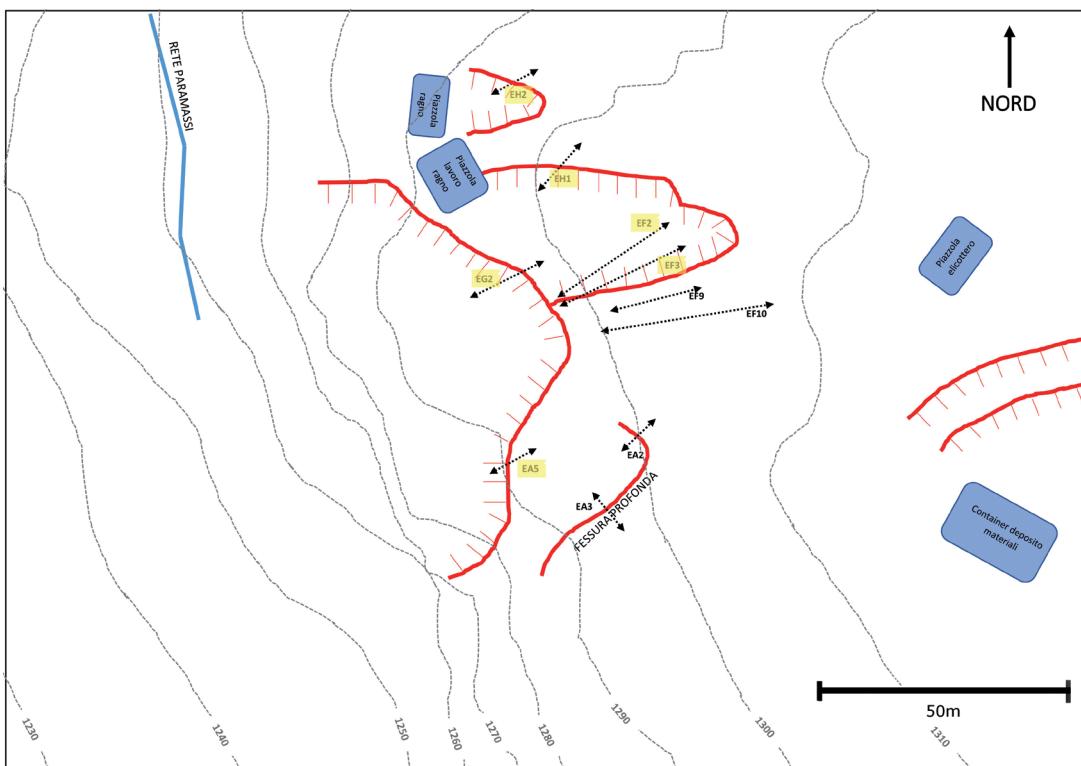
Fig. 13 - Schematic map that show the extensimeter positioning. (A. Pavan)

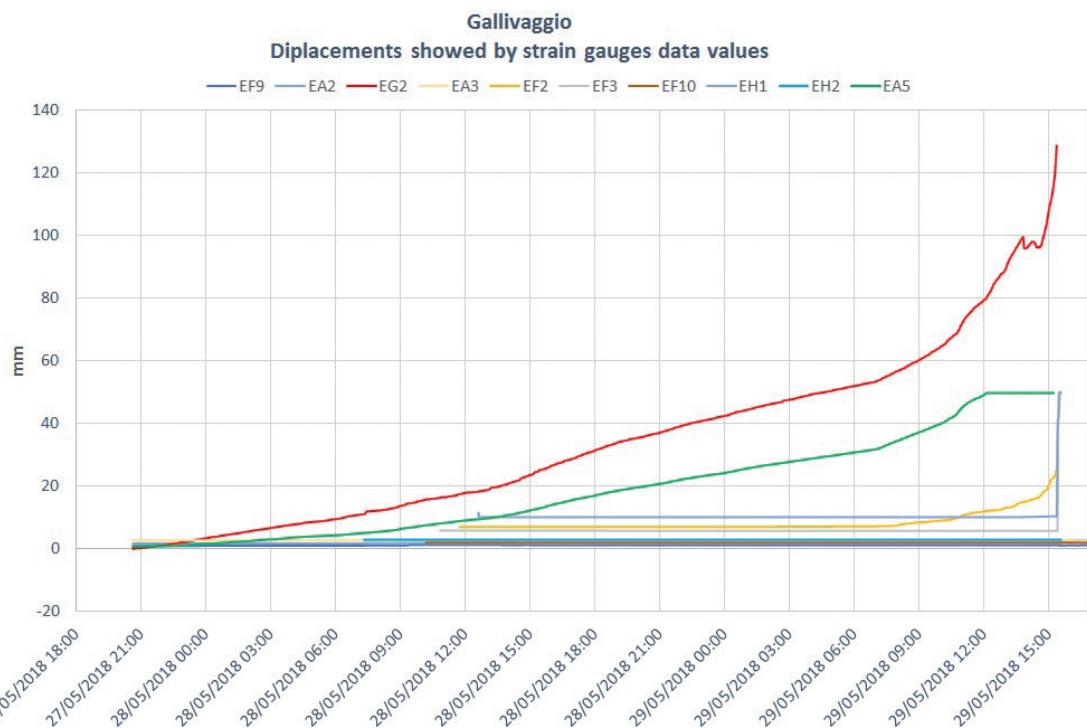
Fig. 14 - Displacement showed by data values acquired with strain gauges located behind and across the main fracture

Using the strain gauges data values (Fig. 14) and by observing the numerous failure video clips, the following considerations can be made:

- until the morning of May 29<sup>th</sup>, there was no displacement in the area behind the main fracture. The only movements acquired by strain gauges (EG2 and EA5) were across the main fracture;

- from the morning of May 29<sup>th</sup>, data values acquired by strain gauge (EF2) showed a displacement. At first it was slow and then it became faster and faster. Both strain gauge EF3 and EF2 share the same lower level anchorage on a rock block located immediately behind the main fracture. Between 4.21 p.m. and 4.28 p.m. strain gauges EF2 and EF3 reached the end of the stroke. At the same time the strain gauge EG2 broke. During the first few minutes of the afternoon data values, acquired by EG2 looked like the displacement had stopped. This situation confirmed that the displacement had begun to appear behind the main fracture as "retrogressive" displacement, but only in the areas nearest to the main fracture. On the other hand, data values acquired by EH2 and EH1 showed no displacement until after 4.23 when EH1 began to move (EH2 showed no displacement until the collapse);

The collapse of the main rock mass caused the detachment of single rock blocks starting after a few seconds from the main failure. Before the main collapse these rock blocks were stationary as can be confirmed from looking at the data values acquired by strain gauges (Fig. 14).

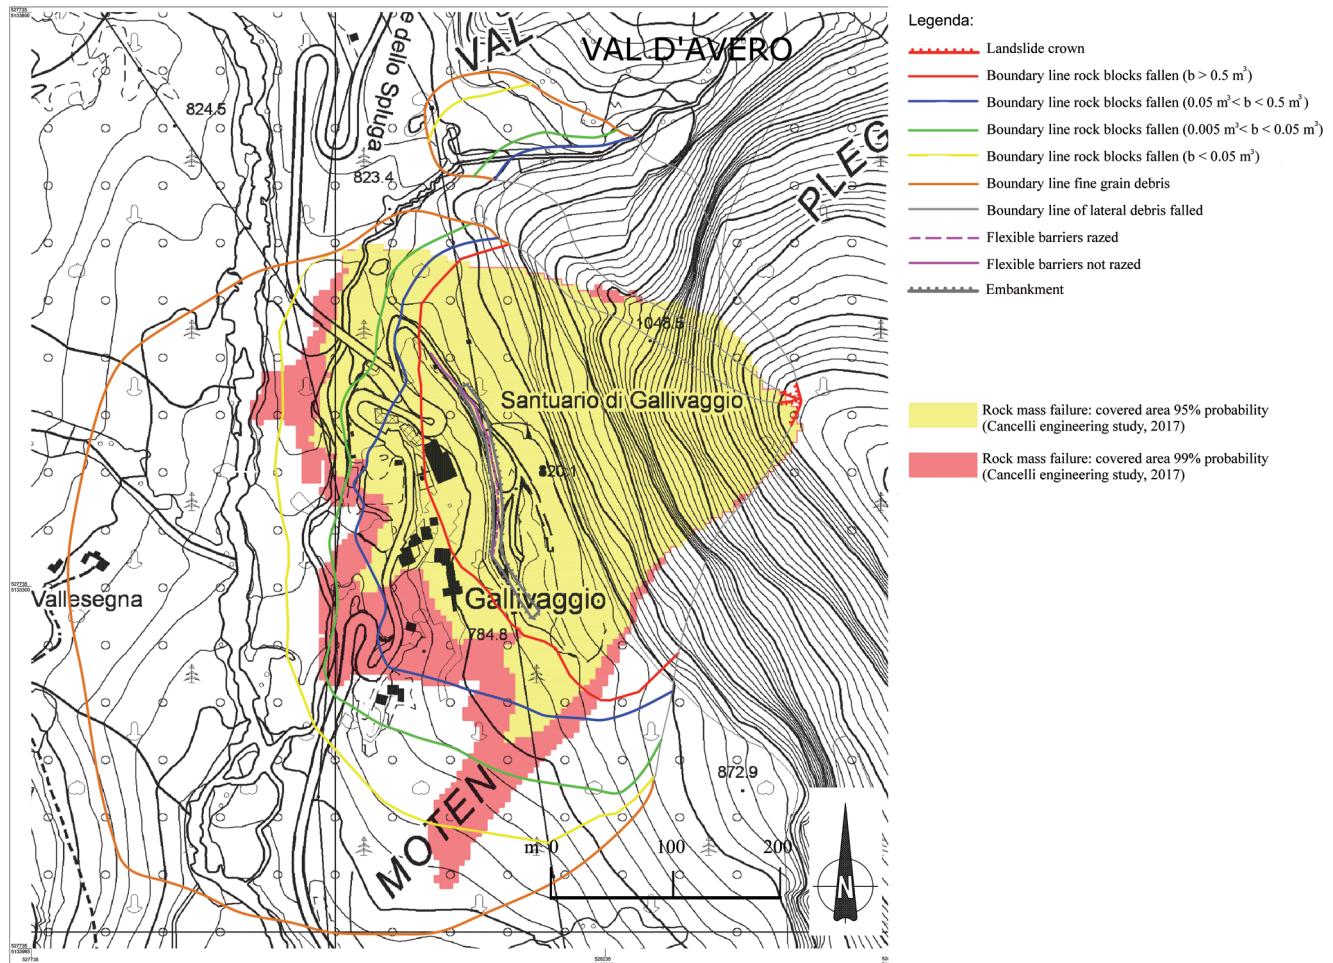
Fig. 15 - Overlapping between forecast of covered area, with 95% or 99% of not exceeded, and areal distribution of the deposit seen after the rock mass failure. (A. Priore - N. Petrella - A Pavan)

For a rock mass failure, the forecast for the areal distribution deposit, made with 99% probability of not exceeding, shows (CANCELLI *et alii*, 2017) quite accurately what happened. This overlapping is especially clear in the area between Val D’Avero bridge and the hairpin bends south of the restaurant (Fig. 15).

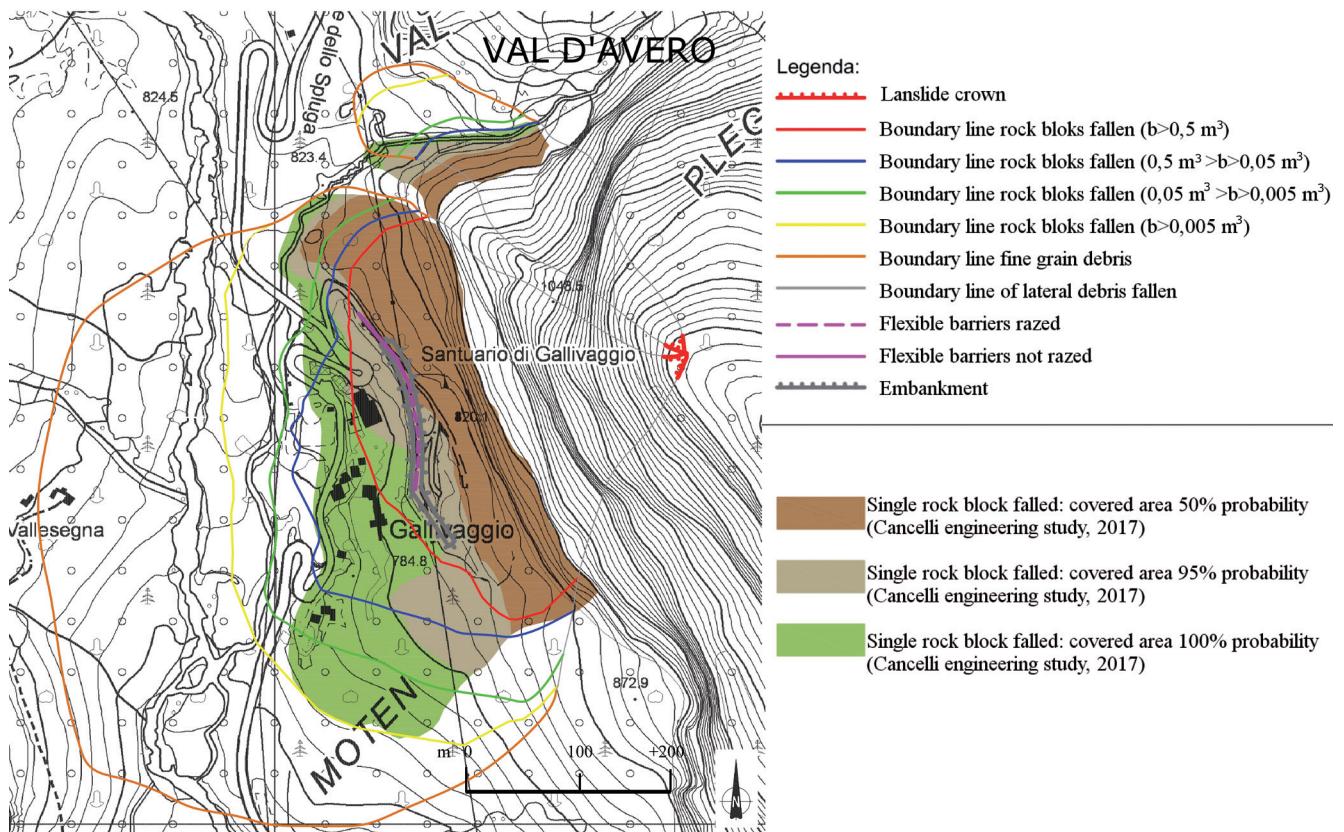
Fig. 16 - Overlapping between forecast for single rock block fall (covered area, with 50%, 95% or 100% of probability), and areal distribution of the deposit seen after the rock mass failure. (A. Priore - N. Petrella - A Pavan)

Therefore, the modality of failure of the rock block which reached Val D’Avero was more similar to the single rock block fall than to rock mass failure. If this is true, it is important to notice how the forecast made in 2017, for the single rock block fall, shows that the Val D’Avero area is one of the areas affected

by block falls (Fig. 16).
