CHARACTERIZATION OF CALCARENITIC STONES IN MONUMENTAL MASONRY BUILDINGS OF COSENZA (ITALY)

The aim of this study is to analyze the deterioration of the stone commercially known as “Mendicino calcarenite”, used for the building of two important portals in Cosenza (Italy), belonging to the Church of “San Francesco di Paola” (XVI century) and “Palazzo Bombini” (XVII century), evaluating, by means of site and laboratory tests, changes in petrophysical and mechanical properties.

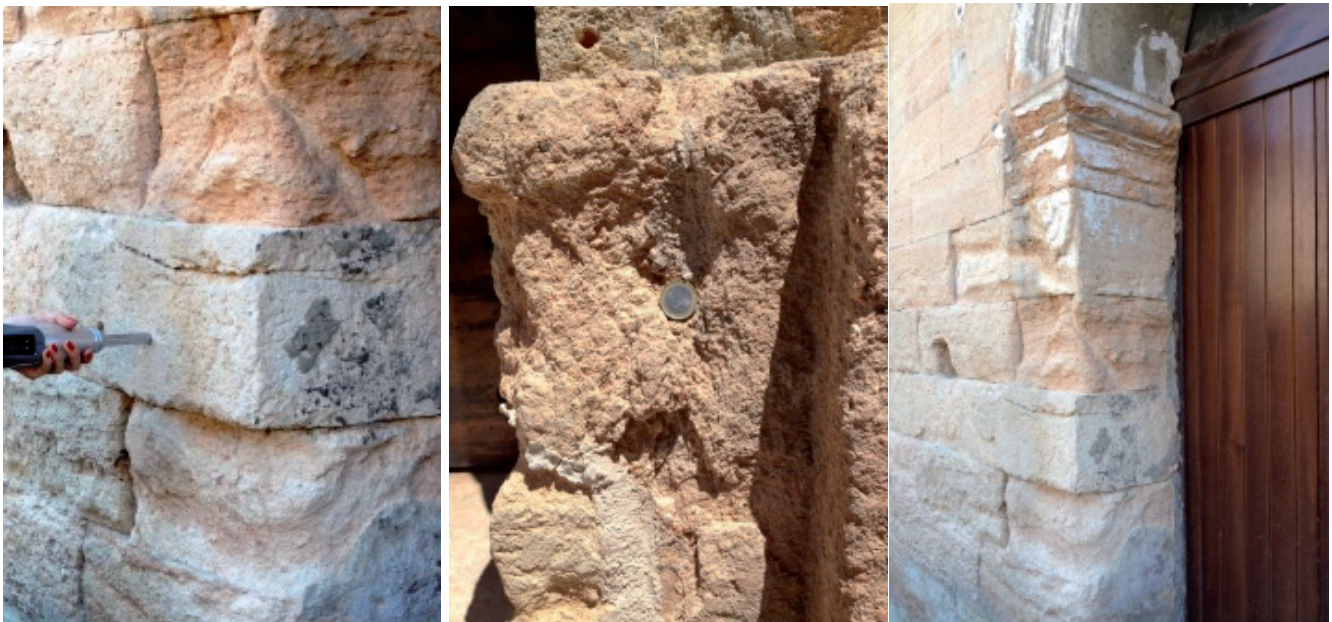
Fig. 3 - Operative phases about: the Schmidt hammer test (Fig.3); the sample “San Francesco_01” belonging to lower part of the left portal’s pilaster of the Church of “San Francesco di Paola” (Fig.4); the sample “Bombini” belonging to the right abutment of the Portal of “Palazzo Bombini” (Fig.5). All the samples have been in-situ tested through the Schmidt Hammer Hardness Test and analyzed by chemical-morphological laboratory analysis

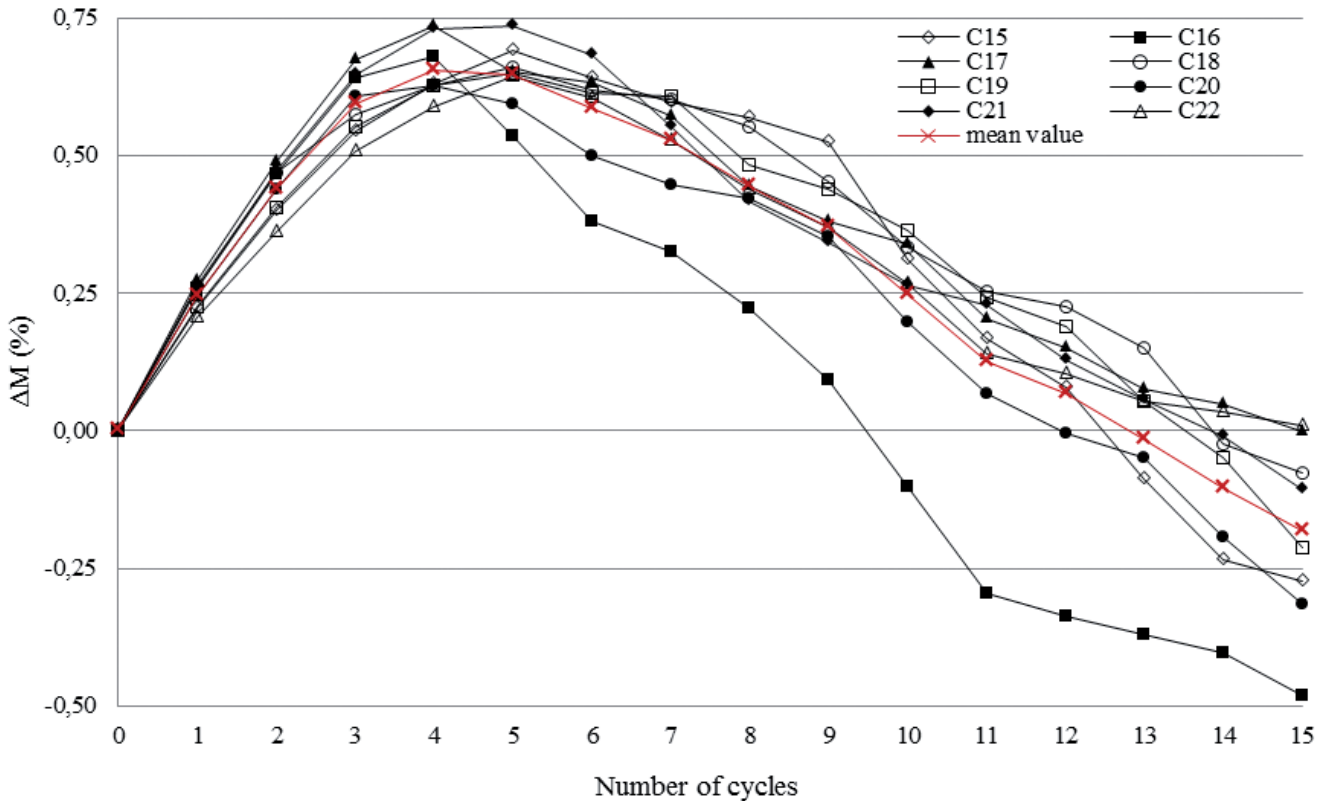
The results of the salt crystallization test are reported into a graph (Fig. 11) showing the curves relative to the modification trend of specimens' weight within the fifteen cycles. The weight variations (ΔM%) for each cycle, at the end of the fifteenth cycle

Fig. 11 - Binary diagram showing the weight variation (ΔM%) of specimens during salt crystallization test

(Δ_{15}) and after washing (Δ_f) are reported in the Table 2. During the first five cycle, all specimens are characterized by a slight mass increase, due to the crystallization of salts within the pore structure. The maximum value of mass increase from the initial weight is 0.74% for the sample C21. From the sixth cycle, can be observed a mass loss (which is particularly evident from the tenth cycle) and the specimens begin to degrade, mainly exhibiting smoothing of corners and edges, granular disaggregation and selective degradation dependent on fossil fragments. At the end of the fifteenth cycle the specimens display an average weight loss of -0.18% with maximum value of -0.48% for the sample C16. The final average weight loss after water washing is -0.24%. The sample C16 at the end of the test has broken. The Fig. 6 shows the sample C16 at the beginning and at the end of the salt crystallization test while the Fig. 10(f) displays the specimen C16, analyzed both by SEM analysis, at the end of the salt crystallization test.

Accelerated aging tests show that the studied calcarenite is sensitive to degradation induced by salt crystallization. The mass loss during the test mostly depends on the open porosity of 16.18+0.81% determined in a previous study (FORESTIERI *et alii*, 2015 b). As known, in fact, only the open pores are interested by salt crystallization so that the higher open porosity the higher amount of salts which crystallize causing the disaggregation of the sample and the consequent mass loss (ANANIA *et alii*, 2012). The calcarenite of this study is characterized not only by high porosity but also by a chemical composition dominated by calcium carbonates, which, as known, gives the rock a high susceptibility to acid attack by gaseous atmospheric pollutants (ZAOUIA *et alii*, 2015). The result of the interaction between calcarenite and atmospheric pollutants is accompanied by structural degradation. The most frequent weathering minerals in our investigation are gypsum and salts of Na, Cl and K. It can be said that their crystallization is responsible for most of the damages in the monuments investigated as in the calcareous monumental stones of the Mediterranean region exposed to weathering agents (ZEZZA, 1993).
