## MERCURY: MULTI-PLATFORM MONITORING SYSTEM FOR RAILWAY INFRASTRUCTURE SAFETY

The MERCURY project aims to develop an innovative multi-platform monitoring system designed to support the inspection and maintenance of regional railway infrastructures, with the ultimate goal of implementing a Decision Support System (DSS). This objective is achieved through a modular and scalable framework capable of integrating data from different sources. MERCURY addresses the critical need for regional railway operators to have a flexible tool that responds to the specific geological and structural vulnerabilities of the territories they traverse. Optimising maintenance procedures is essential for averting critical conditions that could compromise passenger safety, while simultaneously minimising costs related to line downtime and manual on-site inspections. This study discusses the preliminary results obtained following the in-situ installation of a sensor network (comprising flat jacks, capacitive probes, crack gauges, and strain gauges) in the Scrajo locality, situated within the municipality of Vico Equense (Naples, Italy), along the Circumvesuviana railway network. This site was selected as a

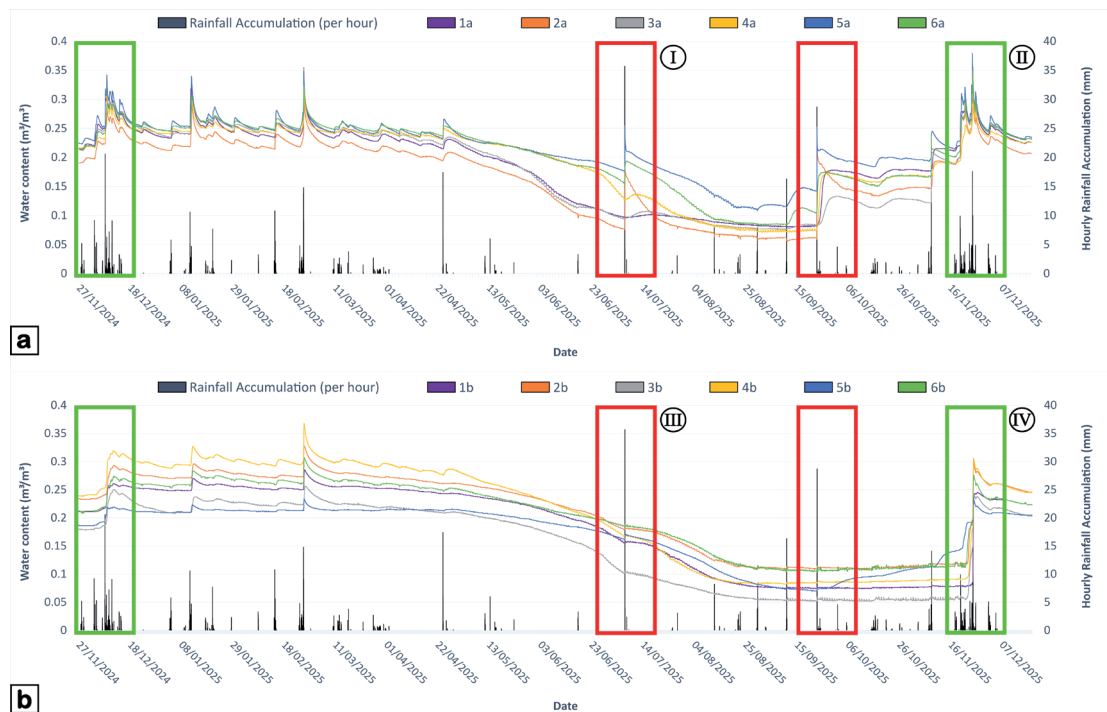
Fig. 5 - Water content measured by capacitive probes in relation to hourly rainfall accumulation. Sensors placed 40 cm above ground level (a); sensors placed 80 cm above ground level (b). The red box indicates high-intensity but short-duration rainfall events, while the green box indicates moderate-intensity but longer-duration rainfall events

Figure 5 presents a comparative analysis of water content and precipitation for sensors positioned at depths of 40 cm (designated 1a–6a) and 80 cm (designated 1b–6b) below ground level. A preliminary analysis of the trends indicates that water content remained relatively stable throughout the winter and spring; subsequently, a significant decrease was recorded until the following autumn, attributable to limited precipitation (as illustrated in Figure 5b, which highlights data from the instrumentation at the 80 cm depth).

Notably, a strong correlation is observed between rainfall events and variations in water content at both monitored depths. Indeed, a clear correspondence exists between precipitation peaks and increases in water content, even during the

Typical examples of the latter include the events recorded on 7<sup>th</sup> July 2025 (35.7 mm in one hour) and 23<sup>rd</sup> September 2025 (28.7 mm in one hour). During these instances (highlighted by a red box in Figure 5), only minimal variations in water content

were registered by the shallower sensors (40 cm), while variations in the deeper sensors (80 cm) were negligible. In contrast, long-duration, low-intensity precipitation triggered significant variations across all sensors. Examples of this behaviour occurred during the periods from 3<sup>rd</sup> to 14<sup>th</sup> December 2024 (150 mm total rainfall) and from 18<sup>th</sup> November to 5<sup>th</sup> December 2025 (163 mm total rainfall), as indicated by the green boxes in Figure 5.

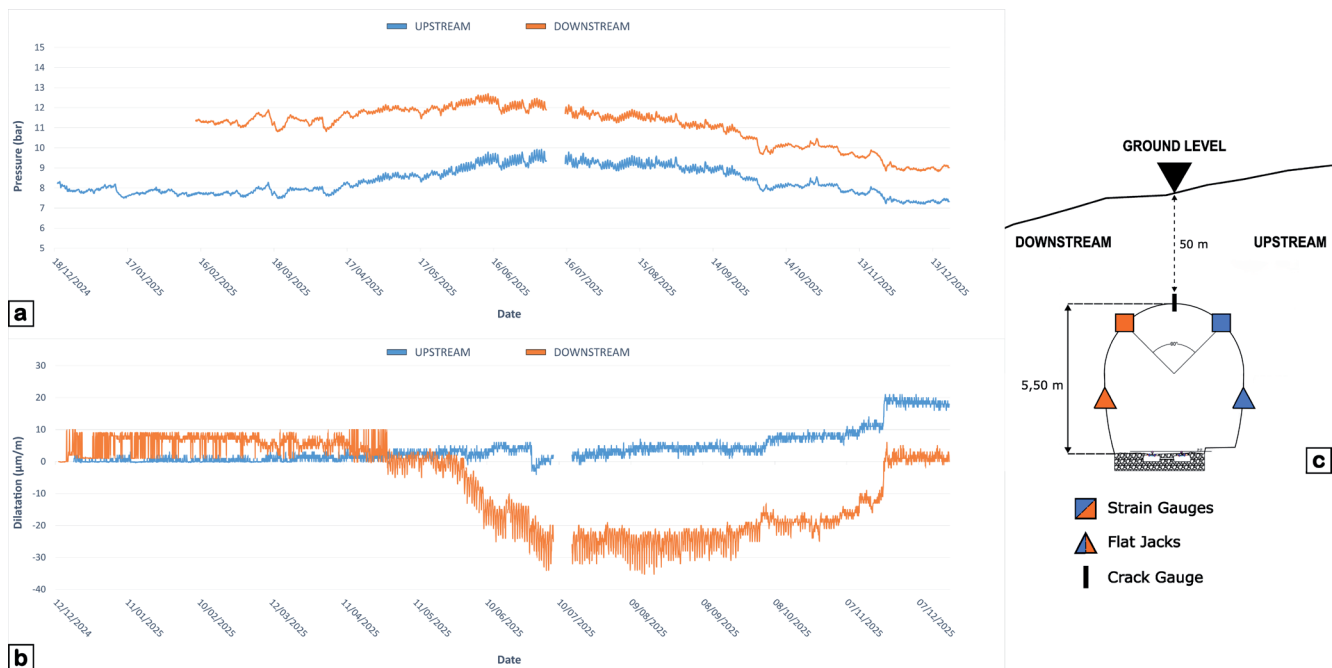
Fig. 7 - Monitoring of the stress state of the tunnel carried out through (a) flat jacks; (b) strain gauges; (c) schematic cross-section of the tunnel showing sensor locations

Figure 7 presents the recorded stress states of the tunnel sidewalls via flat jacks (Fig. 7a) and the tunnel vault via strain gauges (Fig. 7b), both installed at upstream and downstream positions; this instrumentation was subject to continuous monitoring throughout the study period.

Regarding the flat jacks, no significant structural concerns were identified; indeed, pressure variations remained limited to less than 10% for both sensors over the entire year. This pressure

variation is likely attributable to the thermal expansion of the surrounding rock mass, driven by high solar radiation during the spring and summer months. Given that the rock cover overlying the tunnel is approximately 50 m thick, the seasonal rise in rock temperature accounts for the increased pressure observed in the sidewalls; as the rock enclosing the tunnel undergoes expansion, albeit minimal, it leads to a rise in the tunnel's confining pressure. This process, captured by the flat jacks, resulted in a pressure increment of approximately 1.5 bar across both instruments. With the onset of autumn and the subsequent return to cooler temperatures and reduced solar radiation, a corresponding decline in pressure values is observed.

While the seasonal trends in both datasets indicate overall structural stability, a significant deformation was recorded by the downstream strain gauge beginning on 29/04/2025 (Fig. 7b). These parameters returned to near-zero expansion conditions by 22/11/2025. This specific behaviour will be the subject of further investigation once a subsequent seasonal cycle has been observed and analysed.
