PERIODICO di MINERALOGIA
established in 1930

The Baroque architecture of Scicli (south-eastern Sicily): characterization of degradation materials and testing of protective products

Cristina Maria Belfiore^{1,*}, Giusj Valentina Fichera¹, Mauro Francesco La Russa²,
Antonino Pezzino¹ and Silvestro Antonio Ruffolo²

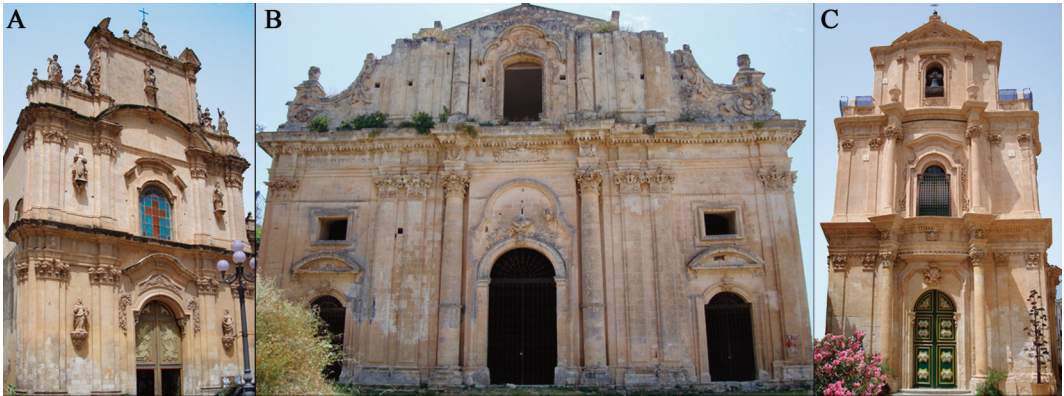
Figure 2. Façades of the three investigated churches: a) Carmine; b) St. Matteo; c) St. Michele.

The churches investigated in this work include: a) the Church of Carmine, built in the first half of the XVIII century, has one of the most beautiful façades of the entire Baroque architecture in eastern Sicily; b) the Church of St. Matteo, representing the symbol of Scicli, dates back at least to the XI century. Strongly and irreparably damaged after the earthquake of 1693, it was rebuilt since 1703 for an entire century, even if the main façade was never completed; c) the Church of St. Michele Arcangelo, probably built between 1740 and 1750, was completed only in 1859 (Cataudella, 1988).
