Analytical study of Coptic wall paintings in Egypt, El-Bagawat necropolis, Kharga Oasis: a case study

Ahmed Abo El-Yamin¹, Hussein Marey Mahmoud^{2,*} and Atef Brania²

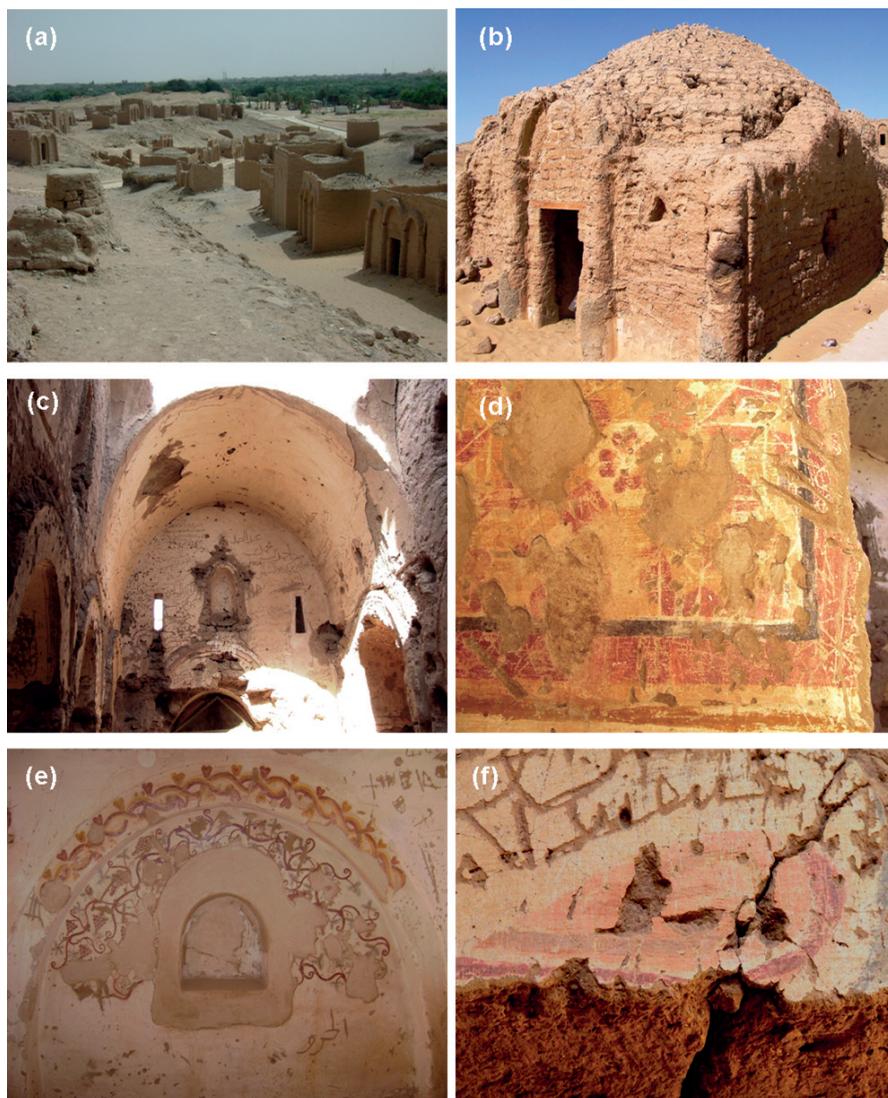
Figure 2. a) General view of chapels of the El-Bagawat necropolis. b) An individual chapel shows one of the patterns found in the necropolis. c, d) Plastered fault and paintings of the chapel (No. 25) at the necropolis. e) An example of the wall decorations at the chapel (No. 210) at the necropolis. f) The state of conservation of the wall paintings at the necropolis.

The wall paintings of the studied chapels show several deterioration forms such as cracking, blistering and detachment of the painted layers. As a result of the state of preservation of the murals, fifteen (15) tiny samples of the detached painted plasters were carefully collected and chosen for analysis. In addition, five (5) representative mud brick samples were collected in order to determine their chemical and mineralogical composition. Table 1 shows codes, description and location of the studied samples.

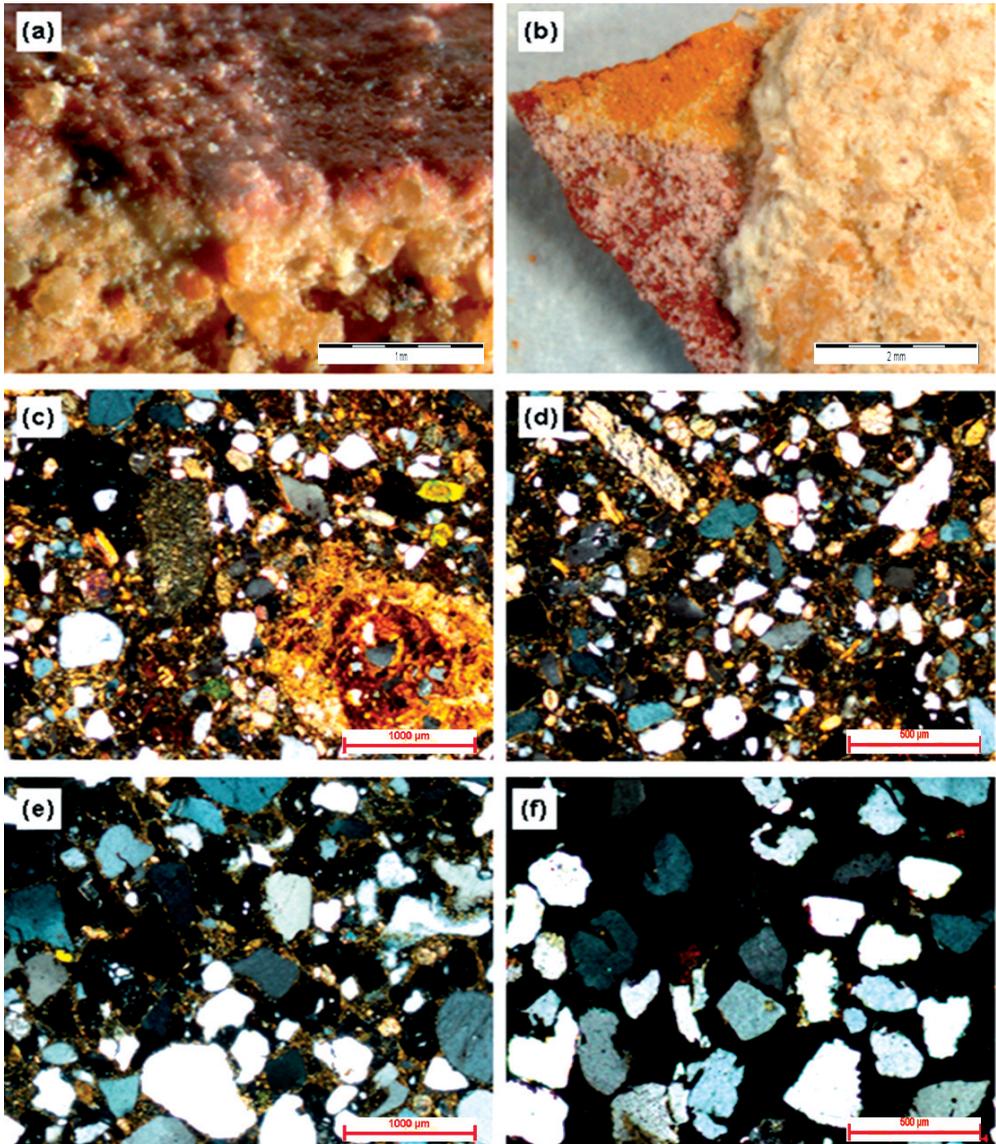
Figure 3. a) Stereomicroscopic image of polished cross-section of the plaster layer showing the stratigraphy of the different layers. b) Stereomicroscopic image showing details of the outer surface of the ground layer. c, d) Optical photomicrograph of thin sections prepared on the fine plaster layers, under cross polarized light. e, f) Optical photomicrograph of thin sections prepared on the coarse plaster layers, under cross polarized light.

The optical examination on fragments of the plaster layers showed their stratigraphic sequence profile. Figure 3a shows photomicrograph obtained on a fraction of the plaster sample. It was clear that the paint layer is well adhered to the underlying preparation layer. Below it, a fine plaster '*intonaco*' with thickness ranges from 150 to 200 μm is clearly observed. In Figure 3b, the thick coarse plaster '*arriccio*' is clearly observed. The thickness of this layer ranges from 300 μm to 15 mm. The coarse plaster is rich in siliceous aggregates mainly of local sands and the matrix binder is mainly of lime. The petrographic analysis carried out on thin sections of the fine plaster layer (Figure 3c, d) shows that the plaster layer is texturally heterogeneous. The matrix is

$KAl_2Si_3AlO_{10}(OH)_2$), with different colours ranges between yellow to reddish-brown hues are also noticeable. The microscopic images obtained on thin sections of the coarse plaster layer (Figure 3e, f) show aggregates of large sharp grains of quartz (SiO_2) and limestone fragments are clearly observed embedded in the carbonated matrix.

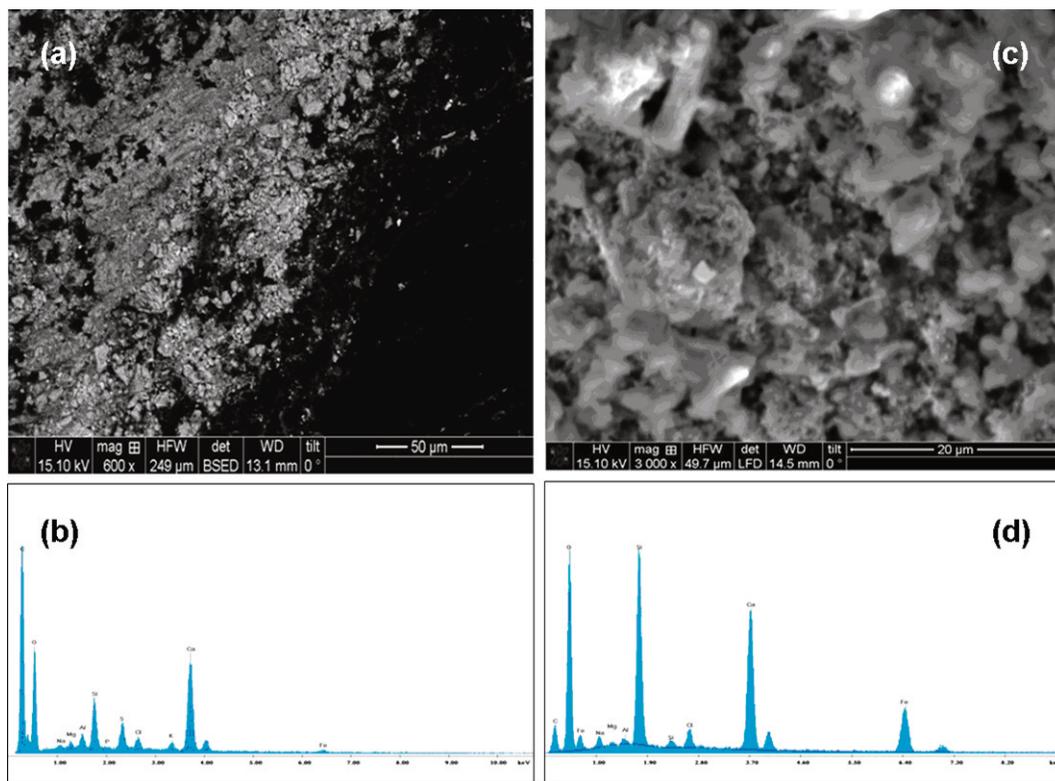
Figure 5. a) BSE image of a polished cross-section of the green paint layer (sample Gr. 1), and the EDS spectrum b) obtained on the same sample. c) SEM image of the outer surface of the yellow paint layer (sample Y.1), and the EDS spectrum d) obtained on the same sample.

glaucanite was used to obtain the green colour. The detection of sulphur is probably due to the presence of calcium sulphates (gypsum) resulting from the chemical transformation of calcium carbonates in the render layer.

The SEM investigation obtained on the outer surface of the yellow pigment sample (Figure 5c) shows a heterogeneous distribution of large and small crystals of ochre and quartz. The EDS microanalysis of the sample (Figure 5d) shows that the peak of iron is present which indicates the existence of iron oxide. The contribution of silicon and aluminium suggests possible existence of an aluminosilicate material (probably the kaolinite). The BSE image

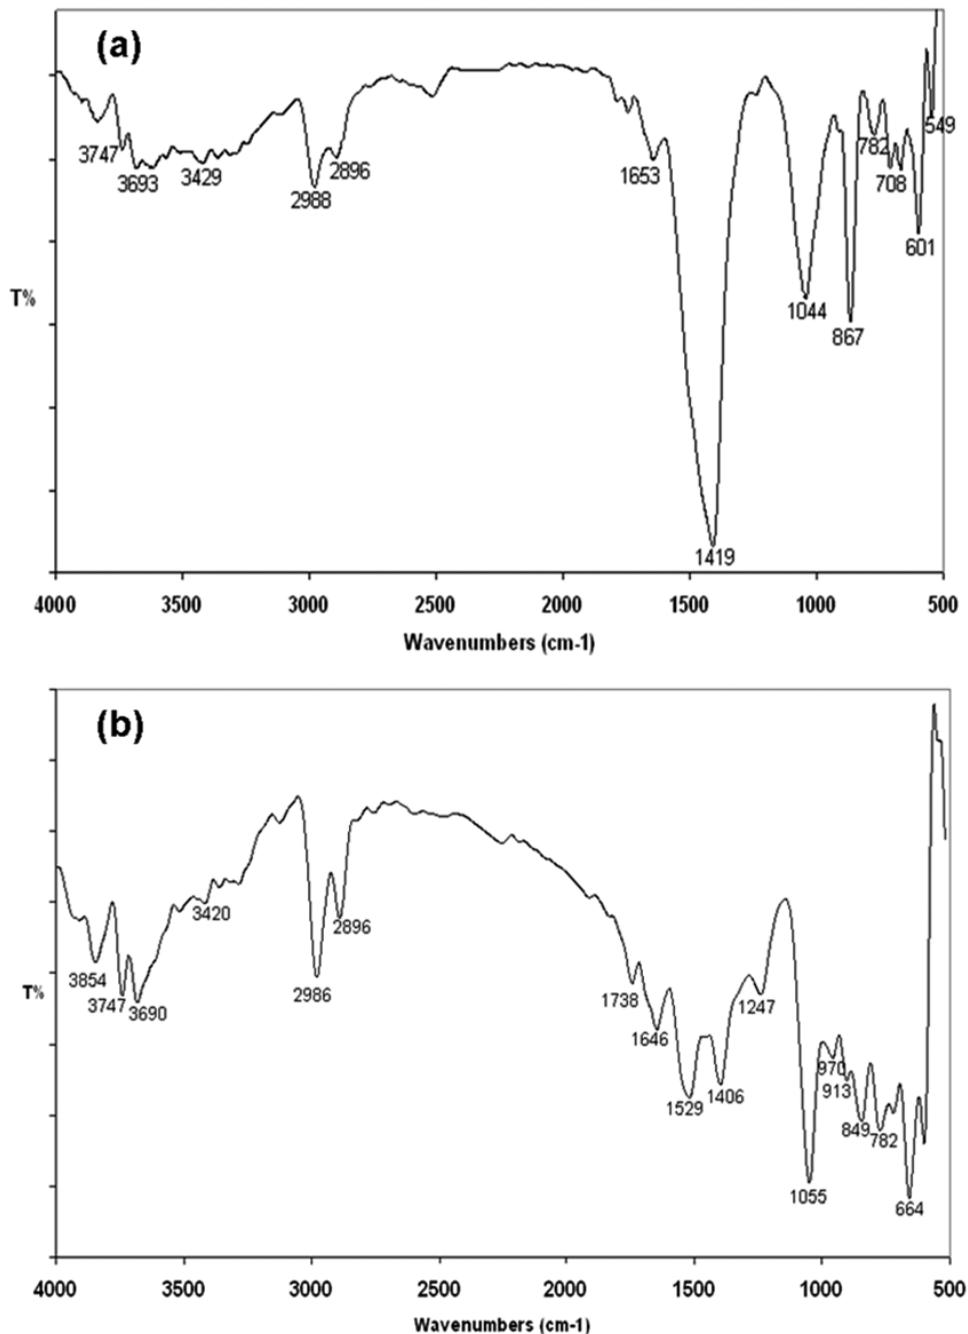
Figure 6. FT-IR (KBr) spectra recorded on some paint layers: a) The yellow paint layer (sample Y.1); b) The green paint layer (sample Gr.1).

Figure 6 displays FT-IR spectra obtained on the yellow and green paint layers (samples Gr.1 and Y.1). In Figure 6a, the characteristic bands at 1419, 867, 782 and 708 cm^{-1} are all of calcium carbonate. These bands are come from the underlying ground layer. The band at 549 cm^{-1} indicates the presence of iron oxide. The outer OH groups at 3747 and 3693 cm^{-1} are attributed to amounts of kaolinite. The band at 1653 cm^{-1} is attributed to ($\nu\text{C}=\text{O}$ amide I) together with the bands at 2988 and 2896 cm^{-1} attributed to

methylene groups (ν_{asym} and $\nu_{\text{sym}}\text{CH}_2$) are believed to belong to a proteinaceous material. The bands at 3000-3750 cm^{-1} indicate hydroxyl group. The bands at 400-475 cm^{-1} indicate the presence of amorphous silicates. The band at 1044 cm^{-1} is attributed to in-plane Si-O stretching modes. In the FT-IR spectrum of the green pigment (Figure 6b), glauconite was characterized by the small band at 664 cm^{-1} with broad peaks in the 1110-950 cm^{-1} region. These last bands are mainly at 970 and 1055 cm^{-1} . In the region 3400-3700 cm^{-1} , three narrow bands at 3420, 3690 and 3747 cm^{-1} are present; such bands are characteristic of the stretching of hydroxyl (O-H stretching) groups depending on the nature of the cations (Moretto et al., 2011).

The bands at 913-849 cm^{-1} are attributed to Si-O stretching bands, and the bands at 1000-1100 cm^{-1} are for asymmetric Si-O-Si stretching bands. The bands at 2989 and 2896 cm^{-1} are for methylenic groups, 1646 cm^{-1} (amide I) and at 1529 cm^{-1} ($\delta\text{N-H}$ amide II) for a proteinaceous material. The presence of oil was concluded on the basis of characteristic bands at 1737 and 1247 cm^{-1} (stretch, C-O-C). The plaster layers
