Chemical and physical characterization of mortars and plasters from a Coptic paternoster: new excavation in the temple of Ptolemy XII, Sheikh Hamad, Athribis, Sohag, Egypt

Keywords: ancient mortar; plaster; Athribis; pozzolanic additives; Coptic paternoster.

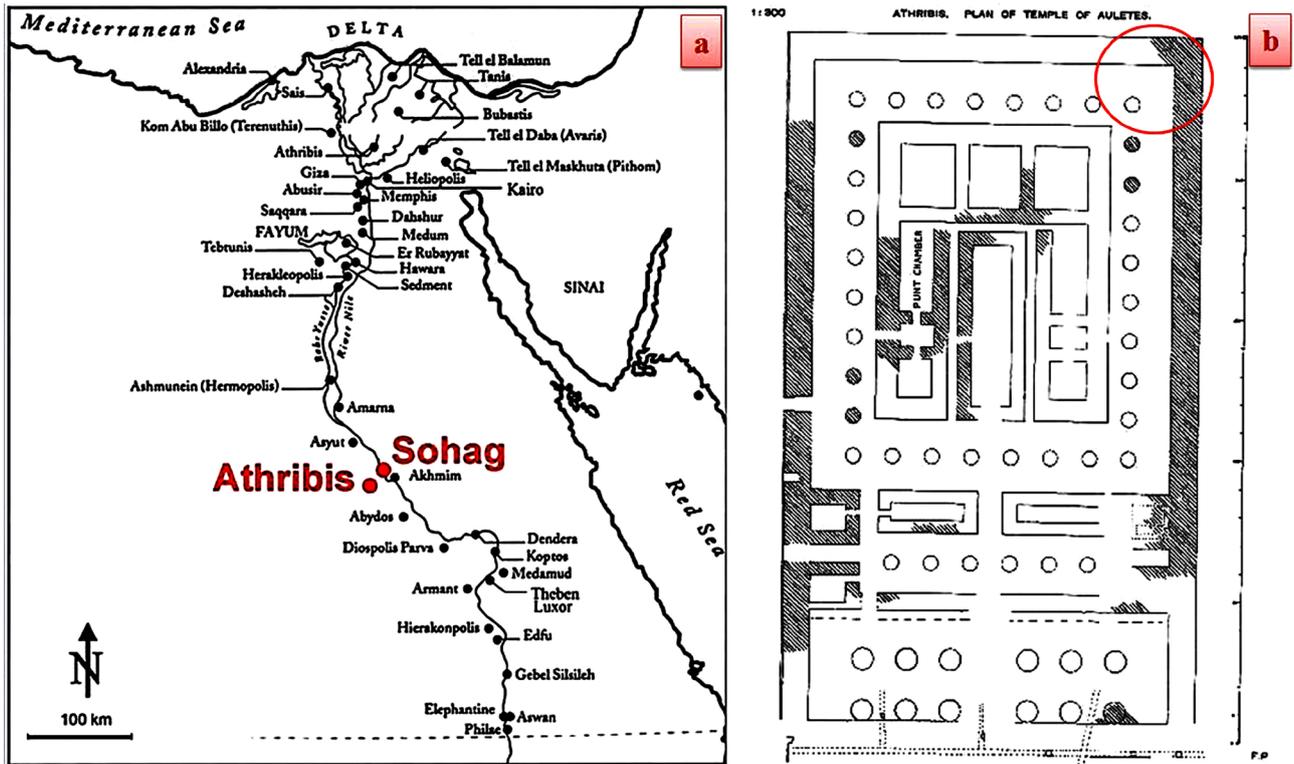
Figure 1. a) Map shows the location of the Athribis temple in Upper Egypt, (Leisen et al., 2008), b) the Petrie plan of the temple of Auletes (Petrie, 1908), the red circle shows the location of Coptic paternoster addition.

Despite of the similarity of Auletes temple plan with the temples of Dendera and Edfu, it differs from any temple yet known because of the Greek influence in its colonnade (Figure 1b, Figure 2).

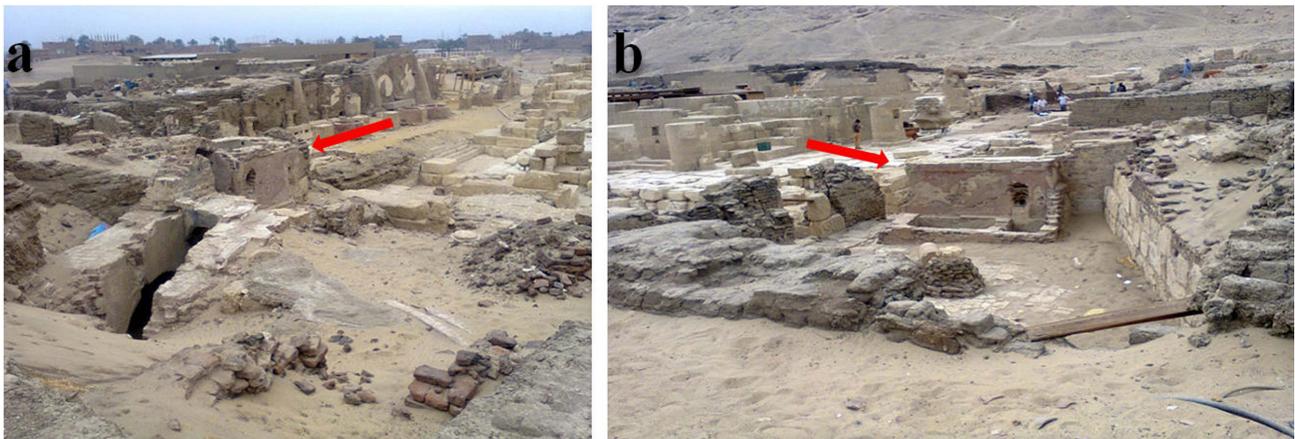
Figure 2. a and b show the location of Coptic paternoster addition.

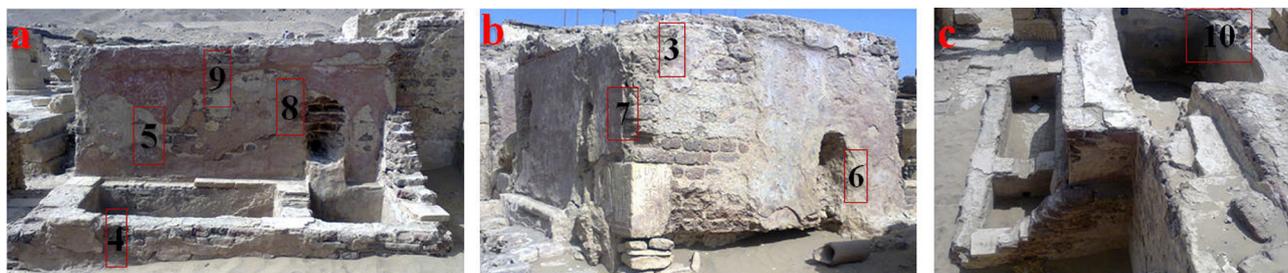
Figure 3. a, b and c shows the samples locations of the Coptic paternoster.

The sampling procedure for plasters and mortars has been carried out by careful collecting of eight representative samples by a micro scalpel from deteriorated and separated parts from the paternoster (Figure 3). All of the analyzed and investigated samples were collected from areas with less historic and aesthetic values and sometimes the same sample was used for more than one analysis or investigation (Table 1). These samples were studied to identify the chemical composition, deterioration aspects and to discover the used building materials techniques in this period.

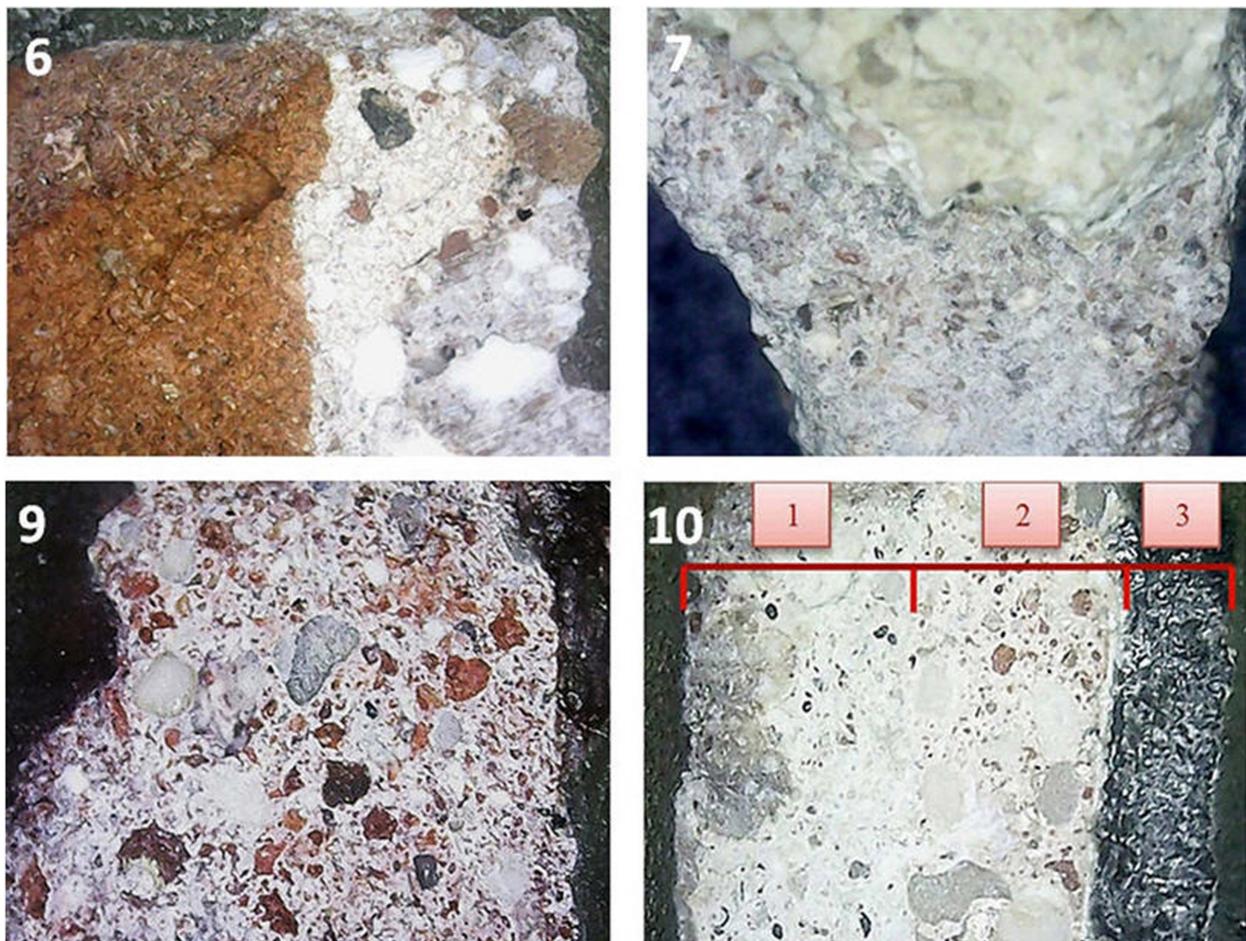
Figure 4. USB digital microscope results of some samples collected from the Coptic paternoster in the temple of Ptolemy XII, Athribis, Sohag, Egypt.

- Figure 4 (sample 6) shows some particles of brick in the first layer of the white plaster layer sample from the southern wall of the upper big tank. This addition may be made to give the air lime mortar some hydraulic properties to be suitable for its use as a plaster in water tank. However the big pieces of brick may be used as a filler material for plaster (See XRD analysis results of sample X6).

- Figure 4 (sample 7) shows the outer two plaster layers sample of the southern-western corner of the upper big tank. As can be seen in the image; the inner layer of plaster is rich in brick powder which was added to increase mortar hydraulicity.

- Figure 4 (sample 9) shows the reddish color of the third reddish plaster layer sample of the eastern wall

middle parts of the upper big tank, this color is related to the addition of brick powder and its fragments. The main purpose of this addition is to make the tank suitable for use as water tank by giving some hydraulic properties to the used mortar.

- Figure 4 (sample 10) shows the cross-section of the plaster layers of the internal face of the big upper tank, which consists of three layers and can be characterized by their color; (1) the whitish internal layer, (2) the reddish layer because of the addition of brick powder and (3) the dark-grayish layer which its color may be related to the addition of pozzolanic material to the lime.

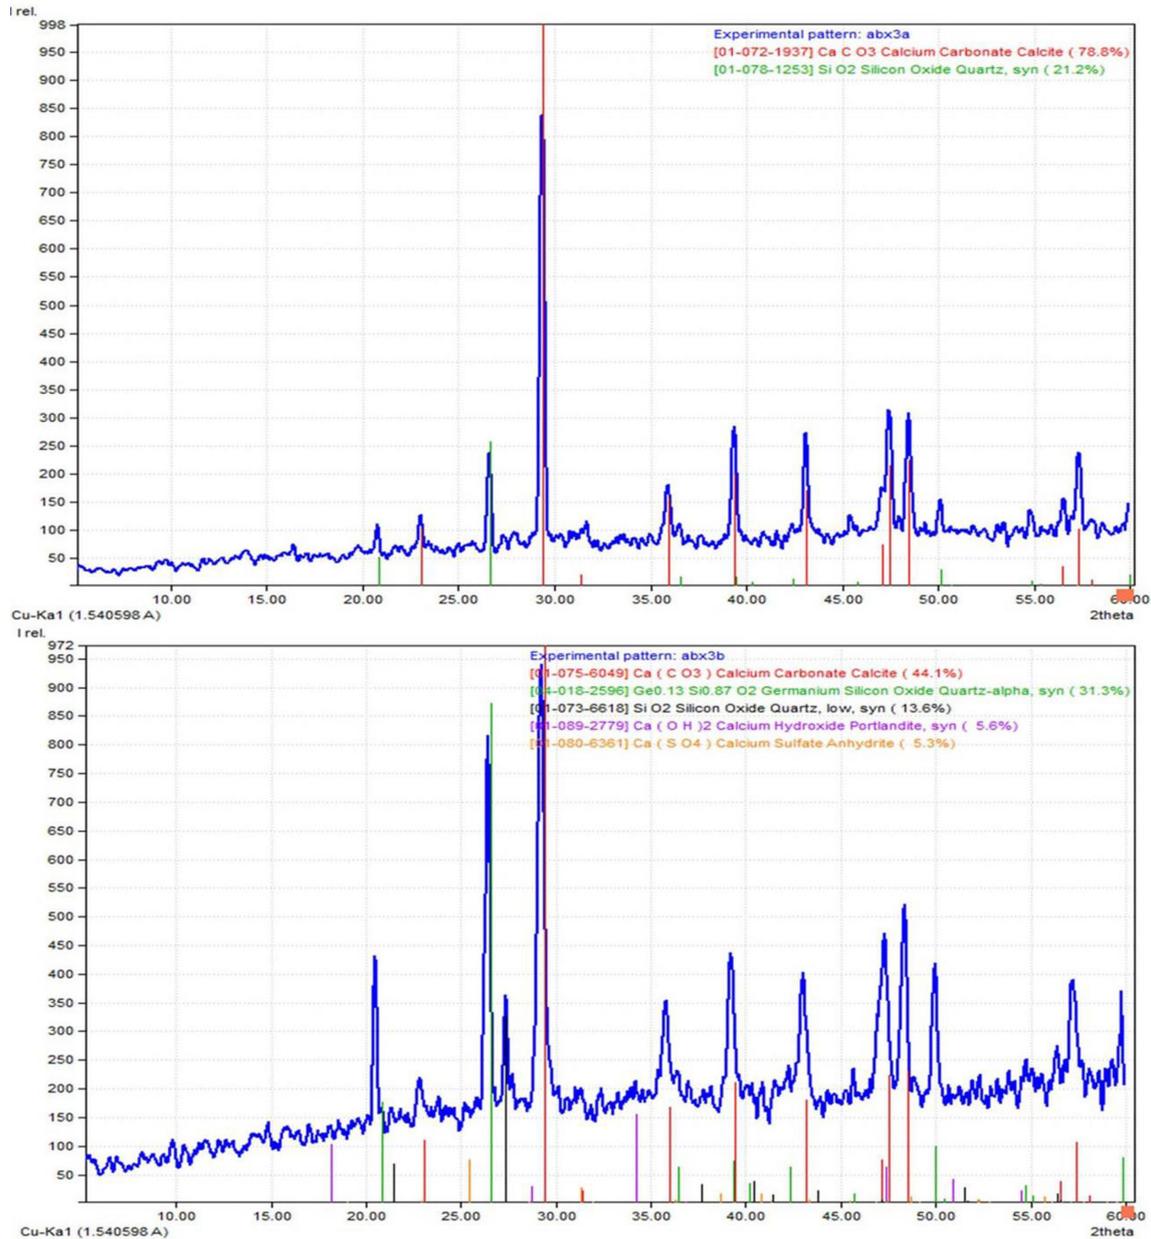
Figure 5. X-ray diffraction patterns of the joint mortar sample from the paternoster upper parts of the south wall of the big tank proved that it consists essentially of calcite, quartz and traces of portlandite and anhydrite.

and X4b) revealed that calcite is the main component and the binding material of these mortars samples. As well as quartz as minor constituent with the exception of its high percentage in sample X3b which may be related to poor mixing of mortar or to deterioration affecting the binding materials through dissolution and leaving sand (Kamel et al., 2015a). The presence of anhydrite traces in joint mortar sample X3b can be explained as an impurity related to the limestone used as a source for lime (Kamel, 1986) or as gypsum impurity which it was transformed to anhydrite because of the firing temperature of lime i.e., gypsum can be transformed to insoluble anhydrite in temperatures lower than which were used for lime production (Kamel et al., 2015b; Charola and Centeno, 2002).

Detection of portlandite may be related to the traces that have not been carbonated because of the relative shortage of carbon dioxide in the inner parts of joint mortar i.e., carbon dioxide is essential for carbonation of lime (Elert et al., 2002) (Figs. 5 and 6).

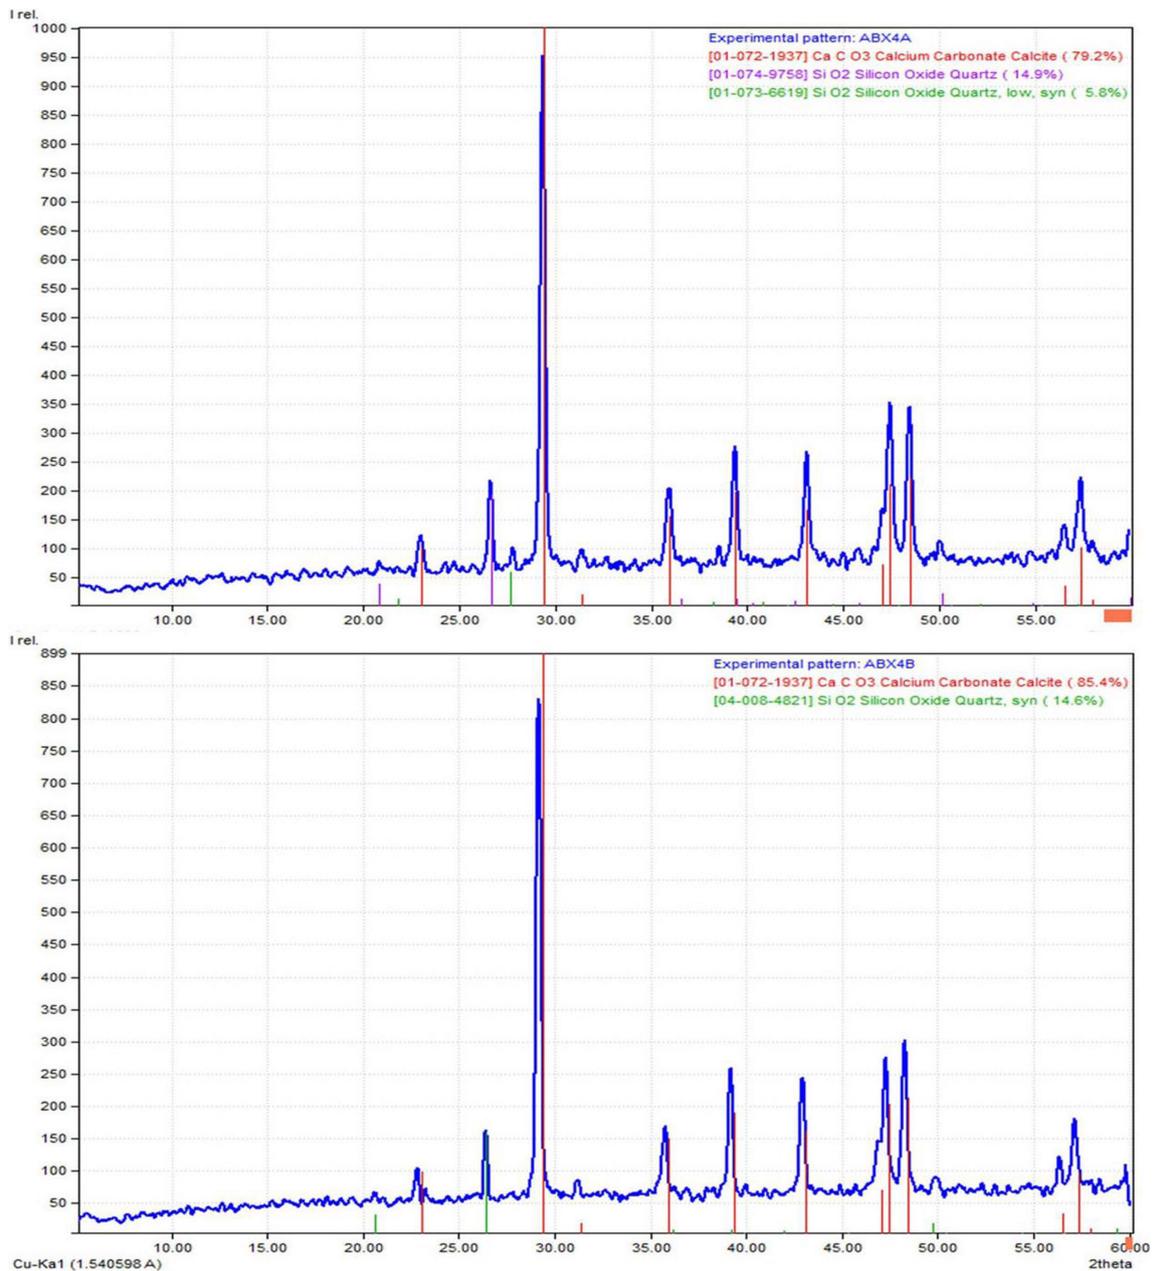
Figure 6. X-ray diffraction patterns of the joint mortar sample from the patenoster upper parts of the east wall of the big tank proved that it consists essentially of calcite and quartz .

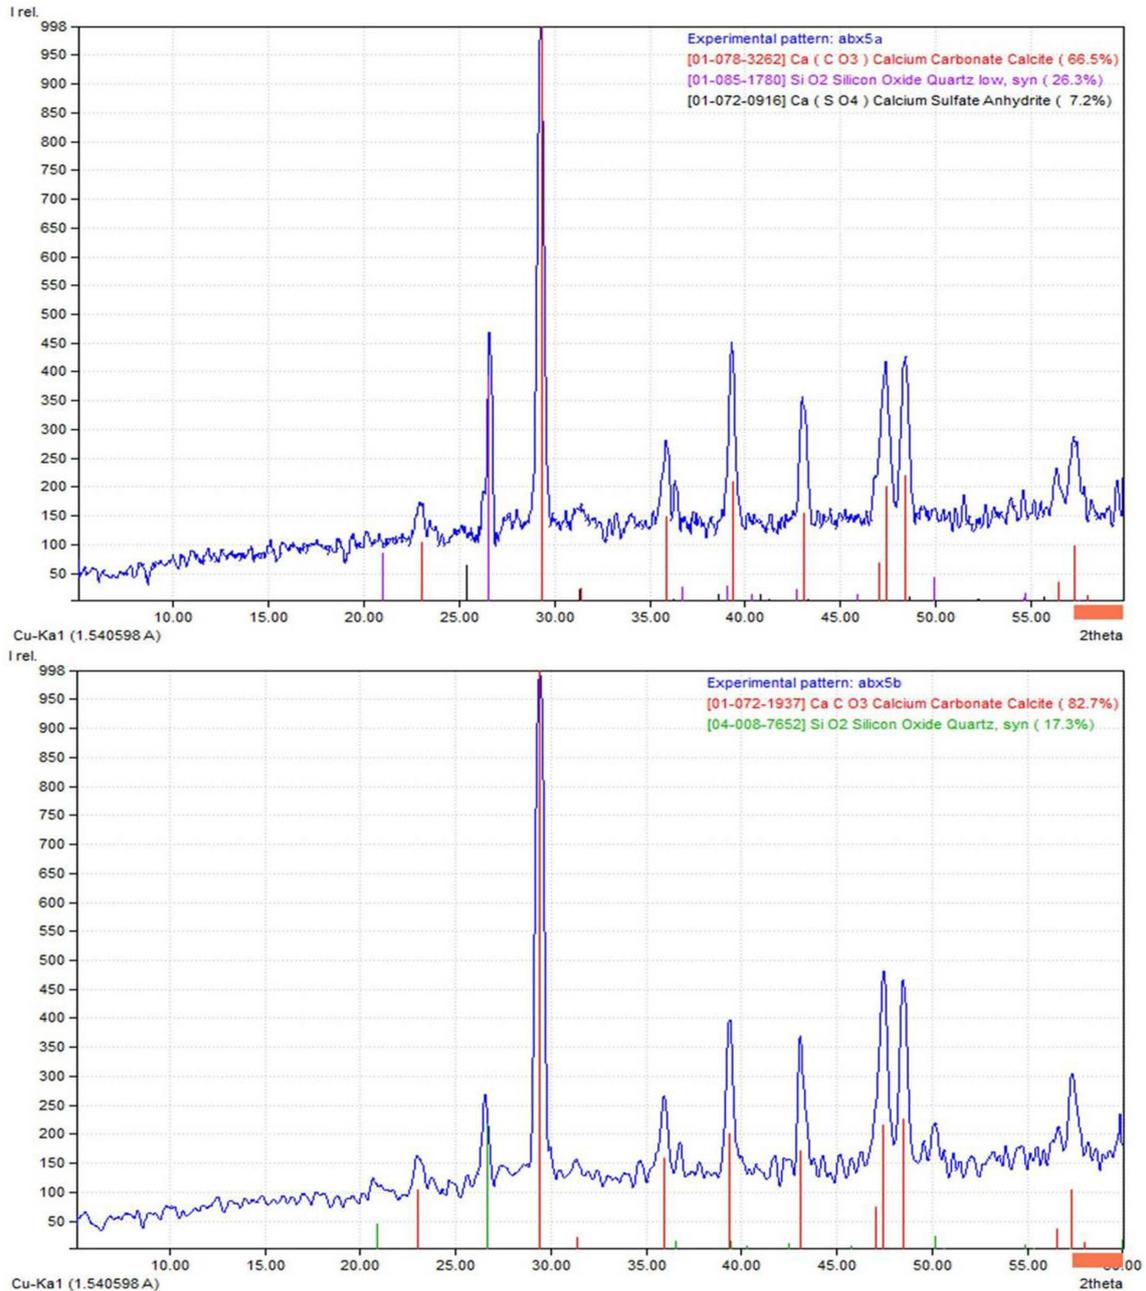
Figure 7. X-Ray diffraction patterns of the first white plaster layer sample from the middle parts of the big tank eastern wall proved that it consists essentially of calcite, quartz and traces of anhydrite.

• XRD analysis of plaster samples (X5a, X5b, X6, X7a, X7b, X8a, X8b and X9b) resembles the results of the joint mortars, with the appearance of hematite as traces in samples (X6, X7b, X8a and X9b). Hematite is a deliberate additive to lime mortar where ground bricks have been used in mortar mixes since ancient times. Although the chemistry of the pozzolanic reaction may not completely have been understood before the 19th century, experience had proven that the addition of powdered bricks to lime mortars can improve the hydraulic properties (Rogers, 2011). These materials are called as Homra in Arabic

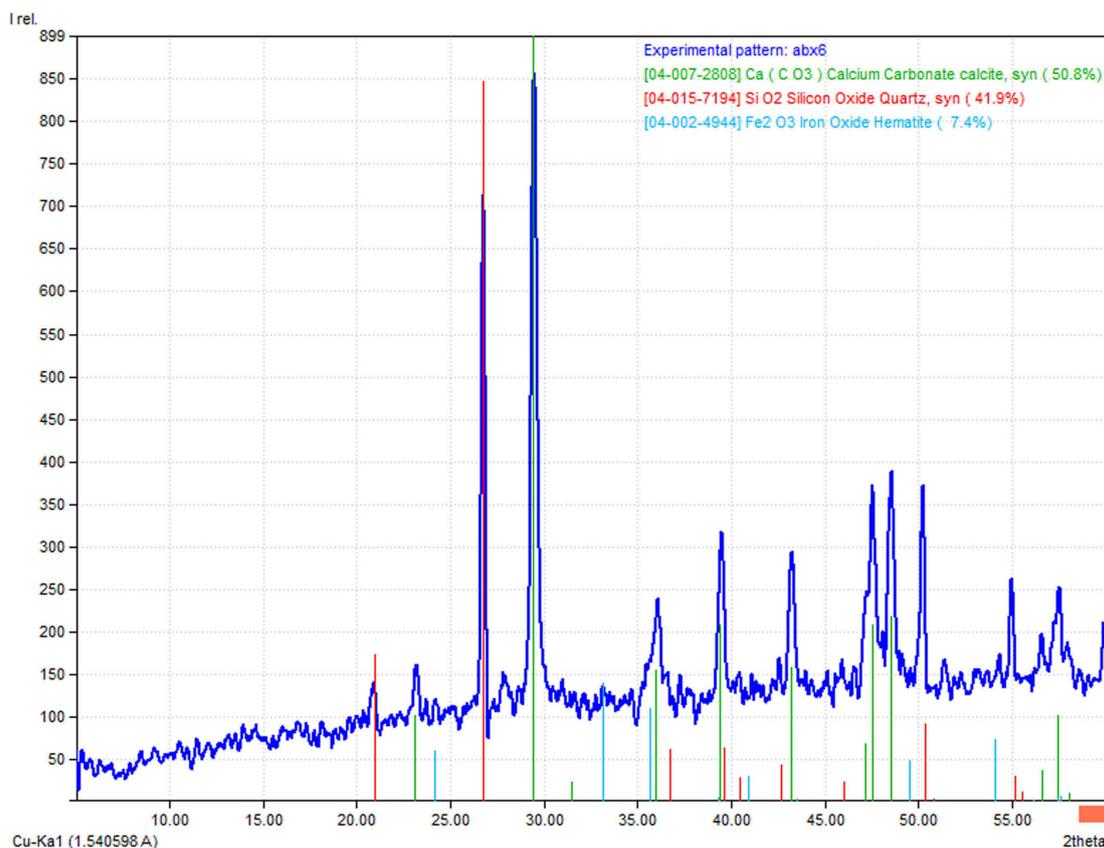
Figure 8. X-ray diffraction patterns of the first white plaster layer sample from the southern wall of the upper big tank proved that it consists essentially of calcite, quartz and traces of hematite which may be related to the addition of brick powder.

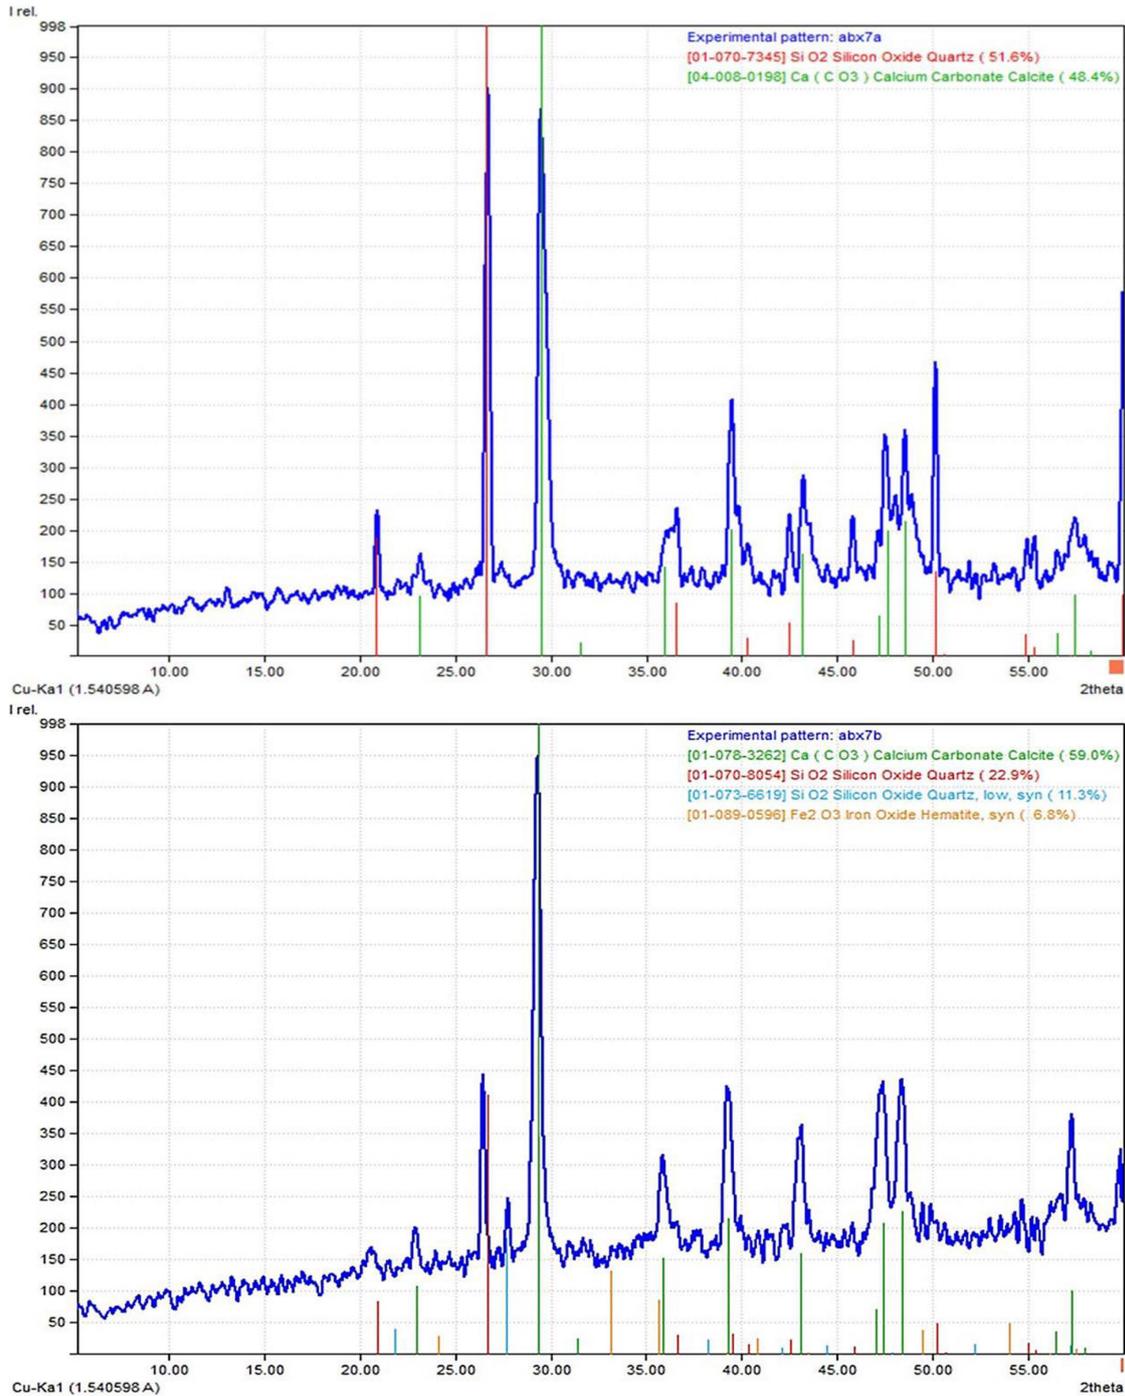
Figure 9. X-ray diffraction patterns of the paternoster outer plaster layer sample of the southern-western corner of the upper big tank proved that it consists essentially of calcite, quartz and traces of hematite which may related to the addition of brick powder.

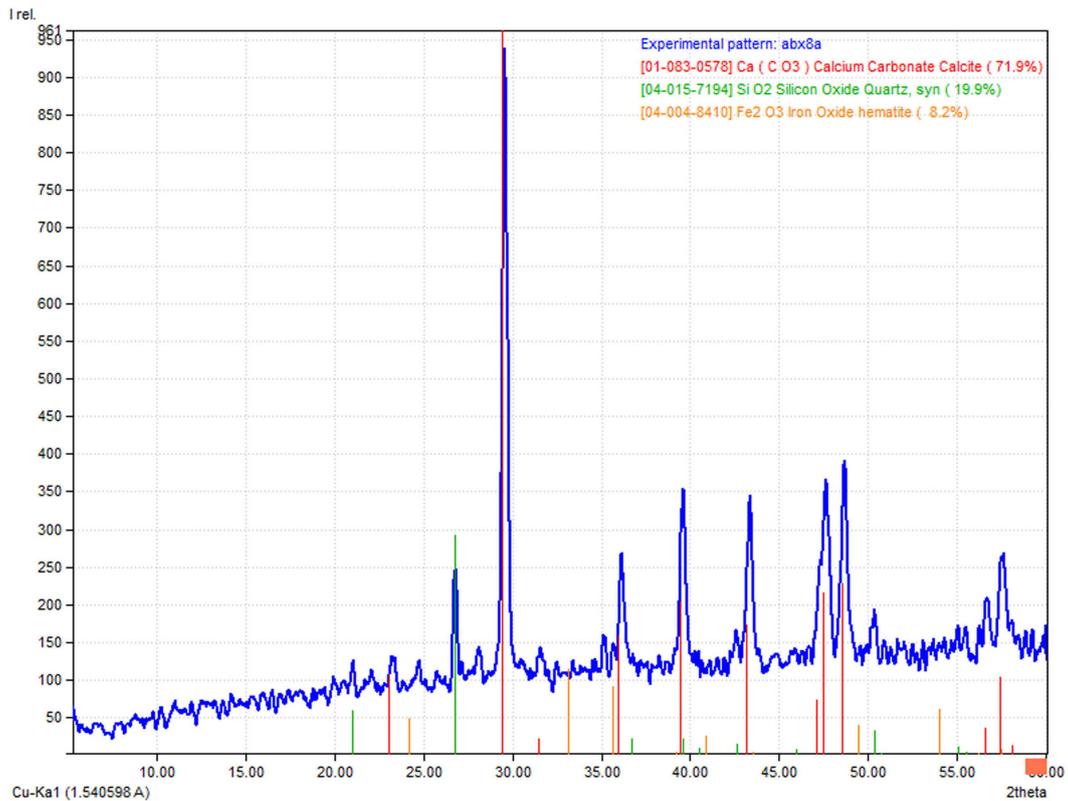
Figure 10. X-ray diffraction pattern of the second reddish plaster layer sample of the eastern wall middle parts of the upper big tank proved that it consists essentially of calcite ,quartz and hematite which may related to the addition of brick powder which gave the plaster its reddish color.

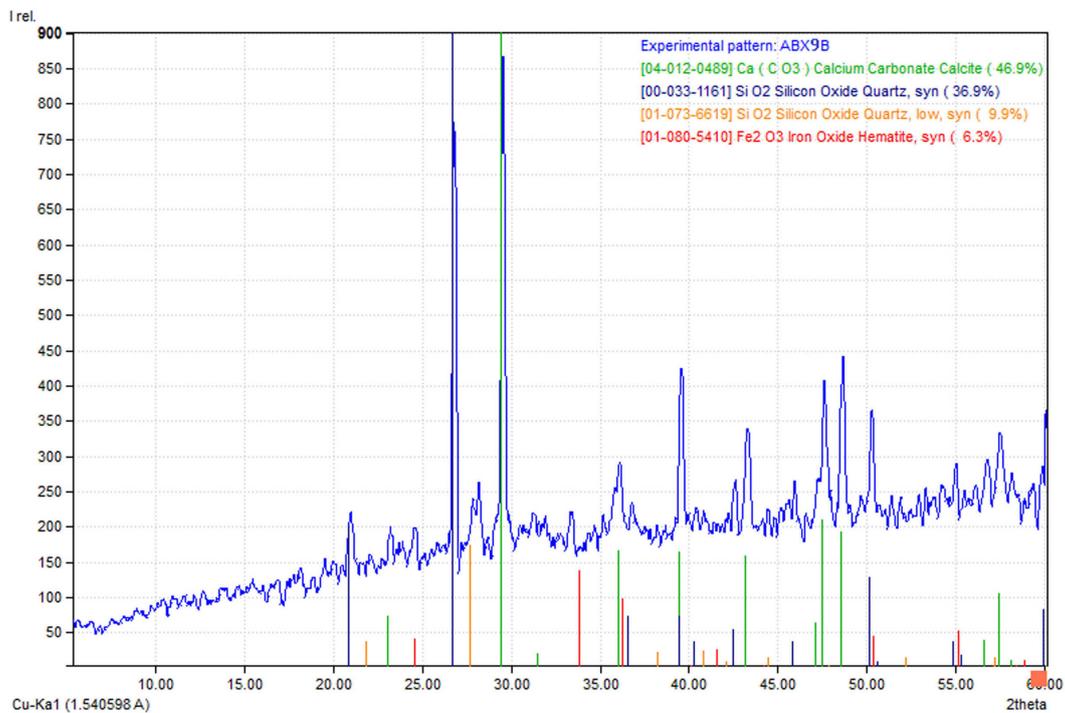
Figure 11. X-ray diffraction pattern of the third reddish plaster layer sample of the eastern wall middle parts of the upper big tank proved that it consists essentially of calcite, quartz and hematite.

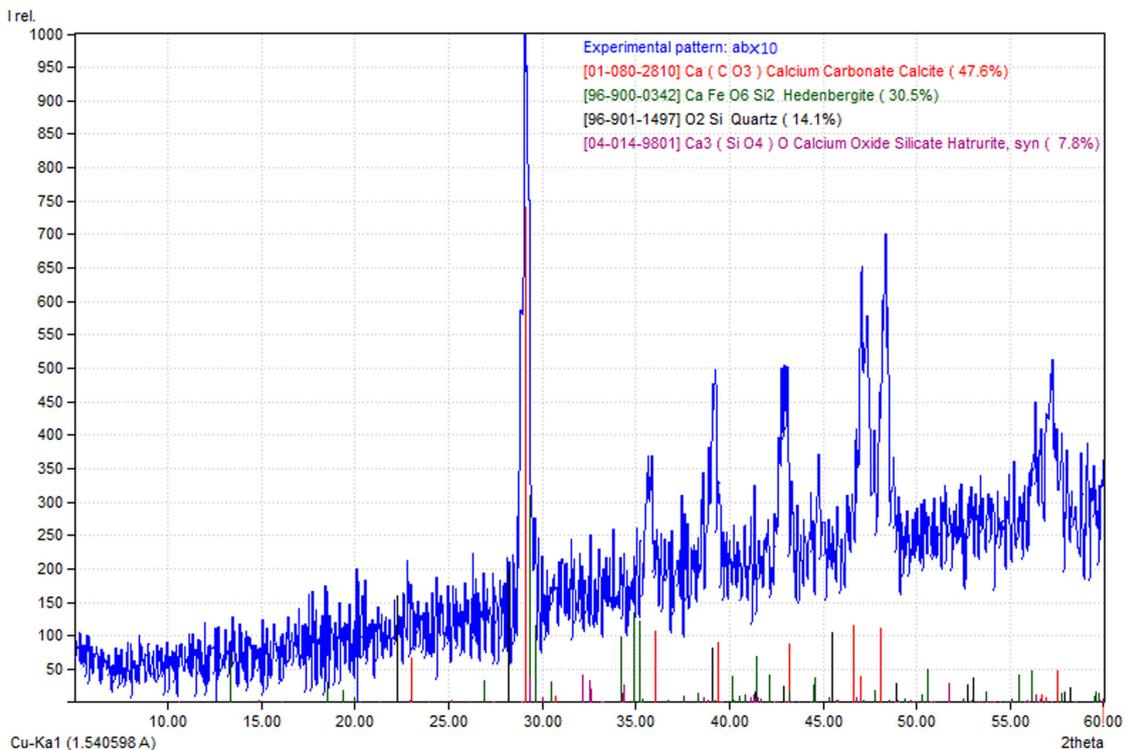
Figure 12. X-ray diffraction pattern of the internal dark gray plaster layer sample of the big upper tank of the paternoster proved that it consists of calcite, hedenbergite, quartz and hatrurite.

• XRD analysis of the internal dark gray plaster layer sample (X10) of the big upper tank of the paternoster proved that it consists of calcite, hedenbergite, quartz and hatrurite. The detection of hedenbergite and hatrurite confirms the hydraulicity of the mortar. As Hedenburgite may be used as a pozzolanic slag additive (Piatak et al., 2015; Dariz and Schmid, 2017), or may be related to the addition of brick powder which is recognized as pozzolanic material in ancient Rome where it was used as a hydraulic additive to lime mortars. (Kepperta et al., 2017). The appearance of hatrurite may be attributed to the reaction of calcium hydroxide with quartz (Labiadh et al., 2009). Other researchers attributed the presence of hatrurite to the addition of marble powder (Buyuksagisa et al., 2017) (Figure 12).

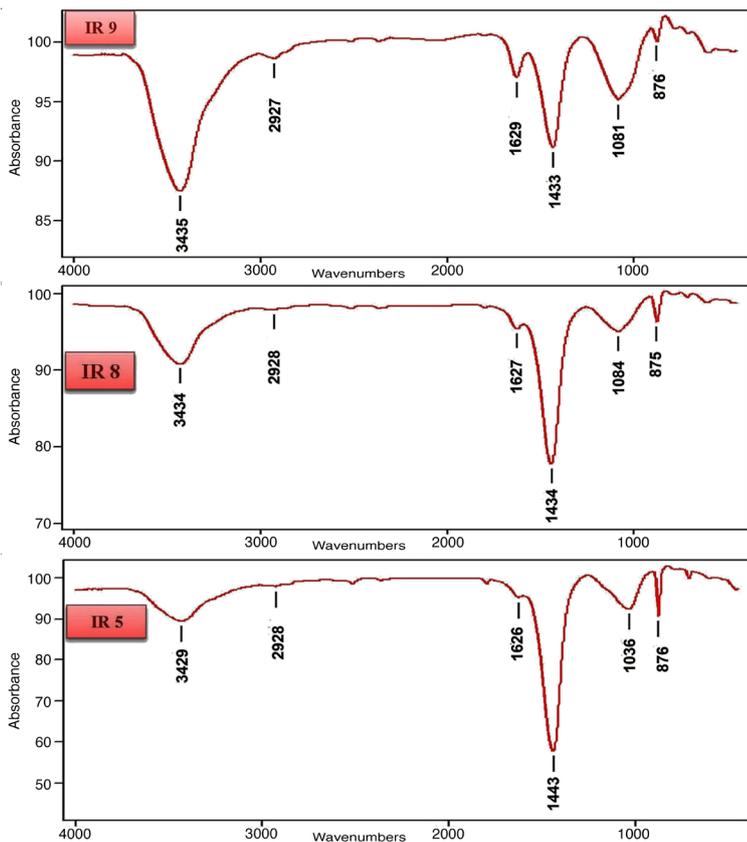
Figure 13. (IR9, IR8 and IR5) Infrared spectra of three plaster samples from the Coptic paternoster confirmed the results of XRD analyzes.

plaster samples were as follows: calcium carbonate was identified in the three samples (9, 8 and 5) through the C=O stretching band of CO_3^{2-} group of calcium carbonate at about 1795 cm^{-1} and 1440 cm^{-1} plus the O-C-O bending bands of carbonate group at about 875 cm^{-1} and 710 cm^{-1} (Mahmoud et al., 2011). FTIR spectra of samples 8 and 9 (Fig. 13 IR9 and IR8) show an intense broad band at $1000\text{--}1100\text{ cm}^{-1}$ corresponding to C-S-H vibrations of hydraulic compounds. These hydraulic compounds may be related to the interaction between crushed-brick or

Quartz was identified by the vibrations at about 780 cm^{-1} and the asymmetric Si-O-Si stretching band at $1000\text{-}1100\text{ cm}^{-1}$ in the three samples (Bosch et al., 2002; Derrick et al., 1999). Presence of quartz may be related to the traces of sand which was detected by XRD analysis (Figure 13).

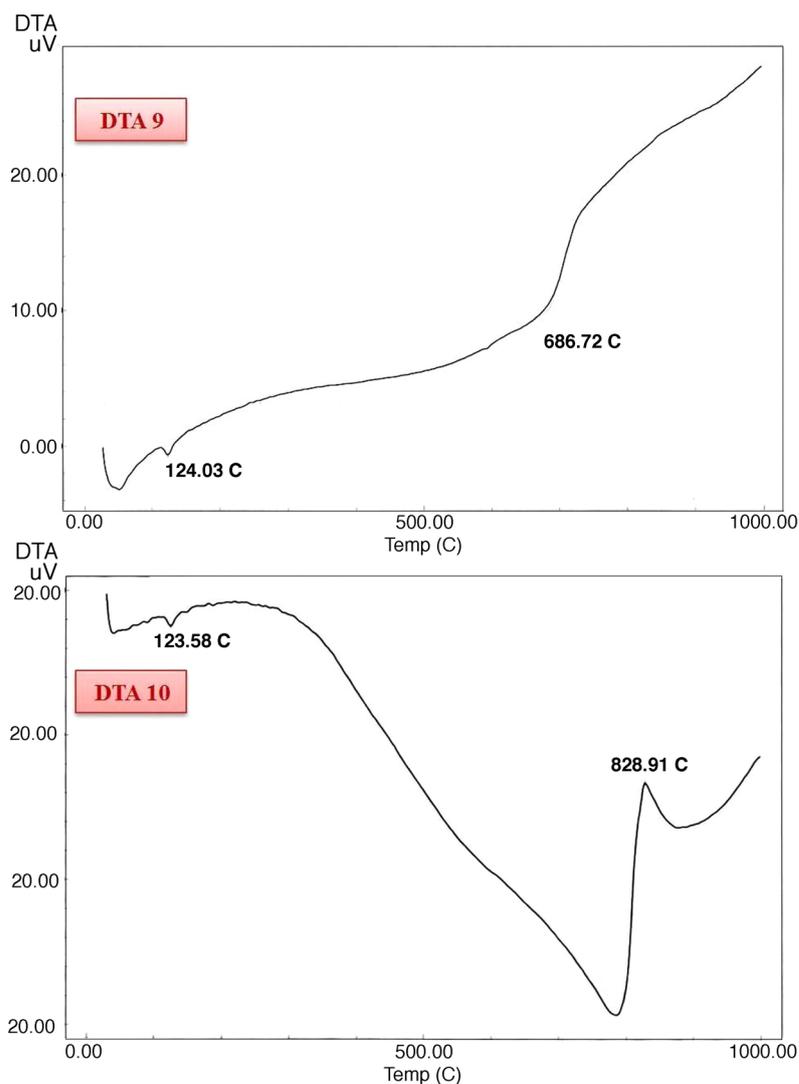
Figure 14. DTA curves of samples 9 and 10, their results are compatible with XRD and IR results.

The (DTA 9) sample showed a peak at 686.72°C which may be related to the decomposition of calcite (Figure 14). Montoya et al. (2004), Alvarez et al. (2000) and Gameiro et al. (2014) mentioned that low temperature of the decomposition of calcite may give an evidence for the presence of dolomite traces (Figure 14).

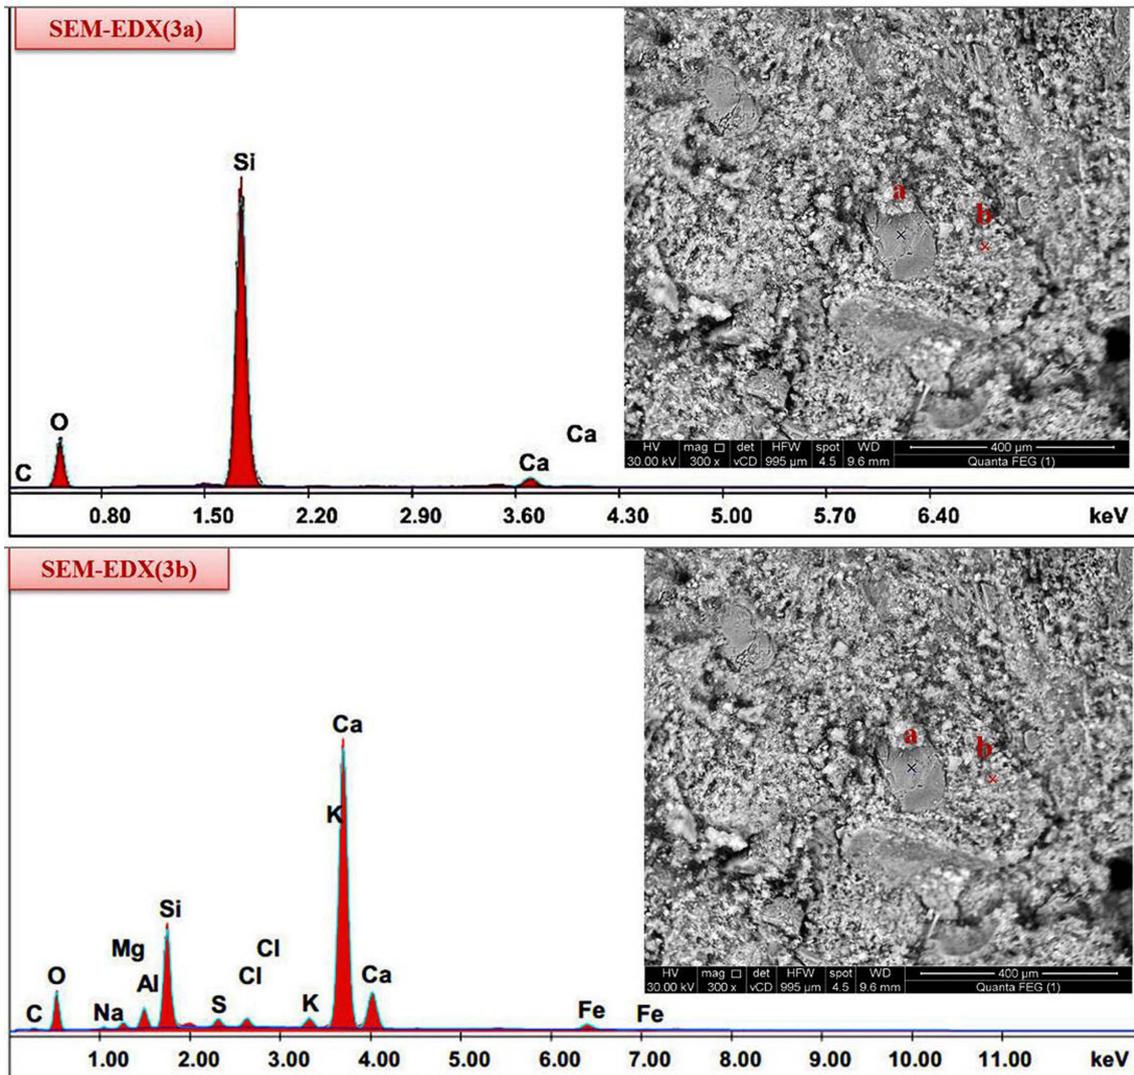
Figure 15. (3a and 3b) EDX spectra of joint mortar sample from the upper parts of the south wall of the big tank as the appearance of Si, Ca, O, C, Fe and Al testifies the occurrence of quartz, calcite and traces of pozzolanic materials.

- The results of EDX analysis of joint mortar sample 3 (SEM-EDX 3a and 3b) show a high proportion of Si and O in sample 3a (Figure 15) indicating the occurrence of quartz (sand), while the results of sample 3b, (Figure 15) show a high proportion of Ca, O, C proving the occurrence of calcite as a major component, Si ratio testifies to the occurrence of quartz (sand). Finally, the presence of Fe, Al

and Si proves the presence of traces of pozzolanic materials; that may be related to the addition of ground bricks.

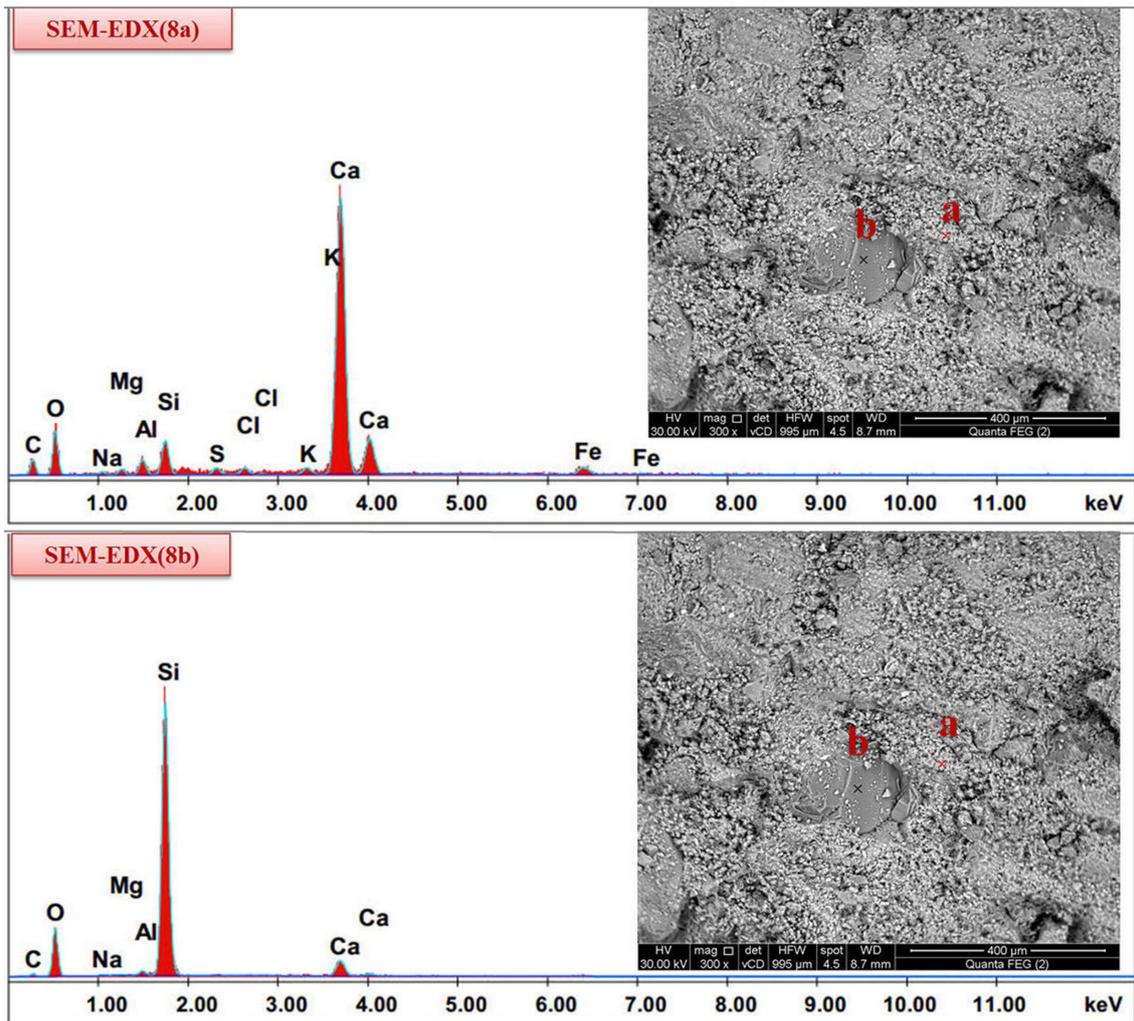
Figure 16. (8a and 8b) EDX spectra of the second reddish plaster layer sample of the eastern wall middle parts of the upper big tank as the appearance of Fe, Ca, O, C and Si confirms that the plaster is a lime mortar consisting of calcite, quartz and brick powder.

- EDX analysis results of the reddish plaster layer sample 8 (SEM-EDX 8a) (Figure 16) show the presence of (Fe) element which gives an evidence of the occurrence of brick powder which was added to give the plaster its reddish color. This result was confirmed by the detection of hematite by XRD analysis. SEM-EDX 8b (Figure 16) reveals the presence of a high proportions of Ca, O, C and Si indicating that the plaster is a lime mortar which consists of calcite, quartz and the addition of brick powder.

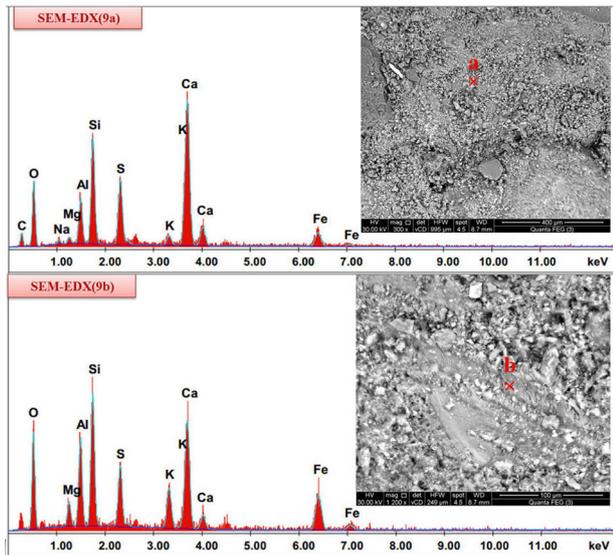
Figure 17. (9a and 9b) EDX spectra of the third reddish plaster layer sample of the eastern wall middle parts of the upper big tank show the presence of Ca, Si, Al and Fe which make this sample resemble sample 8, but the appearance of S may testify the occurrence of traces of one of the gypsum phases as an impurity.

- EDX analysis results of the third reddish plaster layer sample of the eastern wall middle parts of the upper big tank (SEM-EDX 9a and 9b) show the presence of Ca, Si, Al and Fe which make this sample resemble sample 8, but the appearance of S ion may testify to traces of one of the gypsum phases as an impurity (Figure 17).

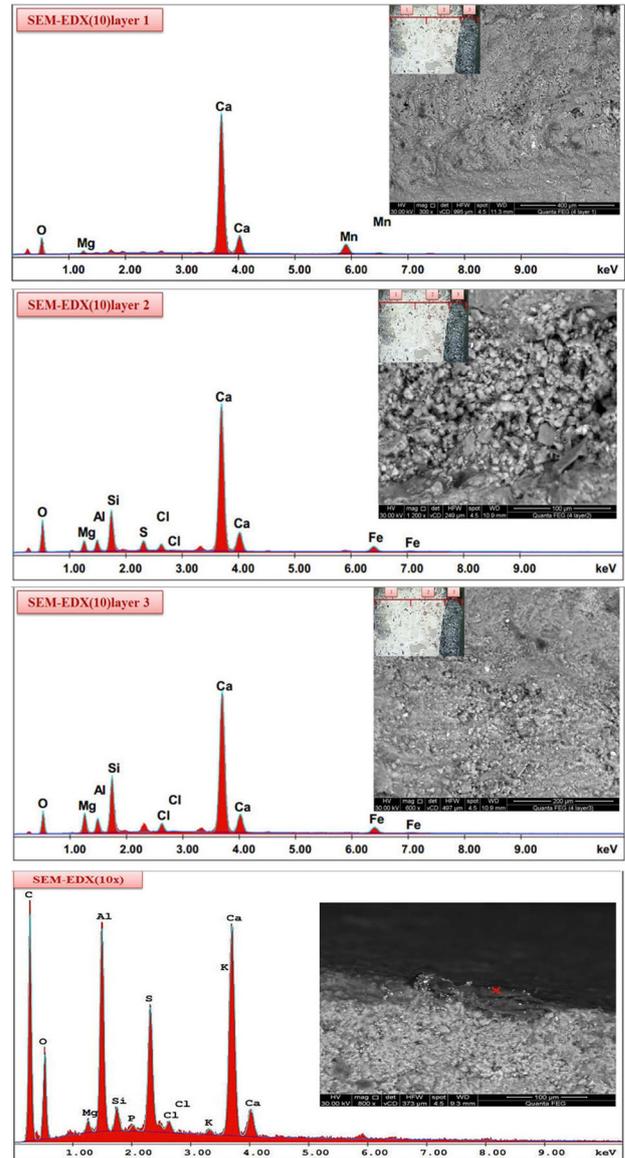
Figure 18. EDX spectra of the three layers sample collected from the internal face of the big upper tank which confirming that the whitish internal layer 1 is a lime mortar while the reddish layer 2 is a lime mortar mixed with brick powder and the elemental composition of the grayish layer 3 testifies to the occurrence of pozzolanic material but the appearance of S in the superficial sample of the grayish layer (SEM-EDX 10x) testifies the occurrence of traces of one of the gypsum phases as an impurity or related to sulfation of lime mortar.

- The whitish internal layer sample (SEM-EDX 10 Layer1) shows a high proportion of calcium Ca as the

major ion contained, which refers to the existence of calcite as a binder (Figure 18).

- The reddish layer sample (SEM-EDX 10 Layer 2) shows the existence of (Fe) and (O) which testifies to the occurrence of brick powder as an additive (Figure 18).

- The grayish layer sample (SEM-EDX 10 Layer 3) shows the existence of high proportions of Ca, Si as well as Al and Fe that testifies the occurrence of hedenbergite and hatrurite minerals. These minerals may be related to the addition of pozzolanic materials to the lime to yield a hydraulic mortar compatible with the usage of the water tank (Figure 18). This conclusion was confirmed by the results of XRD and IR analyses.

- The superficial sample of the grayish layer (SEM-EDX 10 x) shows a proportion of S ion which may be testified to traces of one of the gypsum phases as an impurity or related to sulfation of lime mortar (Cultrone et al., 2008) (Figure 18).
