INITIAL-LEVEL REPORTS OF LANDSLIDES INVOLVING BRIDGES AND VIADUCTS: THE CASE STUDY OF VILLA ILII (CENTRAL ITALY)

Gerardo GRELLE[(*)], Simone PALUMBO[(**)], Giuseppe MAIO[(*)], Luigi GUERRIERO[(**)], Domenico CALCATERRA[(**)] & Giuseppe SAPPA[(*)]

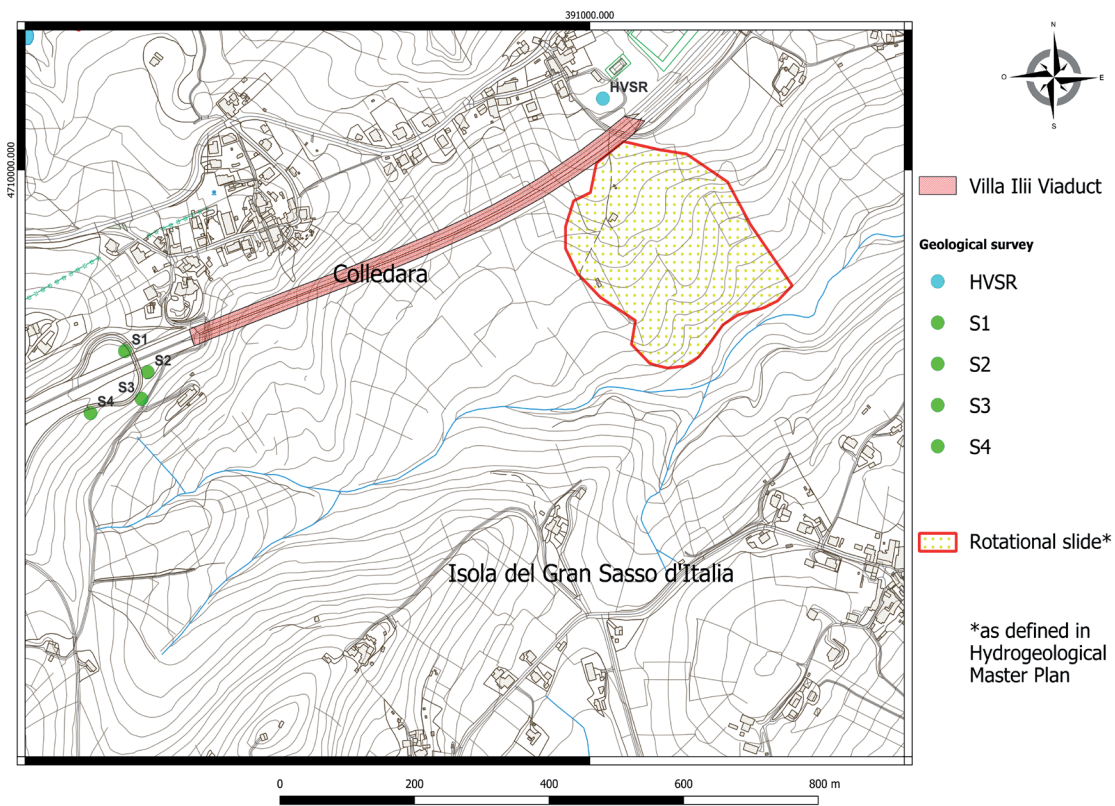
The landslide, identified by local authorities as a "dormant" rotational slide, extends along a moderately steep slope (10-25°) from a maximum elevation of 473 m a.s.l. to a minimum elevation of 425 m a.s.l., covering a total area of 78,000 m². Historical investigations of the area indicate an approximate depth of the sliding surface ranging between 15 and 20 m.

Fig. 2 - *Rotational slide interacting with the viaduct (as defined in Hydro-geomorphological Setting Plan) and ancillary data location*

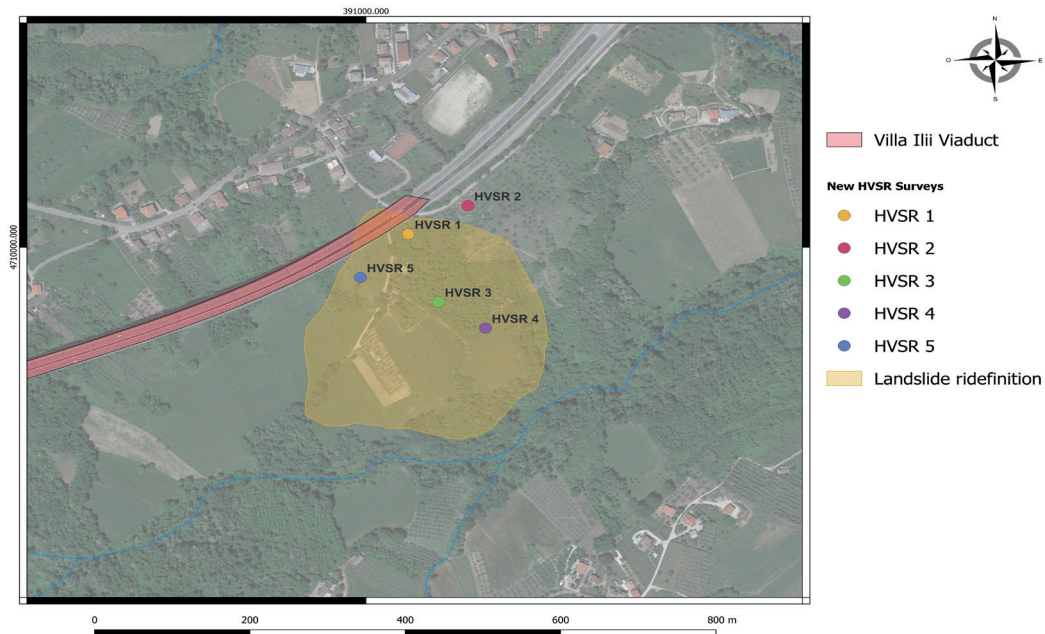
The analysis of HVSR allowed to define a different resonant peak distribution among the records acquired in different sites along the slope involved by the landslide. A relevant migration of peaks toward low frequency is highlighted along the slope. Particularly, the majority of deeper landslide deposits appear towards the middle/low slope at the station HVSR4 to 4.5 Hz in contrast to the thinner

Fig. 4 - *Landslide redefinition and HVSR surveys*

landslide deposits shown at the HVSR1 and HVSR3 over 8.0 Hz and HVSR5 to 6.5 Hz at the head of the movement. Supporting the observation that the terrains detected by these stations belong to the landslide, two additional stations outside the landslide area were also considered. These stations, HVSR P31 MZS (of third parties) and HVSR2 show peaks respectively over 6.5 and 9.5 Hz signing that bedrock is much closer to the topographic surface than that as showed by stations in the landslide area. (Fig.5).

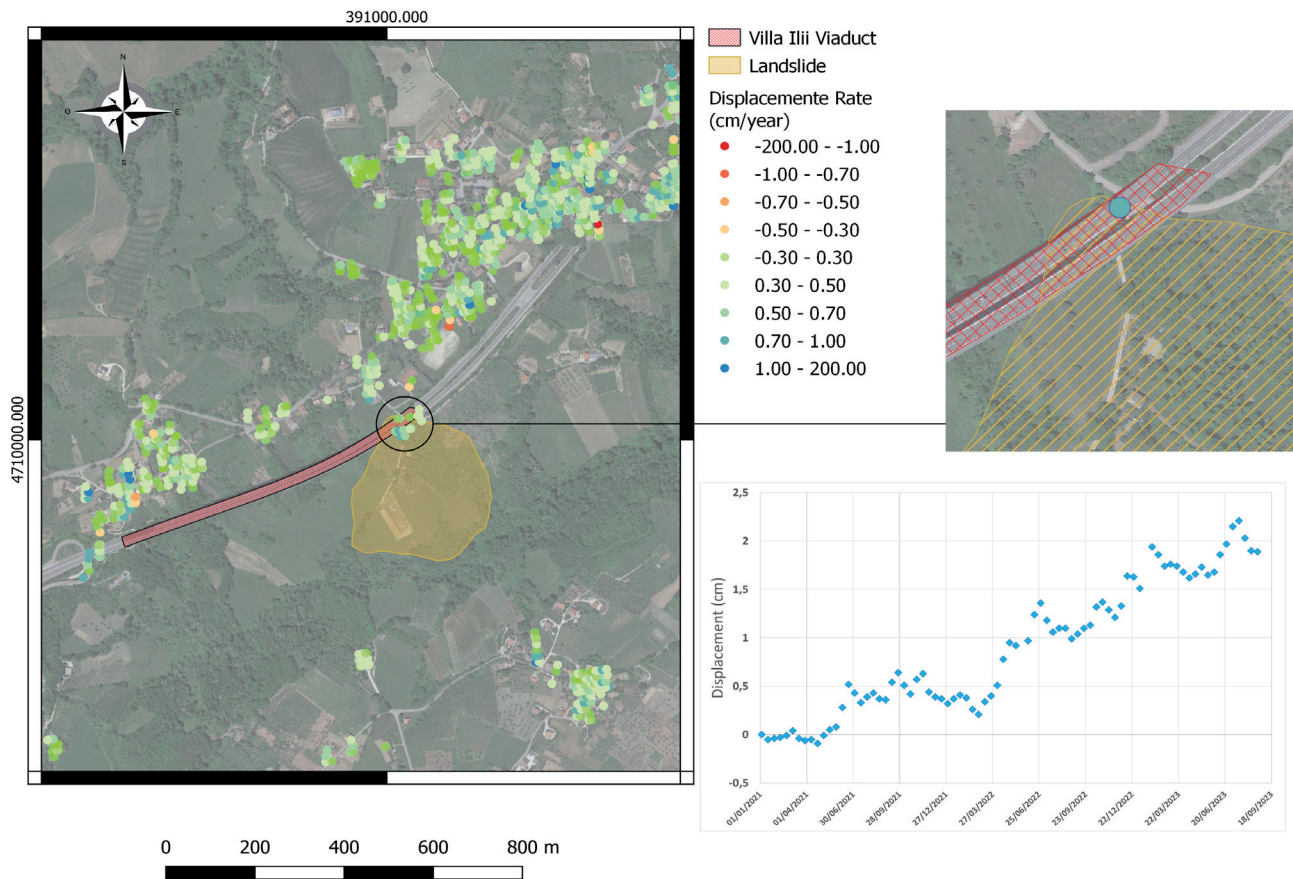
Despite the short period of monitoring, it is crucial to emphasize that a cumulative displacement with a linear progression is highlighted; within this one, it is possible to identify little accelerations during dry periods.

Overall, the recorded displacement rates correspond to slow kinematics, with maximum displacement speeds in the order of a few mm/year.

Fig. 6 - a) Mean displacement rate maps: ascending; b) Time series graph of a Sample PS extracted in the deformation area (right)
