USOY NATURAL DAM: PROBLEM OF SECURITY (LAKE SAREZ, PAMIR MOUNTAINS, TADJIKISTAN)

A.R. ISCHUK

Institute of Earthquake Engineering and Seismology of the Academy of Sciences of the Republic of Tadjikistan

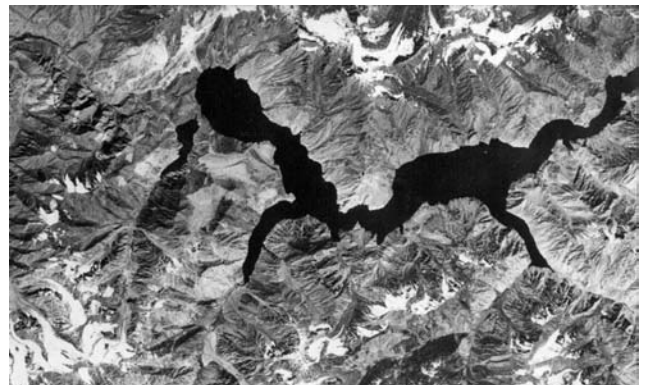
The Lake Sarez is a good example of the outburst flood risk study and assessment. It was formed by strong (M 7.4) earthquake on February 18, 1911 when the huge landslide (about 2.2 km³ in vol-

ume) buried the Usoy village and dammed the Murgab River (Figure 1). Most of the inhabitants were killed (only 4 survived because they were not in the village at that time). The lake started forming upstream from the dam and in Summer-October, 1912 the larger Sarez village (6 km upstream from the dam) was inundated. For this reason the lake was named the Sarez Lake and the dam was named the Usoy blockage. The water didn't pass through the Usoy Dam until 1914 when in the autumn the filtration of water from the lake started and Murgab River appeared again.

Figure 1 - Satellite image of the Sarez Lake, Pamirs Mountains, Tadjikistan
