SINES BREAKWATER HARBOUR: THE OSOM+ MONITORING PROGRAM

This paper presents an application of the OSOM+ program to the study case: the west breakwater of the port of Sines

The (visual and drone) inspections campaigns of this breakwater were carried out on November 13th, 2018.

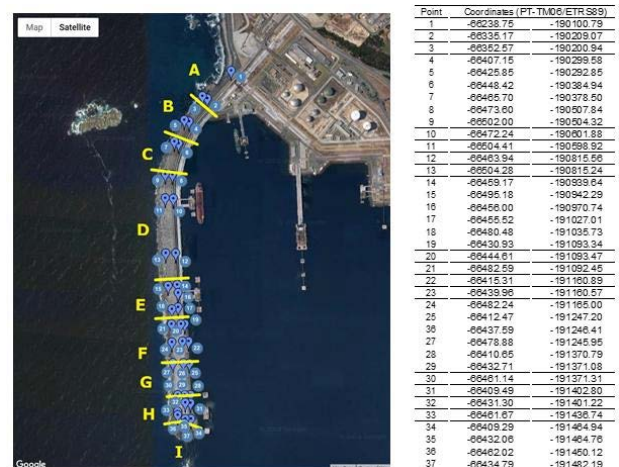
Fig. 6 - Sines west breakwater with division into sections (A to I) and visual observational points (1 to 37), with corresponding coordinates.

For the visual inspection campaign, the structure was divided into nine sections (A to I), according to its different physical and functional characteristics, Figure 6.

Also, notable points considered for each section are marked in this structure. These points (37 points) were ink-marked on the breakwater in order to be used in subsequent campaigns.

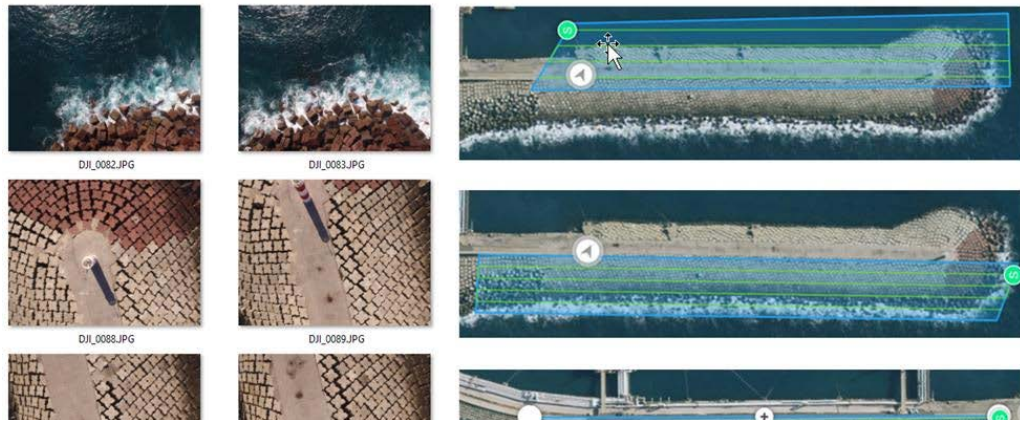
Fig. 9 - Left: examples of six (out of 751) aerial photos; Right: example of three (out of eight) flight plans of drone campaigns.

For the aerial campaign, the flights were automatic, programmed to be performed at an altitude of 30 m and with a photo taking overlapping of 80%. They were made during low tide to maximize the visible area above water. During the flights, 751 photos were taken by the drone, see Figure 9-left, for a number of 8 flight missions, Figure 9-right.

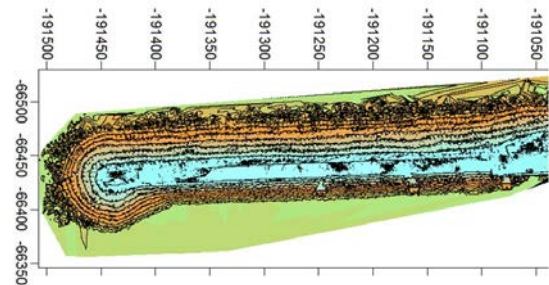
Fig. 12 - Contour maps of the head and adjacent trunk of Sines west breakwater

referred. Figure 10 illustrates the orthomosaic of the breakwater’s head and adjacent trunk – which has a pixel size of around 1.5 cm. Figure 11 shows, as an example, a detail (with a 40% zoom) of the orthomosaic of the head of the west breakwater, where one can attest the excellent resolution attained by the drone. Figure 12 shows the contour maps generated from the point cloud.

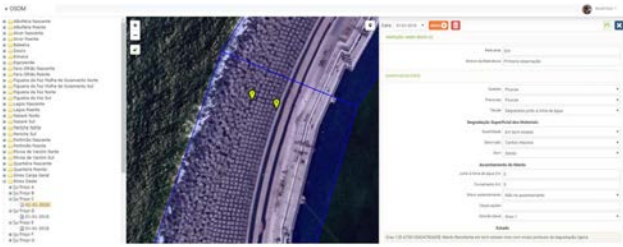
Fig. 15 - ANOSOM_WEB interface. Form inspection of the section C of Sines west breakwater.

Figure 14 and Figure 15 illustrate operations on the database regarding the view of a photo associated to a certain point and inspection.
