RESERVOIR BANK SLOPE IN LAXIWA HYDROPOWER STATION, CHINA

DEXUAN ZHANG^(*) & GONGHUI WANG^(**)

ABSTRACT

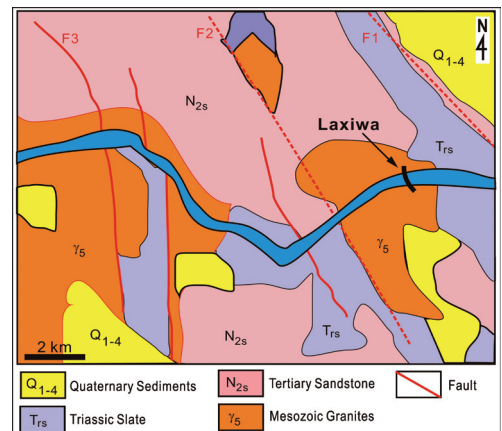
Fig. 4 - Geology map of Laxiwa dam site area

According to the geological map of this area, the bedrocks mainly consist of Mesozoic granites, Tertiary sandstone, Triassic slate and Quaternary sediments, while Laxiwa dam site and the landslide area are Mesozoic granite (Fig. 4).
