THE CASE STUDY OF DEBRIS FLOW HAZARD CAUSED BY TYPHOON MORAKOT IN TAIWAN, 2009

MEEI-LING LIN^(*), KUO-LUNG WANG^(*), TIEN-CHIEN CHEN^(**) & SHEN-CHI LIN^(***)

^(*)Department of Civil Engineering, National Taiwan University, Taipei, Taiwan

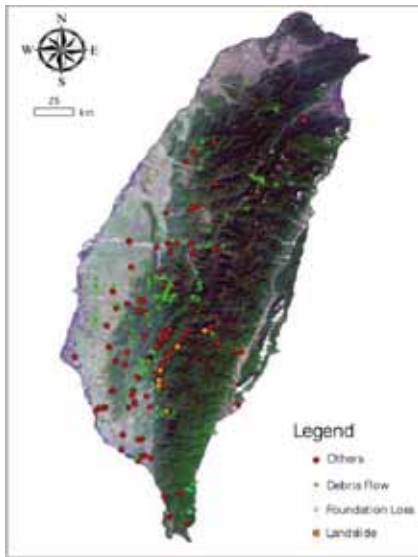
Fig. 1 - Locations of different types of hazards (from DGH, 2009)

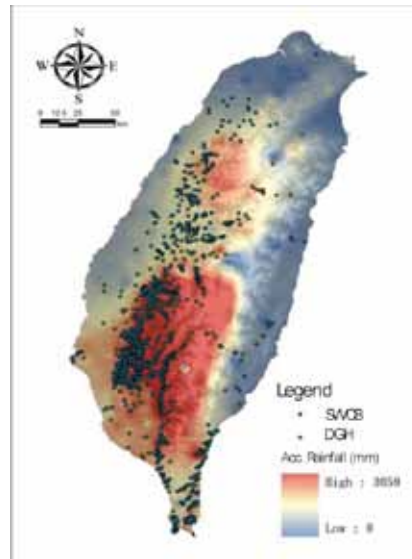
Fig. 3 - The distribution of landslide hazards with rainfall from August 5 to 10, 2009 overlaid with topography

Careful examinations revealed that those cases were debris flows originated from the landslides occurred upstream within the area of heavy rainfall. The results suggest that the major factor causing landslide hazards induced by typhoon Morakot is high accumulated rainfall. The distribution of high rainfall area and landslides were plotted along with topographic map as shown in Figure 3. In Figure 3, it appeared that the elevation increased rapidly in the high mountain areas, and such rugged terrain induced topographical effects which caused high rainfall on high elevation

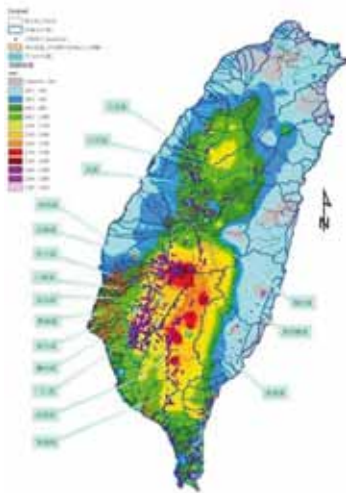
Fig. 2 - The distribution of landslide hazards and watersheds with rainfall from August 5 to 10

for the basins originated from these mountains. The affected areas include Chenyulan river watershed of Juoshuei river watershed, Bazhang river watershed, Jenwen river watershed, Chishan river watershed, Laolun river watershed, Ailiao river watershed, and Taimali river watershed. Severe landslide, debris flow and flooding hazards occurred in each affected watershed; the distribution of landslide hazards and affected watersheds are as shown in Figure 2. Figure 2 illustrated the distribution of identified severe landslide cases with accumulated rainfall. Observing Figure 2, it was found that the locations of severe landslide and debris flow hazards are consistent with high accumulated rainfall area. Several sites located in Taitung county in the east part of Taiwan as shown in Figure 2 which appeared to be different from the trend of rainfall distribution.

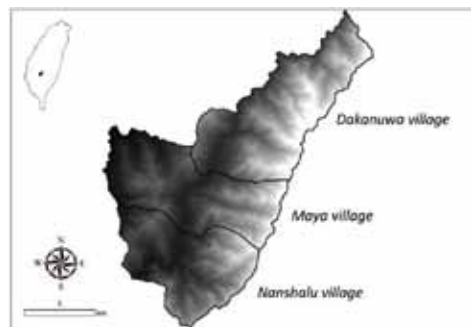
Namasha township locates at the north of Kaoshiung county with Alishan township in north. Nanjishian river flows through the township connecting Kaoping river in the downstream. Three villages, i.e. Nanshalu, Maya, and Dakanuwa villages of Namasha township suffered severe debris flow hazard, and the distribution of villages in Namasha township is as shown in Figure 4.

Fig. 4 - The location of the three villages in Namasha township

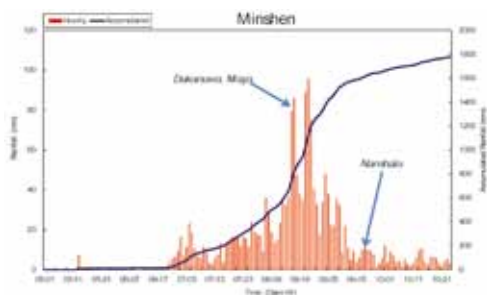
The accumulated rainfall record of Minshen station in Namasha Township was 1778 mm and the maximum rainfall intensity is 96 mm/hr during typhoon Morakot as shown in Figure 11. The accumulated rainfall and intensity were high which induced landslide and followed by debris flow. The elevation varied as much as 1700 meter in the Namasha Township. Main geological formation of these villages is Sanshia group and formation of Nanjishian river is mainly Ruifang group. Sanshia group is mainly consisted with sandstone, shale, and inter-layered sandstone and shale. Ruifang formation in this area is formed by Nangang formation, which is consisted of dark grey shale. The upper part of Nangang formation is mainly structured by thin layered shale with thin sandstone. The geological condition in this area is easy to fracture which results in landslide after heavy rainfall. Most resident areas of these villages locate at lower river terrace nearby Nanjishian river except

Fig. 11 - Rainfall chart of Minshen station during typhoon Morakot

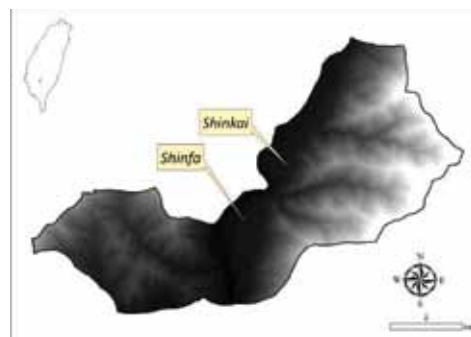
The Shinkai and Shinfa areas are located in Shinfa village, Liugui township, Kaohsiung county. The main road across the area is Highway No. 27 (Shinfa road), which connects to Highway No. 20 and northbound toward South Trans-island Highway and southbound toward Pingtung county. The topographical map of Shinkai and Shinfa areas is as shown in Figure 12. The elevation in the area varies from 300m to 1350m. There is no severe landslide hazard in recent decades except some soil erosion and flooding conditions during typhoon Kalmaegi in 2008.

Fig. 12 - Location and topography of Shinkai and Shinfa

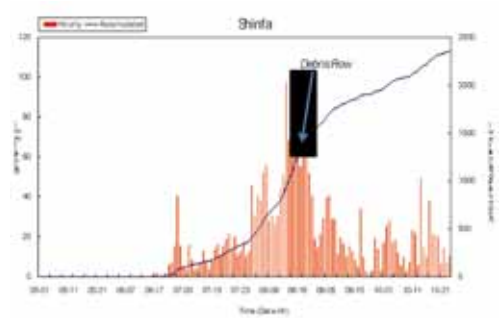
The total rainfall in this area is 2418 mm during typhoon Morakot. The highest rainfall intensity occurred at 1pm, August 8, is 103 mm/hr. The rainfall record in this area is as show in Figure 16. The rainfall intensity higher than 50 mm/hr has lasted up to 10 hours.

Fig. 16 - Rainfall chart of Shinfa station during typhoon Morakot

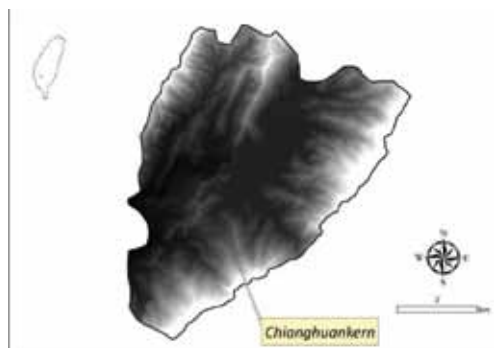
Nanhua township locates at the east part of Tainan county with Kaohsiung county to the east and south. Chianghuankern is located in Yushan village of Nanhua township. The elevation in the watershed varies from 210m to 668m. The major road connecting the site is Highway No. 20. The location and topography of this area is as shown in Figure 17

Fig. 17 - Location and topography of Chianghuankern, Yushan Village, Nanhua Township

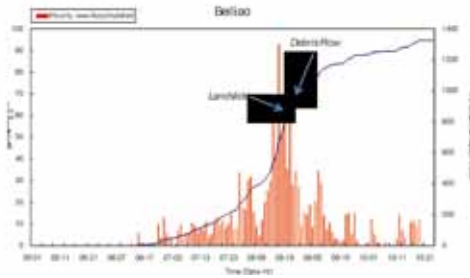
The total rainfall during Typhoon Morakot is 1326 mm and the highest rainfall intensity is 93 mm/hr as recorded by the nearby Beiliao station shown in Figure 20. The elevation of the area decreases from south-east to north-west. The average slope angle in this watershed is about 22.5 degrees, which implies steep slope in the up-stream area. The geological formations in this watershed are mainly consisted with Tangen sandstone and Beiliao shale. Pingshi fault passes through the watershed, resulting in fractured materials and weak strength of rocks. According to the field investigation, there are some large rocks and thick debris deposit located within the resident area before the debris flow occurrence, which suggests that the resident area has been on an old debris deposition area of debris flow.

Fig. 20 - Rainfall record of Beiliao station during Typhoon Morakot

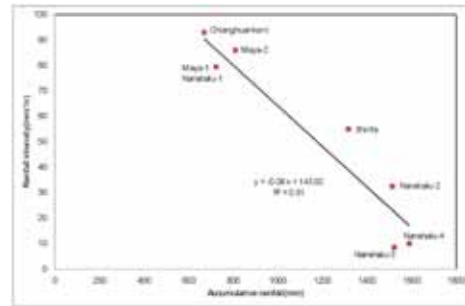
The rainfall records of the debris flow cases in this study were obtained as discussed previously. Based on the reported time of debris flow occurrence, the accumulated rainfall and rainfall intensity at the time of occurrence was determined for each case and plotted in Figure 21. A good linear correlation of data distribution was observed and a linear regression line was plotted as shown in Figure 21. Such linear relationship could serve as the triggering threshold

rainfall for the debris flows in the study area (HONG *et alii*, 2005, BRAND, *et alii*. 1984, WIECZOREK, 1987). Observing the data, it was found that the debris flows occurred with large rainfall intensity usually occurred at the earlier stage of rainfall record, and with smaller amount of debris transportation. While the debris flows occurred at the later stage of the rainfall record, large amount of rainfall accumulated with not so large rainfall intensity. In this stage, the total rainfall accumulation in the watershed is high and often induced large scale landslides, which lead to large amount of debris deposition in the upstream area of the basin. In such cases, the debris flow ended up involving large amount of debris, which caused a very severe hazard. The data point of Nanshalu-4 corresponds to the large scale debris flow triggered by the upstream landslides which dammed-up the river, and the dammed-up lake burst subsequently and caused the large-scale debris flow as discussed previously. The debris flowed downstream and overflowed to the community located near the outlet of stream. Some landslide debris still deposit in the upstream area, and which could be triggered to cause the secondary hazard.

Fig 21 - Accumulated rainfall and rainfall intensity triggering debris flows
