## THE SAN LEO CLIFF IN THE NORTHERN APENNINES, ITALY: SLOPE INSTABILITY AND RISK MITIGATION MEASURES AFTER THE 2014 LANDSLIDE

## ABSTRACT

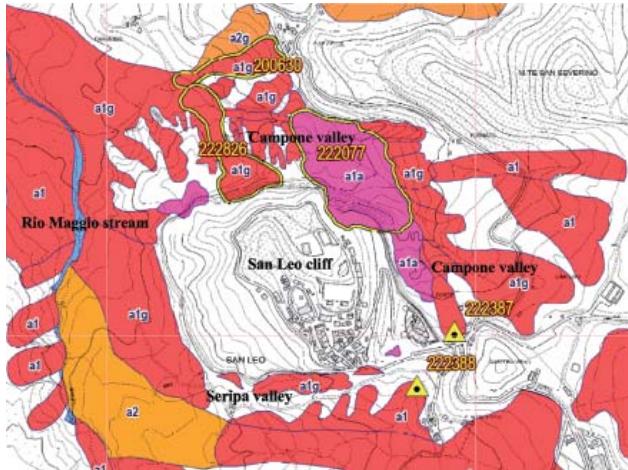
significant imbalance, leading to pronounced erosion and a gradual deepening of the base level. This plays a crucial role in the area's morphological changes and contributes to slope instability at the cliff's base. (Fig. 3).

Fig. 3 - Active landslide deposits surrounding the San Leo cliff, along the Campone and Seripa valleys (from the landslide inventory map of the Emilia-Romagna Region, modified). The Campone and the Seripa streams flow into the "Rio Maggio" stream. Legend: a1=indeterminate active landslide deposit, a1a=rock fall active deposit, a1g= complex active landslide, a2=indeterminate dormant landslide deposit, a2g=complex dormant landslide deposit

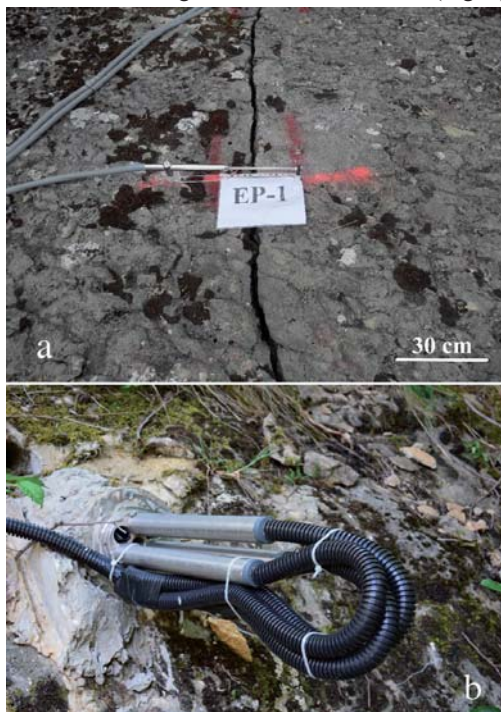
Immediately after the 2014 event, a ground-based SAR was installed opposite to the north-eastern sector for real time control of the residual movement of both the rock wall scar and the rock fall deposits (FRODELLA *et alii*, 2016). Then an integrated monitoring system was installed to control the main fractures (master joints) as identified by geomechanical field survey (LUCENTE, 2014; BORGATTI *et alii*, 2015; BORGATTI & LUCENTE, 2018). It is made up of multipoint borehole rod extensometers, for checking fractures in depth, and wire crackmeters and jointmeters, for checking fractures on the surface (Fig. 8).

Fig. 8 - a) Jointmeters and b) multipoint borehole extensometer

Some fractures are monitored by multiple instruments in order to have more data collected for the same fracture. The monitoring of fractures started in April 2014, and it is still working. The San Leo monitoring system was conceived with a two-folds function, concerning both *i*) study and knowledge and *ii*) alert/alarm.

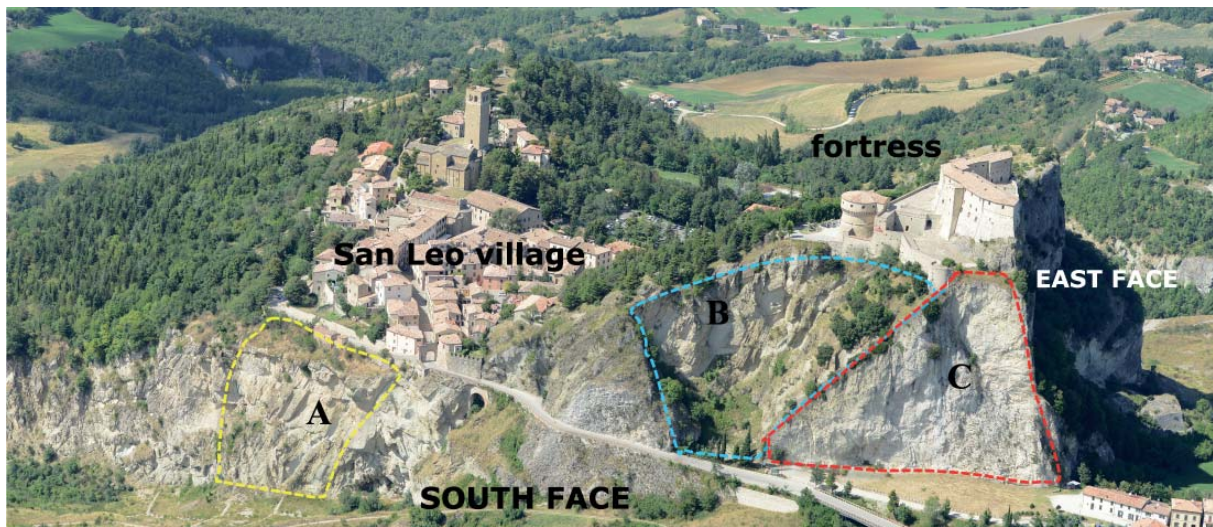
Fig. 16 - The south face of the San Leo cliff divided in three sectors: A, under the San Leo village; B and C, above the access road to the village

road, and the fortress on the southeast corner of the cliff, thanks to the interventions implemented over nearly 40 years (Fig. 16). However, the progressive alteration of the rock subjected to atmospheric and other external agents, occasional small collapses, and the lack of maintenance on completed works need attention. This is particularly important in terms of risk exposure and the vulnerability of the assets involved. Therefore, in recent years, especially following the dramatic event of 2014, there has been a need to implement additional measures to reduce risk. For this purpose, leveraging prior knowledge, a multidisciplinary study was carried out following the same approach used at the 2014 event. This involved photogrammetric and topographic surveys, geo-structural assessments, geomechanical analysis of the rock mass, stability evaluations, deep core drilling from the cliff's top to the clayey substrate, and laboratory tests. A detailed geological survey was conducted using mountaineering techniques to determine the structural layout and geomechanical properties of the walls. The geological survey allowed to identify the main discontinuities, the unstable volumes (Fig. 17), and to check the works already made on the wall. The results of the geo-structural survey emphasized the necessity to conduct consolidation interventions on the southern slope of the cliff. This need is further underscored by the ongoing high-risk conditions, despite previous intervention efforts.

A second intervention, awaiting financing, concerns sectors B and C of the south wall (Fig. 16).

Even the rock face below the fortress (sector C, Fig. 16) has undergone reinforcement and consolidation in the past through nailing (LUCENTE, 2019 and references therein). This process aimed to secure the loose superficial rock layer (superficial nailing) by anchoring it to the solid rock beneath (deep nailing) (D’AMBRA *et alii*, 2004).
