SENIGALLIA HISTORIC TOWN WALLS: MATERIALS AND STABILITY ANALYSES

PAOLO BUSDRAGHI, FRANCESCO VENERI & VALENTINA IAMPIERI

EXTENDED ABSTRACT

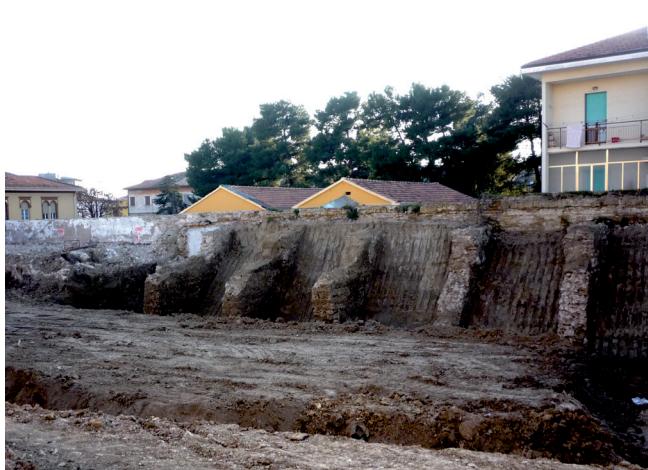
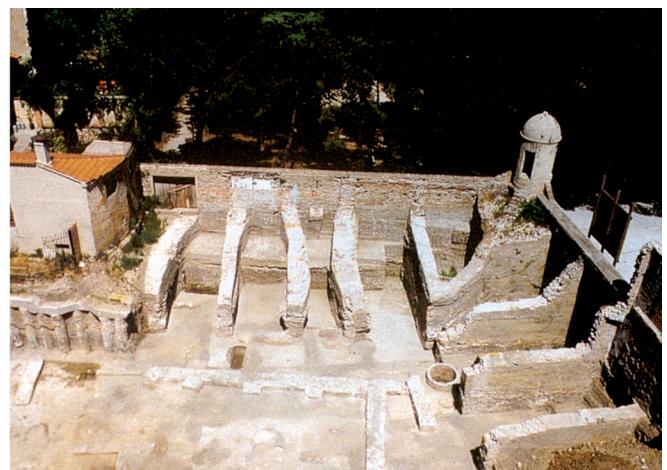
Fig. 4 - Della Rovere walls: spine walls in the excavation site of the Baluardo del Porto (left) and of the new Teatro La Fenice within the San Martino Bastion (right) (RAGGI, 2013)

The cortina walls have an average width of about 170 cm at floor level; due to tapering, it is reduced to about 60 cm at the top, which is embellished by perimetral calcarenous circular edgings. Well-connected orthogonal spine walls stem from the cortina wall to create a structural link between masonry and rampart (Fig. 4).

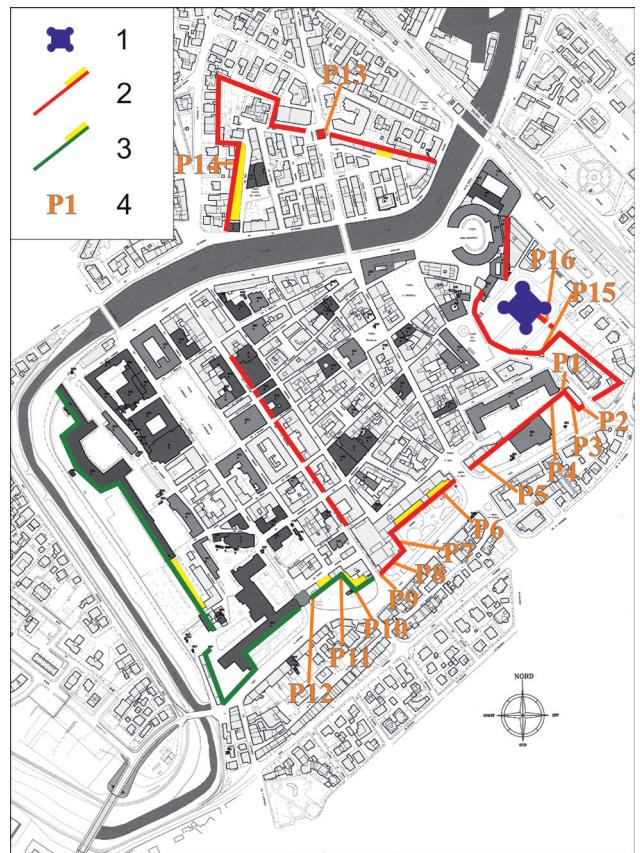
As described above, the Senigallia historic town walls are made up of bricks and, to a lesser amount, of blocks of stone (mainly calcarenite), with a mortar binder. In order to characterize these constituents, 16 1m x 1m 'sample squares' have been chosen (Fig. 8); they represent different degradation scenarios, as well as the construction characteristics of the diachronic phases. For each station, in addition to the photographs, macroscopic analysis have been made, with archeometric description and state of degradation evaluation, highlighting different employment typologies, from structural to joint utilization, for the mortar.

Fig. 8 - Senigallia city map with, in color, the perimeter of the three main construction phases of the urban walls: 1) the Rocca Roveresca (end of XV Century); 2) the Renaissance walls (XVI Century); 3) the eighteenth century walls and 4) location of the 16 survey sites. The yellow coloured bands indicate the sections in which rampart is preserved

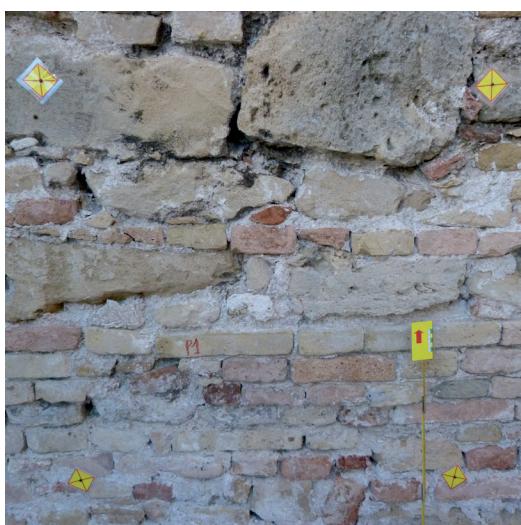
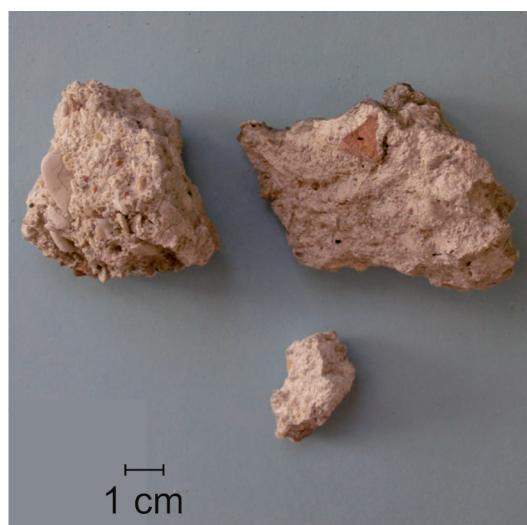
Then, from each 'sample sites' small parts/portions of mortar have been collected (Fig. 9) to be destined for ESEM microscopic observation and X-ray diffractometry, so as to, consequently, characterize the mortar to be utilized in operations of preservation and restoration. This will ensure an affinity with the original materials, both for durability and, more importantly, will not damage the pre-existing structure. In addition, ad hoc investigations have been carried out for the physical-mechanic characterization of the mortars with the following parameters: gravity weight (G_s), dry unit weight (γ_d), porosity (n), inbibition coefficient in weight and volume ($I.C.w$ and $I.C.v$) and saturation index ($S.I.$). Finally, given the aims of this study, to evaluate the entire wall structure resistance under compressive and/or shear stress and, at the same time, to verify the overall stability conditions along with the foundation soils, even the mechanical properties of wall less resistant materials, i.e. the mortars, have been determined.

Fig. 9 - Left: part of sample P1 (1m x 1m) in which four reference points in cross formation mark the extremities; Right: mortar sample taken from this site

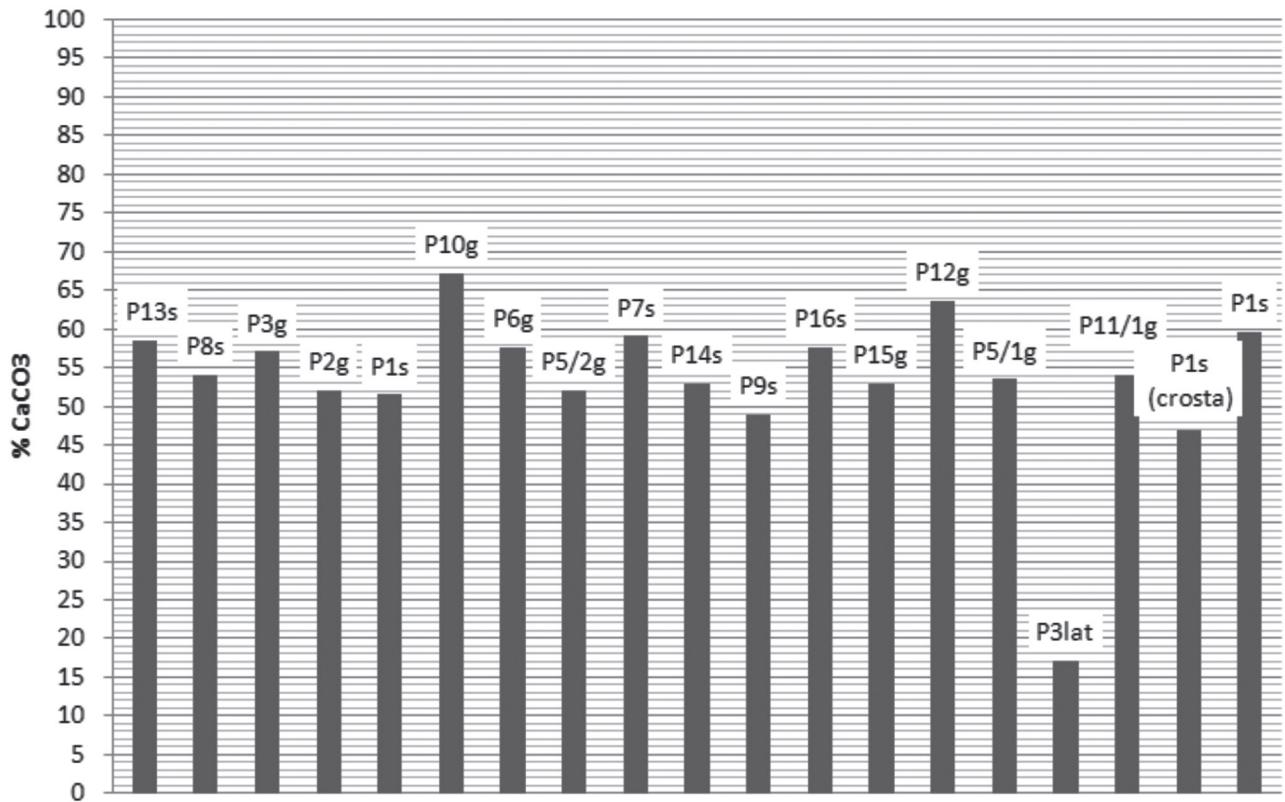
fragments at around 600-650°C (BUSDRAGHI *et alii*, 1994). They are defined as 'bastard' for their poor purification from their non-carbonated fraction and/or containing a certain amount of non-hydrated calcium oxide (quick lime lumps), giving rise to mediocre physical-mechanical characteristics (the total of samples taken/observed break apart easily with mere pressure of the fingers) with earthy appearance. The inert, with a 2:1 ratio presence to the binding material, is part carbonate, part silicate, with a relatively dispersed grain size distribution, medium-

Fig. 12 - Calcium carbonate content test results. s = structural mortar, g = mortar joints, lat = brick sample

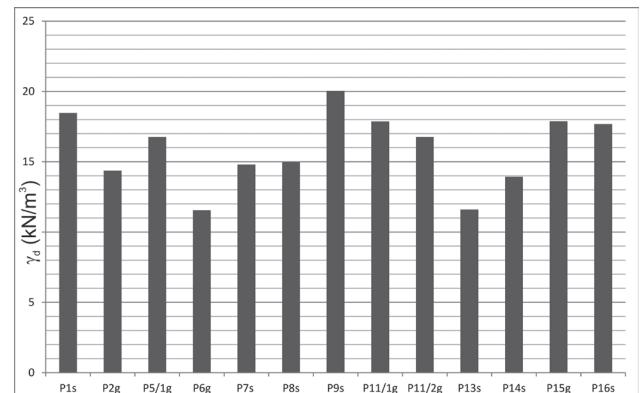
A sand volumetric method analysis was chosen to define the mortar dry unit weight γ_d , given the highly irregular shapes of the small samples collected, elevated porosity and permeability of the material tested, making it very difficult to utilize other analytical methods. A sand pycnometer was custom built to solve this problem; the results are shown in Figure 13, yielding a mean value of $\gamma_d = 15.9 \text{ kN/m}^3$. This value is rather low in comparison to the characteristics of a similar mortar, the latter oscillating between $16.7-17.6 \text{ kN/m}^3$, but it is nevertheless close to the mortar used in the same era in the Urbino walls. (BUSDAGHI *et alii*, 1994). The low values of γ_d (see also the elevated porosity values and the consequent absorption levels) are to be contextualized along with the presence of newly-formed minerals (transformation/dissolution - cf. Tab. 2)

Fig. 13 - Dry unit weight γ_d value determination through the sand volumeter method
