Hydraulic mortar and problems related to the suitability for restoration

Nadia Bianco¹, Angela Calia^{1,*}, Giampiero Denotarpietro² and Pietro Negro²

Key words: hydraulic restoration mortar; properties; porosimetry; durability; compatibility.

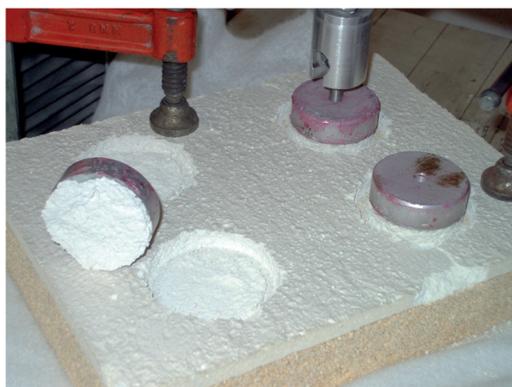
Figure 1. Adhesive strength test on the stone/mortar composite specimen.

- adhesive strength test (UNI EN 1015-12) (Figure 1).

Interesting results were also obtained by the adhesive strength test. This test provides the adhesive power of the rendering mortars but it also records the type of fracture related to the pulling out of the mortar layer from the underlying support. The test was carried out using CP and CS stone as supports, in order to evaluate the behaviour of the mortar with respect to the soft and porous stones.

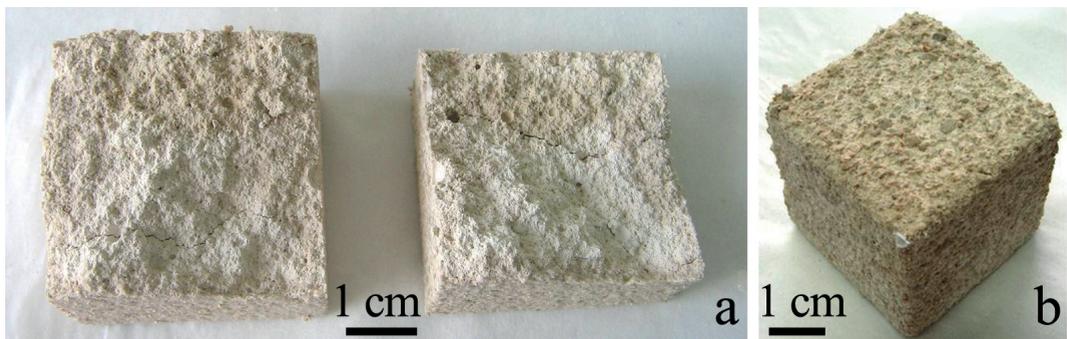
Figure 9. Broken sample with the evidence of internal fissures (a); sample after 15 cycles, showing material loss from the surface by granular disintegration (b).

part of the broken samples (Figure 9a). Damage by salts crystallization occurs when the pressure developed by the salt growth exceeds the tensile strength of the material. An adverse role with respect to the mortar durability could had been played by microcracks occurring during the shrinkage, that were observed microscopically. Shrinkage microcracking was found to strongly decrease the flexural strength of mortars (Velosa et al., 2009). Their random presence could explain why certain samples broke and other are able to resist to the salt action.
