## EXAMPLES OF CLIFF INSTABILITY ALONG THE APULIAN COASTLINES

## ABSTRACT

This paper proposes an overview of the different typologies of cliff instability typically occurring along the Apulian coastlines, along with the failure mechanisms and the factors controlling the

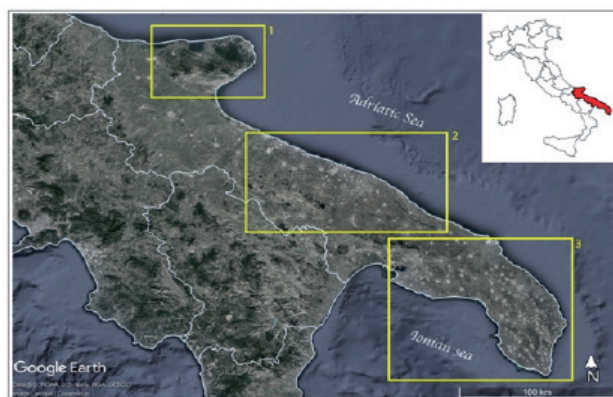
Fig. 1 - Study site locations. Yellow rectangles represent the three considered areas: 1. Gargano Promontory, to the north, 2. Murge Plateau, central sector, and 3. Salento Peninsula, to the south

The coast of Apulia is characterized by a total length of about 900 km (Fig. 1), and is composed by three alternating morphological types: cliffs, beaches and slopy rocky coasts (CALDARA *et alii*, 1998).

In this section, we describe some examples of Apulian cliffs affected by instability (Fig. 1), covering the main sectors in the region, and that greatly contribute to the geo-hydrological disasters occurring in Apulia (VENNARI *et alii*, 2022).

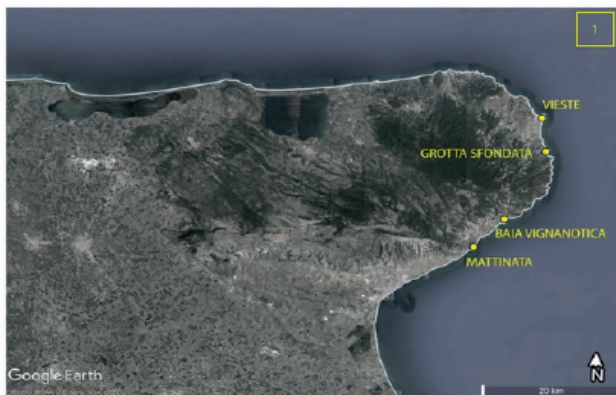
Fig. 2 - Gargano, Northern Apulia: detail of the study sites

The studied coastal sector of Gargano Promontory (Fig. 2), in northern Apulia, is highly variable in terms of geology.

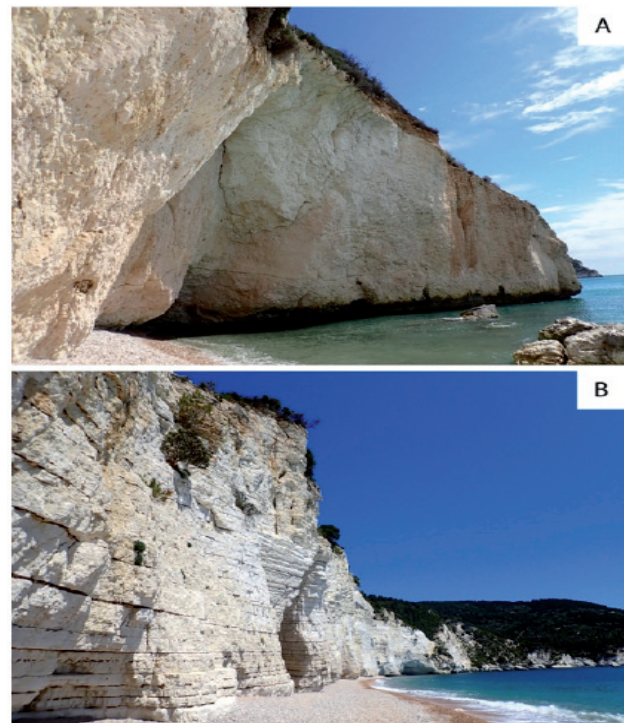
Fig. 4 - Limestone cliffs in the Gargano Promontory: A) massive limestone; B) limestones with flint layers and nodules

Moving further north, still in the Gargano Promontory, it is possible to recognize cliffs in stratified Cretaceous limestones with flint layers and nodules (Baia di Vignanotica, Vieste, etc.) (Fig. 4). In this case, due to the high cementation degree of the rock matrix, cliff failure processes are mostly controlled by the

existing bedding planes and the structural features in the rock mass. Locally, there are also many sites where the effects of karst strongly interact in producing peculiar morphologies, such as at Grotta Sfondata (Fig. 5), with the collapse of the vault above marine and karst caves, through sinkhole processes (GUTIERREZ *et alii*, 2014; PARISE, 2019, 2022).

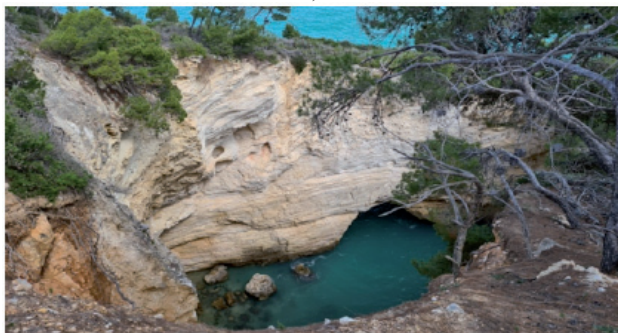
Fig. 5 - Grotta Sfondata (Vieste, Gargano). Limestone cliff affected by karst processes leading to collapse sinkhole

The deriving morphology, often characterized by possibility of further detachments, are highly attractive in terms of tourism, and heavily frequented during the summer, with significant increase as concerns the presence of vulnerable elements.

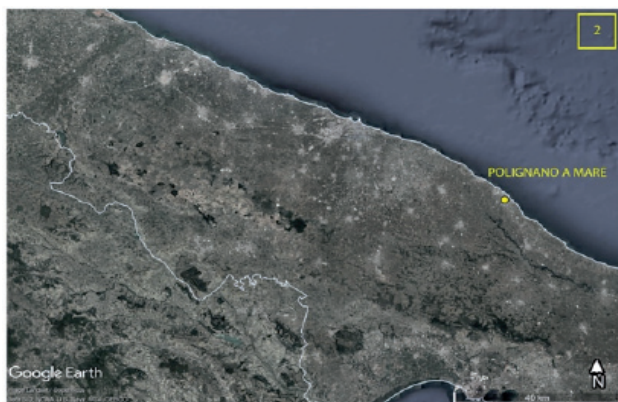
Fig. 6 - Murge, central Apulia: detail of the study site

In central Apulia, the cliffs in the coastal area of the Murge Plateau are characterized by Cretaceous limestones, fractured and intensively affected by karst processes (SAURO, 1991; PARISE, 2011), with presence of many caves, and development of typical karst valleys, known as lame (PARISE *et alii*, 2003). Most of the Murge coastal stretches are low cliffs alternating to beaches, but the case of Polignano a Mare represents an exception (Fig. 6).

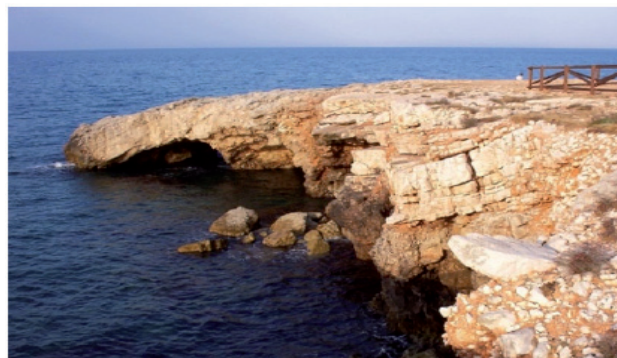
Fig. 7 - Planar failures along bedding planes in the proximity of "Grotta Chiar di luna" cave (northern coastal stretch of Polignano a Mare)

Locally, the erosion mechanisms along the coast are very different and, other factors being equal, they are strictly influenced by lithology and rock strength. In fact, the coast stretches where vertical or overhanging cliffs show mainly exposures of soft and porous calcarenites are more susceptible to weathering and slope instability than those where fine-grained limestones predominate, even though the pattern and density of joints in the latter might be higher and more complex. In contrast to fine-grained limestones, the medium-grained calcarenites are more porous, loosely packed and weakly cemented; for these facies, weathering, mainly due to wetting/drying cycles and salt crystallization, is uniformly distributed in the rock mass and promote decay mechanisms and material disintegration. Three mechanisms of cliff instability can be recognised: slides, falls and topples. Planar failures along dip seaward bedding planes, which are evidence of folding, occur where the coast develops in fine-grained limestones and calcareous breccias, in correspondence of the northern coastal stretch of Polignano a Mare (Fig. 7).

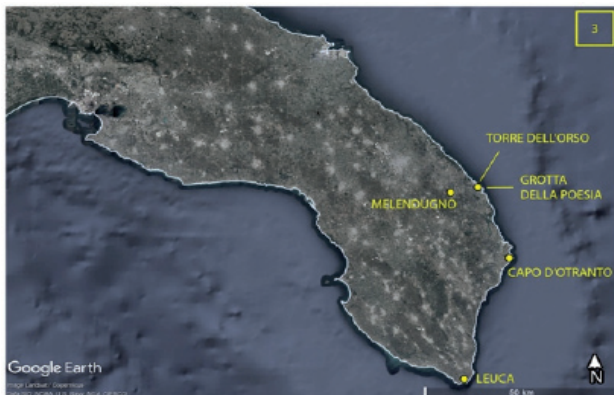
Fig. 8 - Salento, south Apulia: detail of the study site

On the Adriatic side of Salento Peninsula, the main typical cliffs are made by soft to very soft rocks, in particular Plio-Pleistocene calcisiltites and calcarenites, leaving space to outcrops of Cretaceous-Oligocene limestones along the southernmost coastal sector, from Capo d'Otranto to Leuca (Fig. 8).

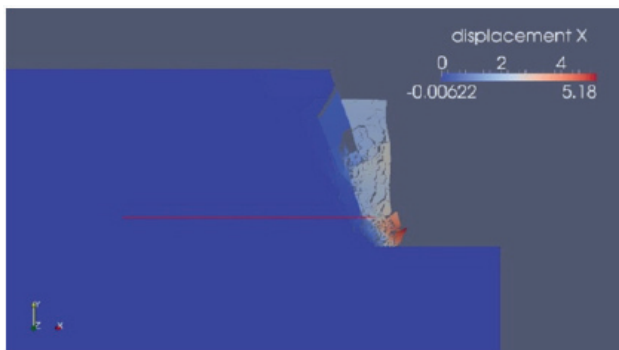
Fig. 10 - Numerical results of a FEMDEM ideal model of the Melendugno cliffs

These studies have been developed by means of either finite element method or more advanced hybrid finite/discrete element techniques and highlight the different role of toe erosion and rock weathering, as well as the structural control due to joints and faults in conditioning the failure process. As an example, Fig. 10 shows the results of the application of the finite/discrete element technique (FEMDEM, MUNJIZA 2004) to an ideal cliff representative of the Melendugno coastal stretch: it clearly indicates a brittle failure mechanism of the cliff as a consequence of a slightly inclined joint structural control, combined with sea erosion at the toe.
